TIR GOFAL MANAGEMENT PLAN: HERITAGE MANAGEMENT INFORMATION (HE2)

**Prepared for:
Cefncoed Mawr**

**Tir Gofal Reference No
W/12/4763**

**ACA Report No. 2005/29
Project Record No. 49572**

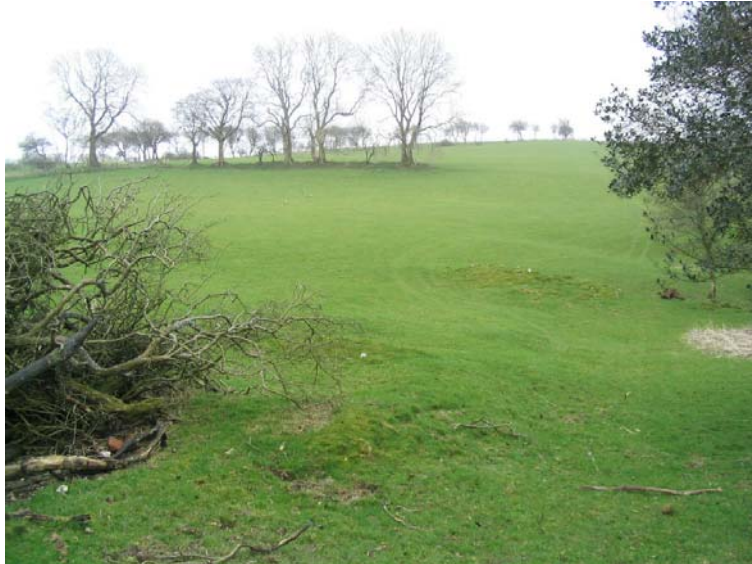
The structures are still marked on the 1st edition Ordnance Survey map of 1888 but they may have been abandoned by this time. The site is now divided by a field boundary. On the eastern side of the boundary earth and stone banks c0.5m high define a rectangular structure at the northern end of a level platform c12m long, defined at its southern edge by another short bank. An area of levelling on the western side of the field boundary probably defines the associated yard and gardens. Former trackways run off to the northwest and southwest. The site lies in improved fields, grazed by sheep and divided by a wooden post and wire fence. The majority of the site appears in a relatively stable condition, although a long standing large pile of dead wood partly covers the northern end of the structure, preventing grass growth. *Visited 21/03/2005 (Phil Poucher)*

Looking southeast across the building remains of Tynlan/Penlan Dole farmstead. The pile of deadwood is visible at the edge of the photo.

No ground breaking should be undertaken within 10m of this site. The area of dead wood should ideally be moved away from the site, to prevent damage from in situ burning and allow a protective grass cover to re-grow. Care must be taken when removing brash, any machinery used will have to avoid the archaeological area, preferable done on dry day when ground breaking will be less likely from machinery.

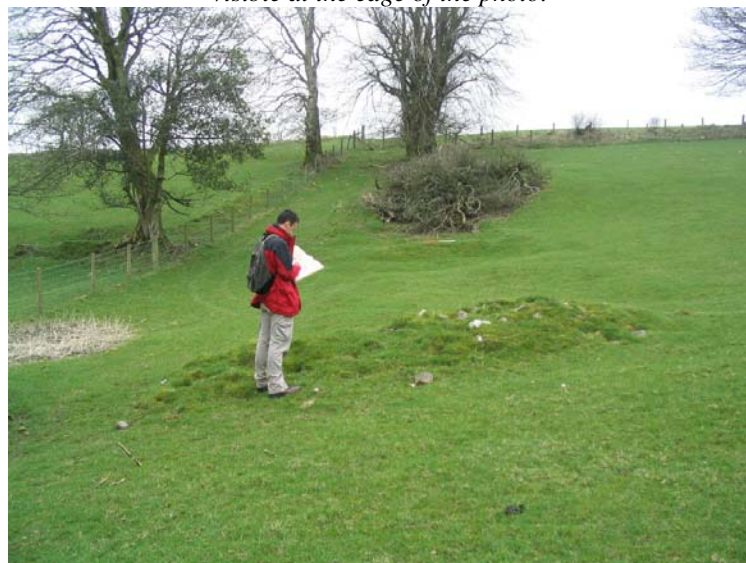
Looking northwest across the buildings remains.

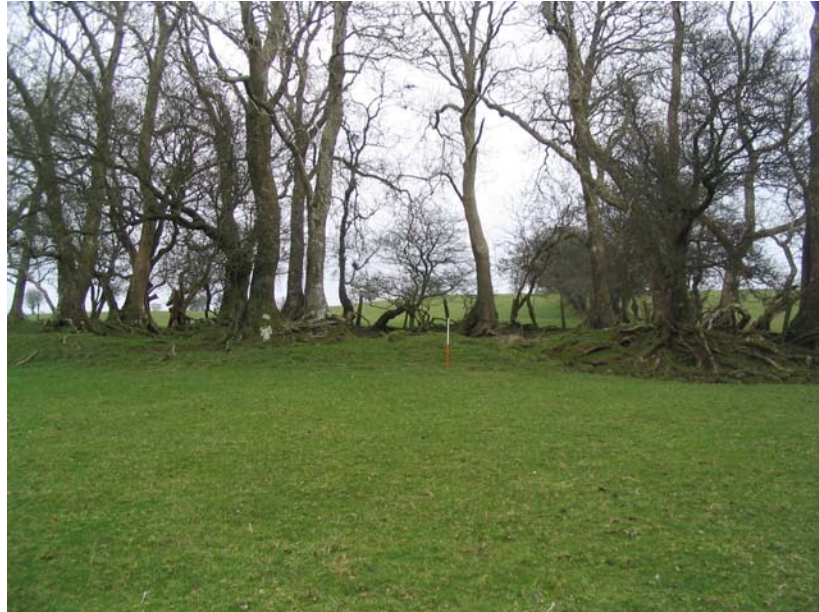
A square enclosure in the corner of the field marked on the 1st (1888) and 2nd (1906) edition Ordnance Survey map. Still visible, defined by four low (c0.8m) and broad (c2.5m) banks. Mature trees grow on the banks, no internal features are visible. The interior is covered in bits of dead wood and is often used by sheep as a shelter during bad weather. Erosion scars have been noted on some of the banks, and tree cover is preventing the re-growth of low vegetation. Hedgerows are due to be established along the field boundaries forming the eastern and southern edges of the enclosure. *Visited 21/03/2005 (Phil Poucher)*

Looking east at the banks of the enclosure with mature trees growing along them. 1x1m scale.

Mature trees along the banks do define this feature however they are also preventing grass growing and are unlikely to be replaced by new trees once they fall. Erosion scars have also been noted on the banks, presumably caused by sheep using the enclosure as shelter during bad weather. Hedgerows are due to be established along the field boundaries forming the western and southern boundaries of this enclosure, these could be extended around the enclosure, some mature trees may have to be removed to allow vegetation re-growth inside. To retain this as a sheep shelter a gateway may be required to restrict access and allow the erosion scars to repair.

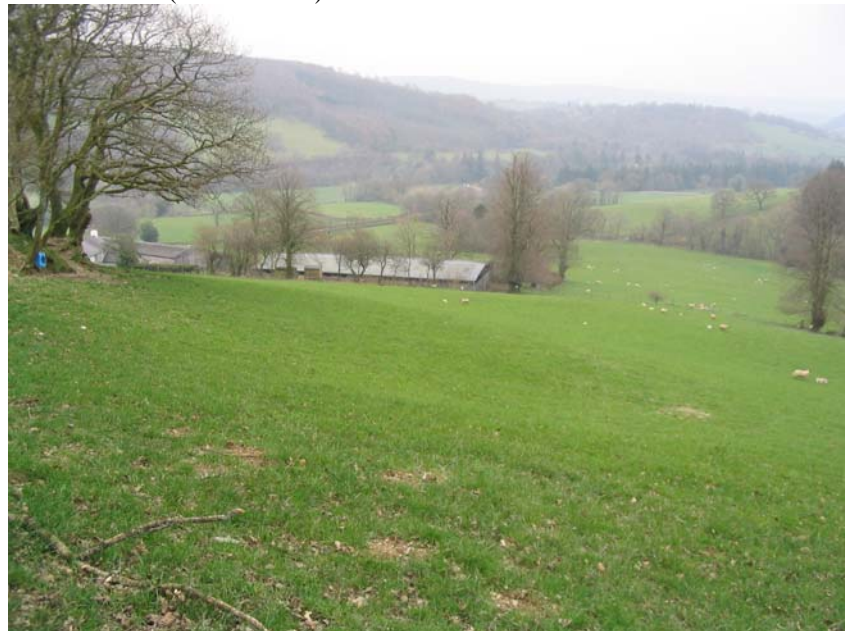
A site numbered on an estate map of c1770. No feature is drawn but the site is described as 'Site of Ty yr handy House'. Although no building is actually marked on the map water channels dug in the mid 18th century convey water to this site, indicating the house probably existed at that time. Any structural remains appear to have been long gone by the mid 19th century however, as no features are marked in this area on either the Ordnance Survey original surveyor drawing of 1819/20, or the 1st edition Ordnance Survey map of 1888. Today this site is visible as a level area cut into the top of the field in front of a kink in the field boundary. The area has been 'softened' by ploughing and no definite identifiable remains of the house can be traced, but the siting of the house is still clearly visible. The site lies in a field of improved grassland, grazed by sheep. *Visited 21/03/2005 (Phil Poucher)*

Looking southeast at the site of the former house, visible as a hollow/level area in the sloping field.

Although ploughed in the past ground breaking activity should be avoided within this hollow/level area.

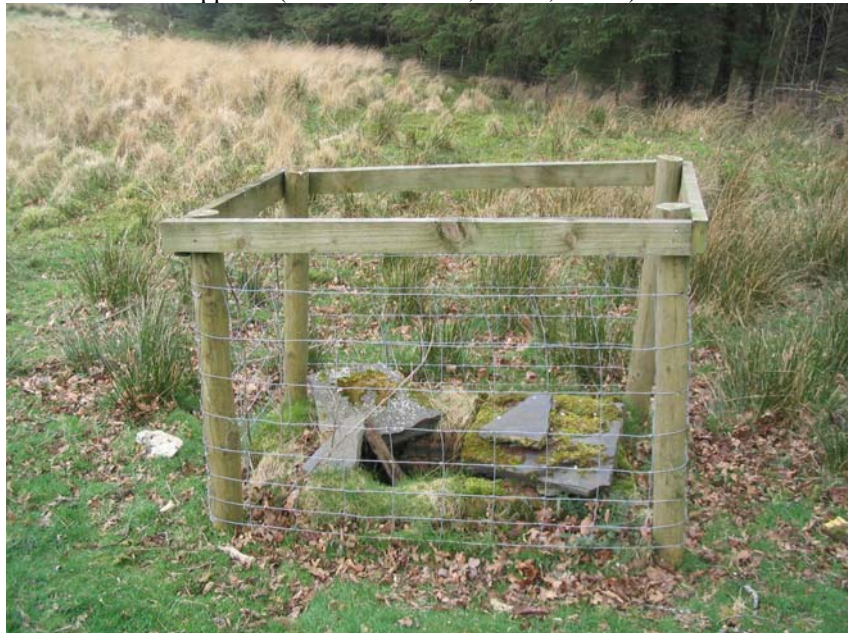
A brick built well, now fenced off. The well is of interest since it represents the continuation of a tradition of using this field for local water supplies. (See PRNs 49967, 49970, 49971) Visited 21/03/2005 (Phil Poucher)

The fenced off brick built well, with broken slate covering.

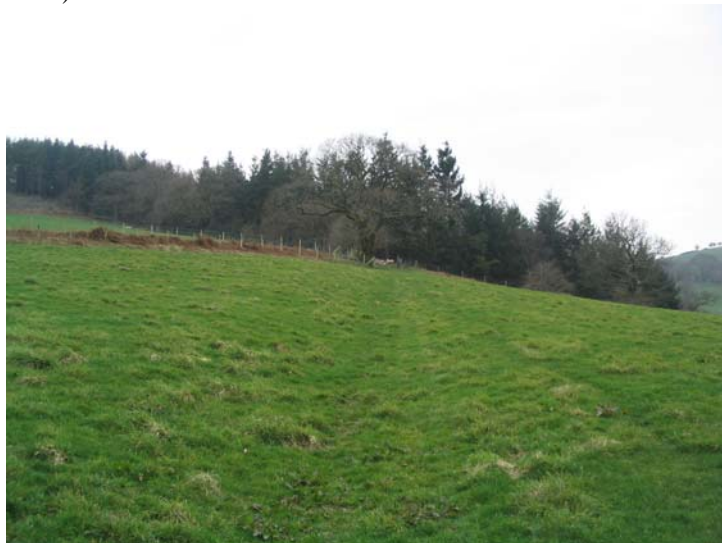
A trackway seen on an estate map of around 1770. The track still survives, but has been re-surfaced for much of its length within the woodland and part of it is also open as a public walk through the woods. The line of the trackway is still traceable through the improved fields to the south of the woodland. *Visited 21/03/2005 (Phil Poucher)*

Looking north along the line of the trackway.

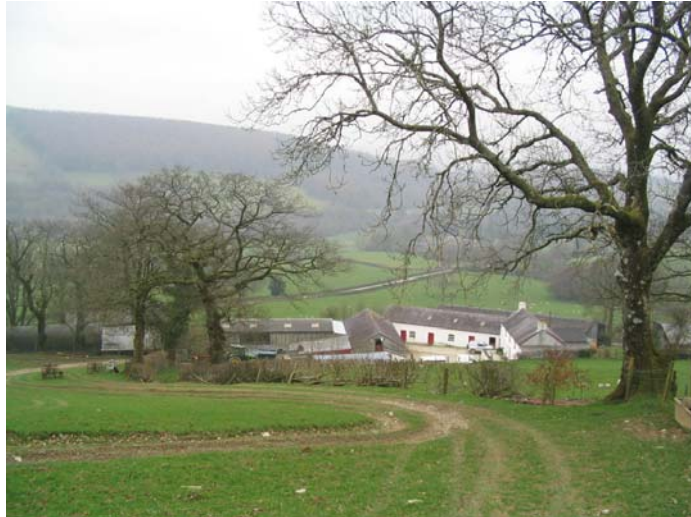
A farmstead complex including traditional buildings which have been grade II listed as a representative example of an unspoilt upland farmstead. The farmhouse has been dated to the mid to late 18th century, remodelled in the later 19th century when the walls were raised and the farmstead rearranged. The barn range opposite was remodelled at this time from an earlier barn with a somewhat unusual plan. An early 19th century cow shed to the south with an integral lofted stable was extended and re-roofed in the late 19th century. All three of these buildings are whitewashed regularly with woodwork painted red, consistent with the Dolaucothi estate, as requested by the National Trust. More modern animal and storage metal sheds surround the farmstead. An estate map of c1770 marks garden enclosures to the west of the farmhouse, this area is now occupied by a large cattle shed. The listed buildings are well maintained by the current farmer, in accordance with the wishes of the owners, the National Trust. The barn and cow shed are still in use housing cattle and storage (see also management prescriptions section ii). *Visited 21/03/2005 (Phil Poucher)*

Looking south over the farmstead complex.

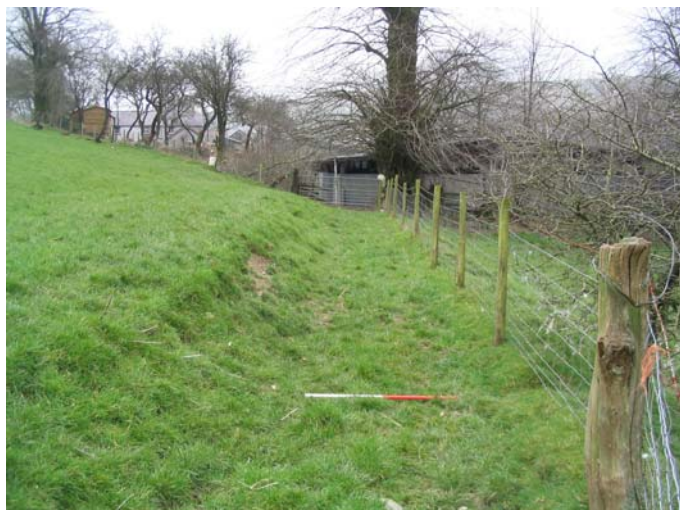
The approximate line of a water channel marked on an estate map of c1770 providing water to Cefn Coed Mawr. The channel is described as 'made by Richard Davies about 30 years last' (ie c1750). A trench roughly 1.5-2m wide and 0.5-0.7m deep can be traced along the southern field boundary, running towards Cefncoed Mawr farmstead, this may represent remains of this water channel. *Visited 21/03/2005 (Phil Poucher)*

Looking east along the line of the possible former water channel. 1x1m scale.

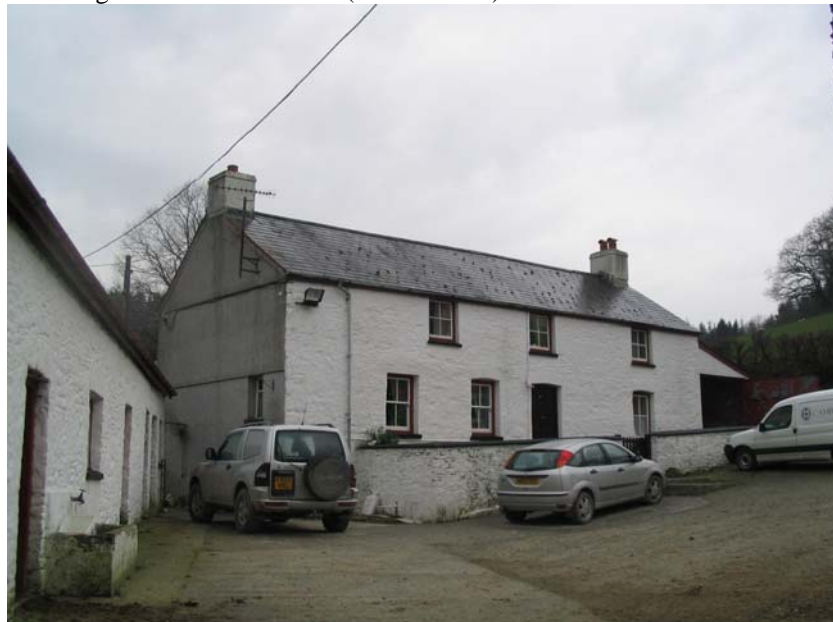
A farmstead complex including traditional buildings which have been grade II listed as a representative example of an unspoilt upland farmstead. The farmhouse has been dated to the mid to late 18th century, remodelled in the later 19th century when the walls were raised and the farmstead rearranged. The barn range opposite was remodelled at this time from an earlier barn with a somewhat unusual plan. An early 19th century cow shed to the south with an integral lofted stable was extended and re-roofed in the late 19th century. All three of these buildings are whitewashed regularly with woodwork painted red, consistent with the Dolaucothi estate, as requested by the National Trust. More modern animal and storage metal sheds surround the farmstead. An estate map of c1770 marks garden enclosures to the west of the farmhouse, this area is now occupied by a large cattle shed. The listed buildings are well maintained by the current farmer, in accordance with the wishes of the owners, the National Trust. The barn and cow shed are still in use housing cattle and storage. *Visited 21/03/2005 (Phil Poucher)*

Looking west at the farmhouse.

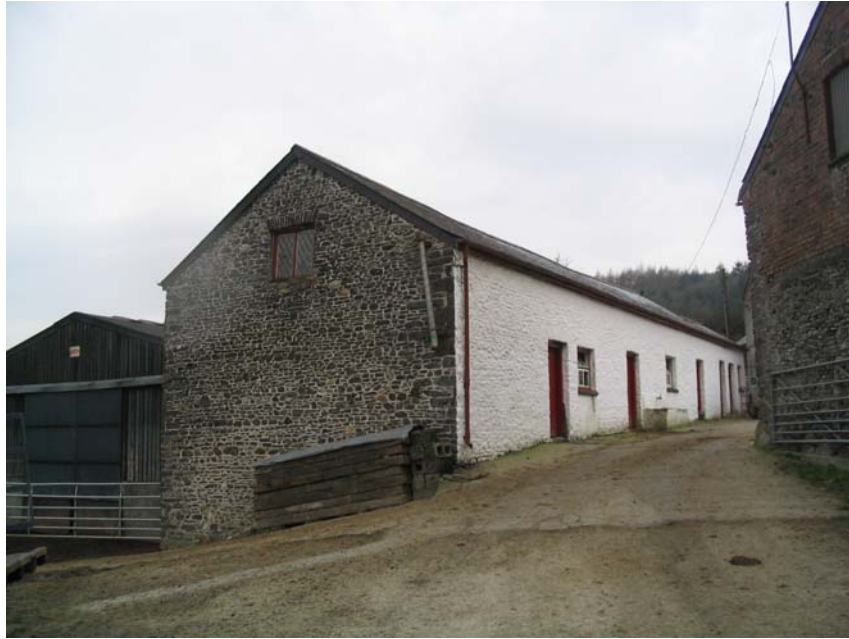
Looking west at the cow shed.
