HEN GAER HILLFORT, TIR-Y-MYNACH, CEREDIGION

ARCHAEOLOGICAL WATCHING BRIEF, 2003-4

Report No. 2004/50

Report Prepared for:
SCOTTISH POWER SYSTEMS LTD.

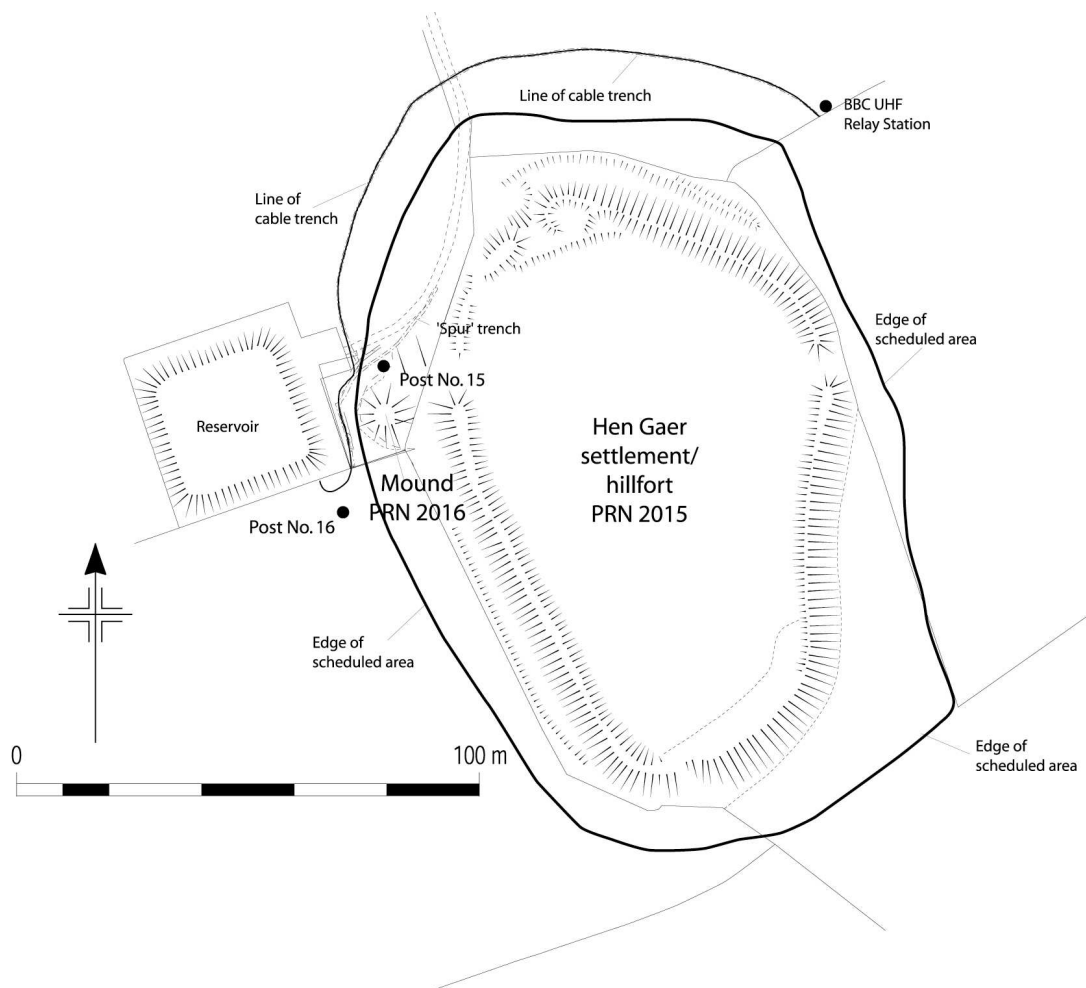
Fig. 2 - Plan of site showing scheduled area and cable trench

The cable trench was designed to connect two points either side of the northern part of the Hen Gaer Enclosure (see Fig. 2). However, in order to avoid the water pipes leading east from the modern reservoir, it became necessary to route the cable between the reservoir and the entrance mound (PRN 2016). Although this line was just outside the scheduled area, the trench did impact upon the hillfort and archaeological deposits were disturbed.

A further site visit was made on 11 February 2004, to observe two trenches being excavated to house two electric posts (Fig. 2).

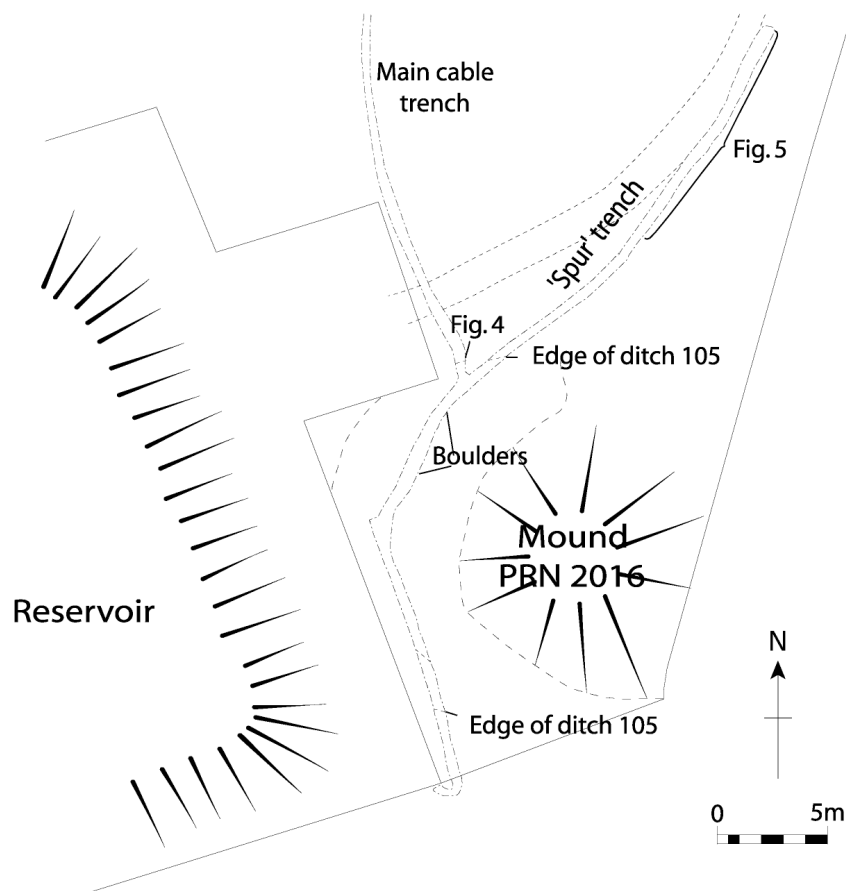
Fig. 3 - Plan of western section of trench, and 'spur' trench

Moreover, due to confusion between two sets of plans which had been drawn up by the client, the initial, western section of the trench was mistakenly continued eastwards by the contractor, as a 'spur' that ran through the scheduled area for a distance of 50m (see Fig. 3). The watching archaeologist contacted Cambria Archaeology Heritage Management (CA-HM), who in turn contacted Cadw, and a site visit was made on 22 October 2003 by Helen Burnham (Cadw Regional Inspector) and Lucy Bourne (CA-HM). An amended route was agreed, which ran at least 10m outside the scheduled area thereby limiting the risk of damage to potential archaeological deposits.

The westernmost section of the trench ran approximately north-south, to pass between the reservoir and the entrance mound PRN 2016 (Fig. 3). This section was approximately 25m long and, for almost its entire length cut through the fill of a large ditch [105] which followed the curving base of the mound and almost certainly represented the construction ditch for the mound (Fig. 4). Although the ditch had not been sectioned it was faintly visible in plan and appeared to be between 5m and 7m in width, and was clearly over 1m in depth. Given such dimensions it seems likely that this ditch was defensive and that the mound was therefore likely to be part of the defences rather than a burial mound.

This section of trench was mistakenly excavated within the scheduled area around Hen Gaer, extending northeastwards from the western section for almost 50m into the scheduled area (Fig. 3). A number of archaeological features were revealed in section, all less than 10m from the northwest corner of the defensive bank (Fig. 5). As these features were only exposed in section it was not possible to determine their relationship with each other.

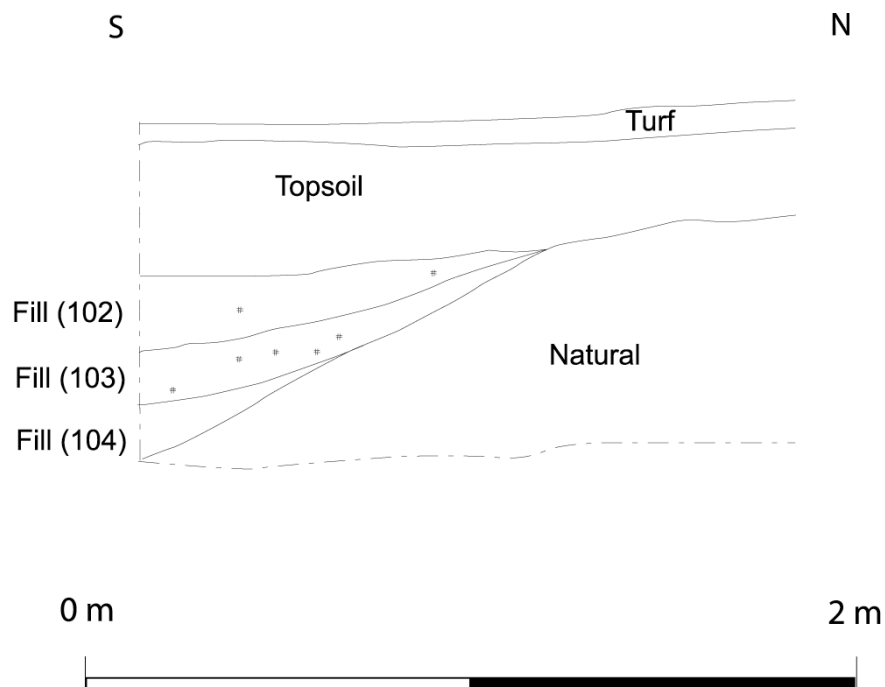
Fig. 4 - East facing section of ditch [105]

The cable trench initially cut the ditch at a very oblique angle, but it exited from the ditch at an almost right angle and therefore provided a clear section. It appeared to have a well defined edge with a fairly gentle angle of slope on its north side. The lowest, ie. earliest ditch fill that was observed, (104), was a light brownish-grey silty clay, approximately 0.20m in depth, with occasional angular shale inclusions (Fig. 4). Given its similarity to the surrounding natural it is likely that this was a primary fill resulting simply from the erosion of the sides of the freshly dug mound and ditch.

Overlying this fill was a dark brown silt layer (103) which was approximately 0.16m in depth, with angular stone inclusions and occasional charcoal flecks throughout (Fig. 4). This seemed to represent a soil that had built up within the ditch, possibly during the occupation of the Hen Gaer enclosure.

The uppermost fill (102) was a fairly friable mid brown clay silt with approximately 40% small angular stones which averaged about 0.08m in size. There were very occasional charcoal flecks throughout this layer but not enough to indicate any definite occupation activity. Where exposed by the cable trench, this fill seemed to extend across the entire width of the ditch, and appeared to be fairly homogenous (Fig. 4). However, the degree of charcoal flecking seemed to increase with depth while several large rounded boulders were removed from the centre of the ditch. They all appeared to lie within context (102), at a depth of at least 0.80m, and were up to 0.75m x 0.40m x 0.35m in size. They clearly formed part of the fill, in contrast to other boulders of this type which could be seen in the surrounding natural soil. It is therefore possible that they were originally part of a revetment wall around the mound.

Nevertheless there have been very positive results. The watching brief has provided some important new information relating to the Hen Gaer site, indicative of its complex nature. The size and character of the large ditch [105], around entrance mound PRN 2016, is such that the mound will certainly have to be re-evaluated. The width of the ditch is very similar to that of the defensive ditch still visible on the western and northern sides of the hillfort implying that the mound represents part of the hillfort defences, rather than being a separate monument that was previously thought to perhaps represent a burial mound. If this is the case then it is likely to represent part of an outer 'hornwork', defending the entrance to the fort, and its presence affects future interpretation of the status and function of the enclosure itself. Its isolation suggests that a section of bank joining the mound to the rest of the hillfort defences has been levelled off at some point in the past. This would also explain the lack of any visible ditch between the mound and the northwest corner of the fort, when it is clearly evident for the rest of the western side, and also the greater depth of topsoil in this area. The one pottery sherd recovered may also give a possible date for this event - after the 18th century - although the levelling work that occurred when the reservoir access road was constructed should also be borne in mind.

It is therefore recommended that the scheduled area be extended westwards, as far as the modern reservoir, to include the new ditch line.

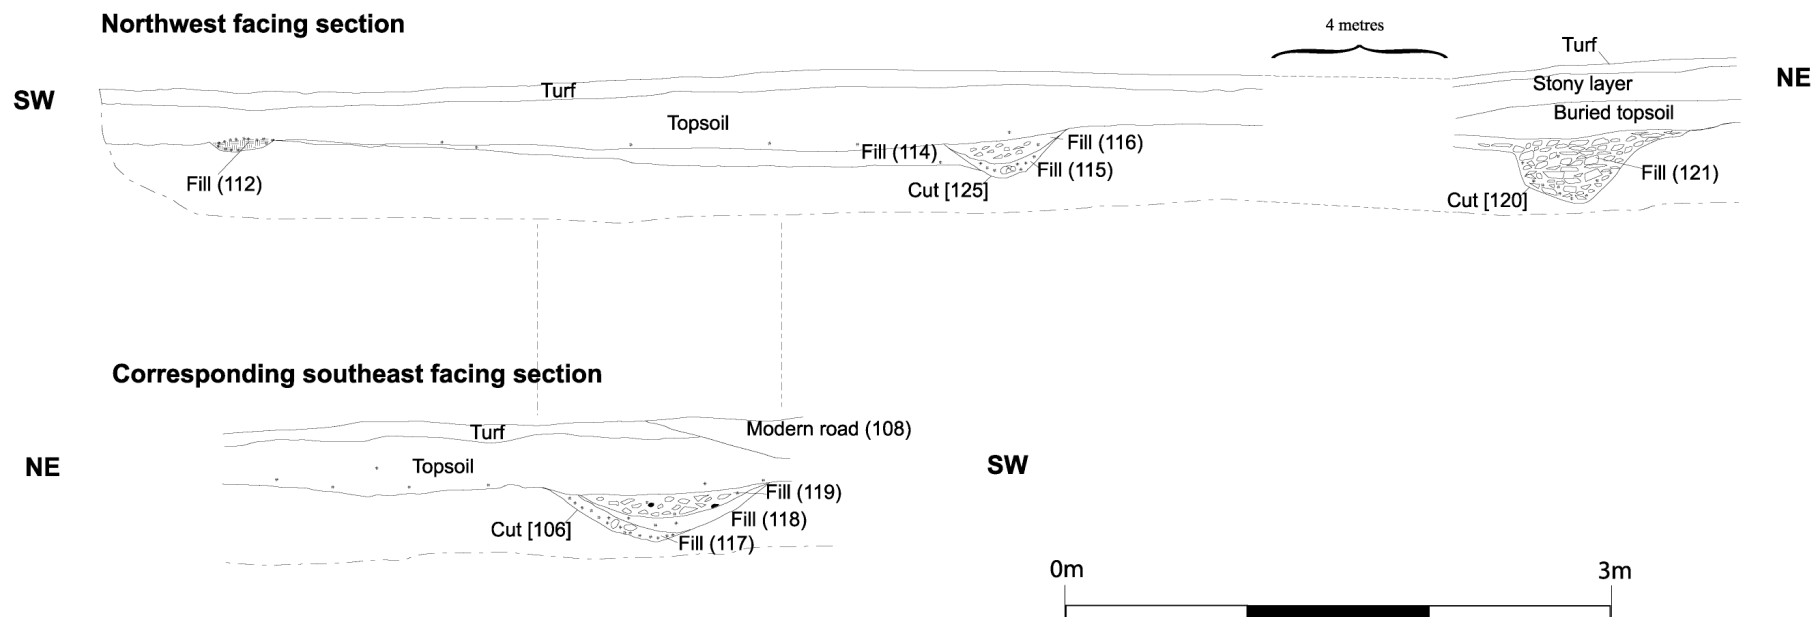
Fig. 5 - Section drawings of the 'spur' trench, showing features

The three cut features closest to the defensive bank were however very similar in nature. The easternmost, and closest to the bank (Fig. 5), was fairly shallow, being 0.10m in depth (no context number), and contained charcoal and heat-affected clay (112). This burning appeared to be *in situ*, but as only the edge of the feature was exposed it is not possible to determine its true character.

The second pit, [125], was much smaller, being only 0.90m wide and 0.26m in depth (Fig. 5). However it was very similar to [106] in being a concave cut feature, while its primary fill (115) was in all aspects almost identical to that of (106), including the inclusions. Moreover, although there were only two fills, the secondary fill (116) was very similar to the final, upper fill of [106], but lacked charcoal pieces. Neither pit clearly registered in the opposing section, meaning either that they were both truncated by the cable trench, or that they represent a single feature that had been cut very obliquely by the cable trench.

Feature [125] appeared to be cutting a band of light yellowish brown stony silt that ran along the southern section edge of the cable trench for a length of about 3.6m (Fig. 5). This layer was up to 0.12m in depth and contained occasional charcoal flecks. It is possible that it was simply a natural layer, as no cut was visible and it did not appear in the opposing section. However it is possible that it was in fact the edge of the main defensive ditch belonging to the hillfort.

The westernmost feature in this area appeared to be an irregular pit, [120]. It was slightly larger than the other features being 0.80m wide and 0.50m in depth (Fig. 5). It had a single, homogenous fill (121), which was a mid-brown clay silt, with very frequent large angular shale inclusions and very occasional charcoal flecks.

The nature of all these features, and the content of their fills, were consistent with domestic activity. However, given the fact that they were only observed in section it was not possible to determine how they related to the hillfort. It was noticeable that the topsoil exposed in this section of the cable trench was considerably deeper than that seen in the rest of its length. There were also frequent flecks of charcoal present along the interface between this topsoil and the underlying subsoil for the whole of this section of trench. One piece of 18th century pottery was recovered from this layer, at a depth of about 0.10m.

The group of small features exposed by the mistakenly excavated 'spur' section of cable trench all appear to be of a type common on domestic sites. However, they cannot be closely dated. They were clearly cut before the deeper topsoil built up, but it is not possible to state how they relate to the hillfort itself. Nevertheless their presence does indicate the potential and complexity of the site, and the importance of protecting not only the monument but also the immediate surrounding area.

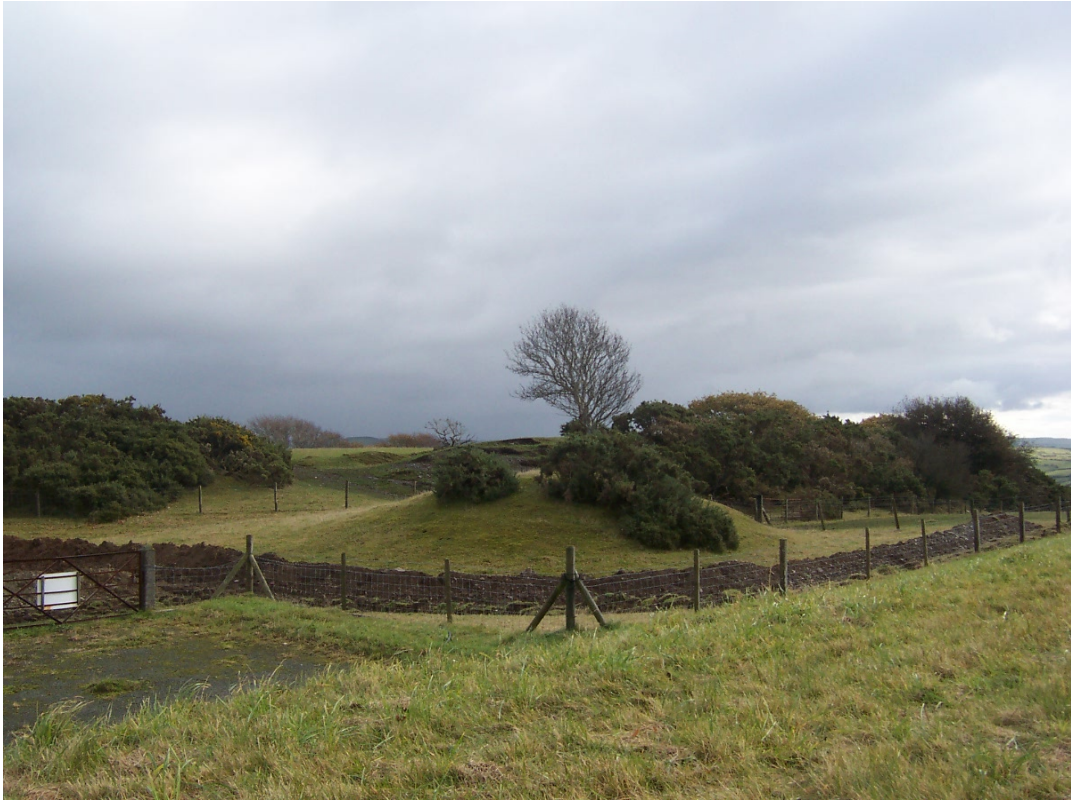
Photo 1 – view of Hen Gaer from the northwest, showing entrance mound PRN 2016 (centre), and ramparts beyond

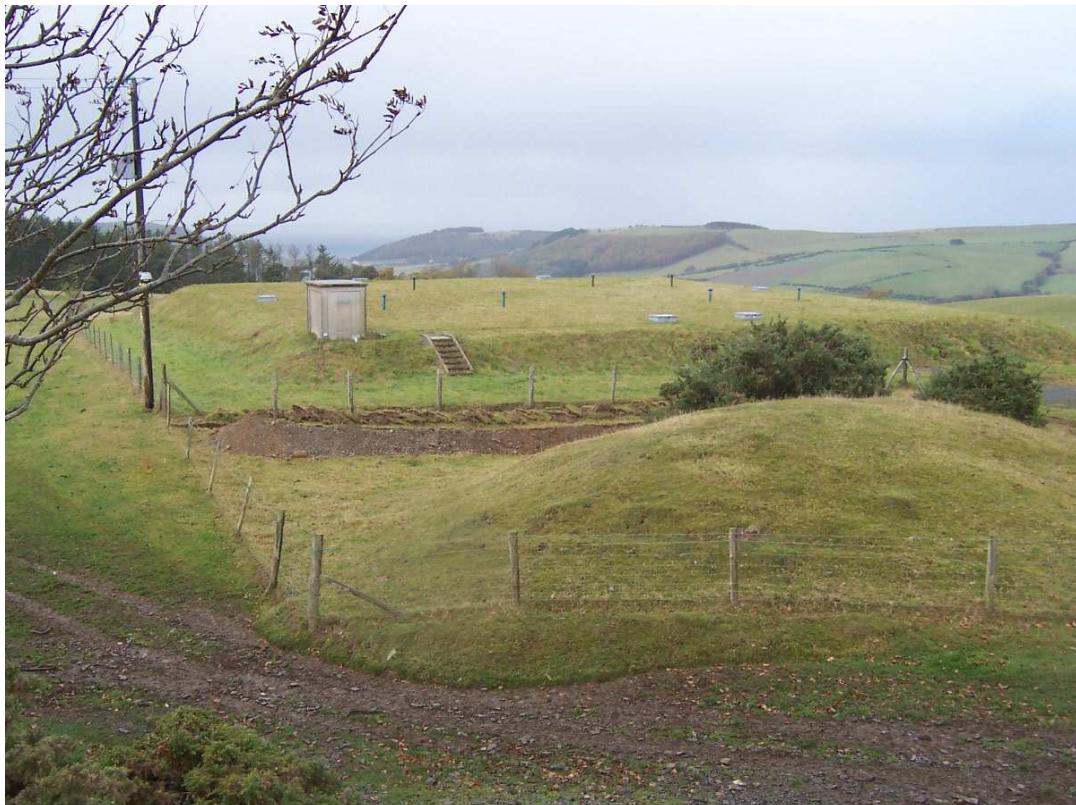
Photo 2 – view of Hen Gaer entrance mound PRN 2016, and reservoir beyond

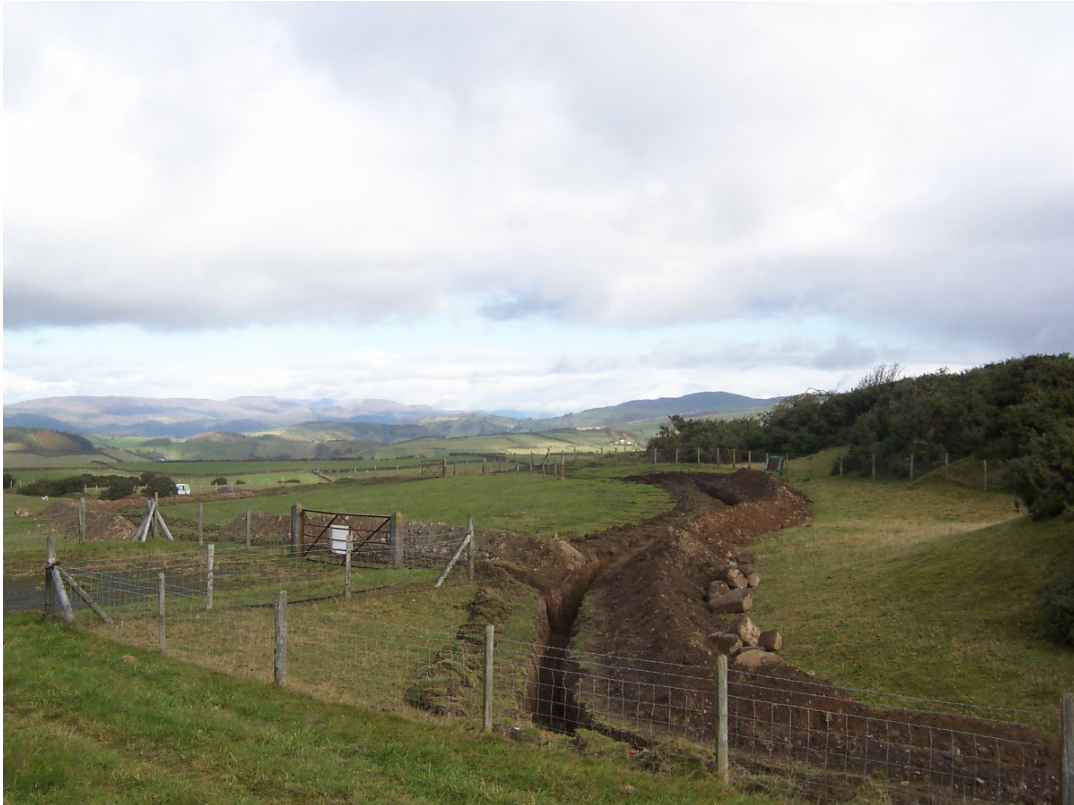
Photo 3 – view of cable trench from the southwest, showing western section (foreground) and ‘spur’ trench beyond

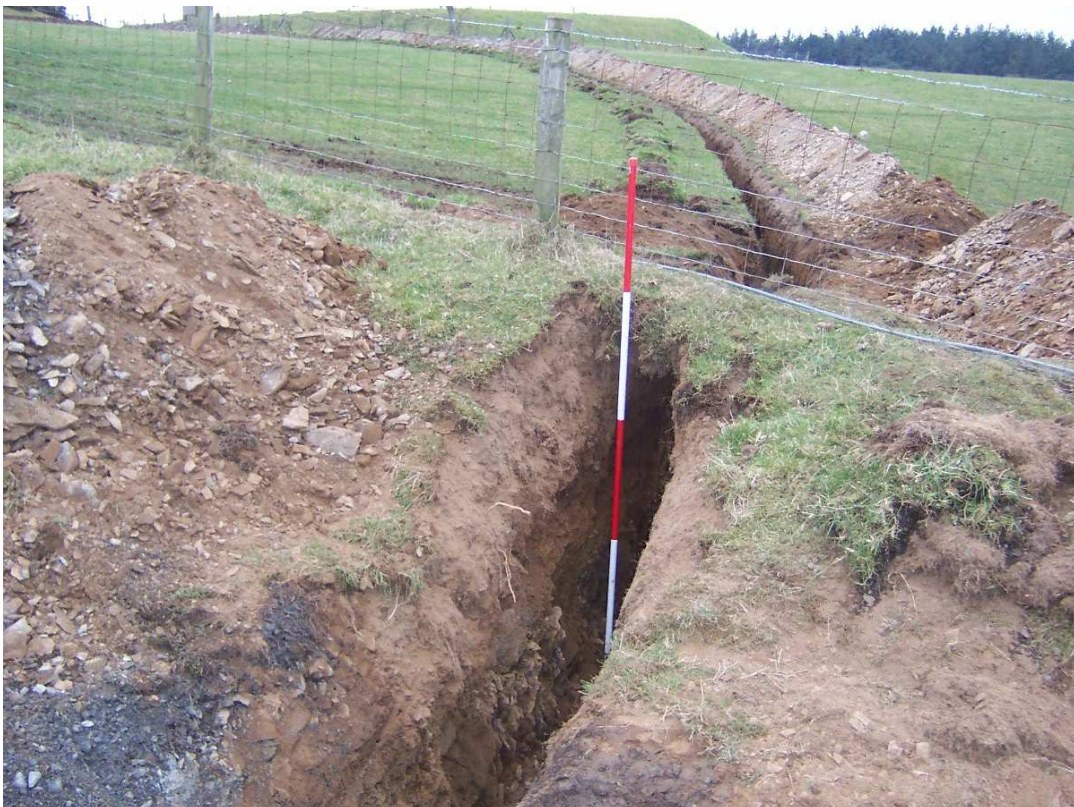
Photo 4 – view of central section of cable trench from the northeast, looking towards reservoir
