Ffynnon-brodyr W/13/3960

Tir Gofal Farm Visit Historic Environment Report

REPORT NO. 2004/03
PROJECT RECORD NO. 39087

Ffynnon-brodyr
Tir Gofal Farm Visit Historic Environment Report

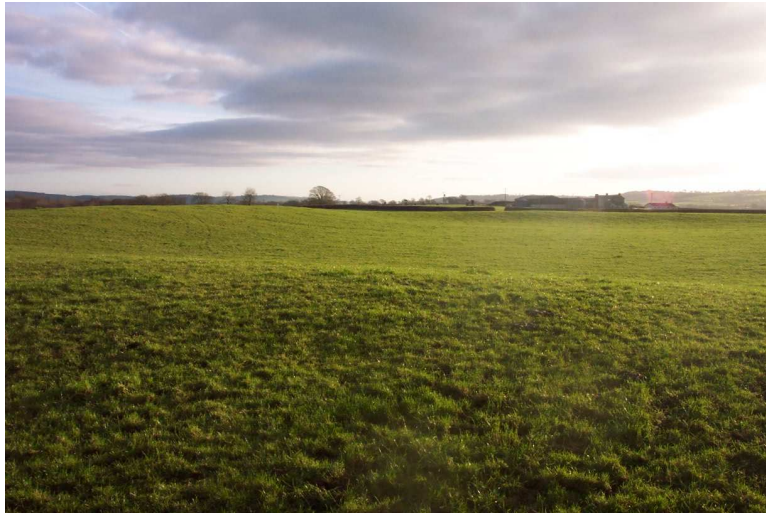
This large sub-oval shaped earthwork enclosure with a lowered interior measuring approximately 80m NE-SW by 110m NW-SE is interpreted as a possible henge and is a Scheduled Ancient Monument. It is well defined by spread earthwork banks, which stand to about 2.3m internally and 1.7m externally, despite repeated ploughing. The west corner of the monument is overlain by a field boundary.

The site was under stable pasture at the time of the archaeological farm visit. The field is ploughed every 5/6 years for arable cropping.

Plate 1- looking east over the earthworks of Y Gaer (PRN 3729) towards Ffynnon-brodyr farmstead (PRN 6484).

The principal management aim is to maintain a stable grass sward over the site with no breaks in the ground surface. Periodic ploughing is potentially damaging to the profile of the monument, and below ground archaeological remains. The main priority here is to remove the site, and the area extending approximately 15 metres from the base of the earthworks, from future cultivation. If this cannot be achieved at this stage, then it should be considered during the 5 year break. Otherwise plough depth should not be increased.

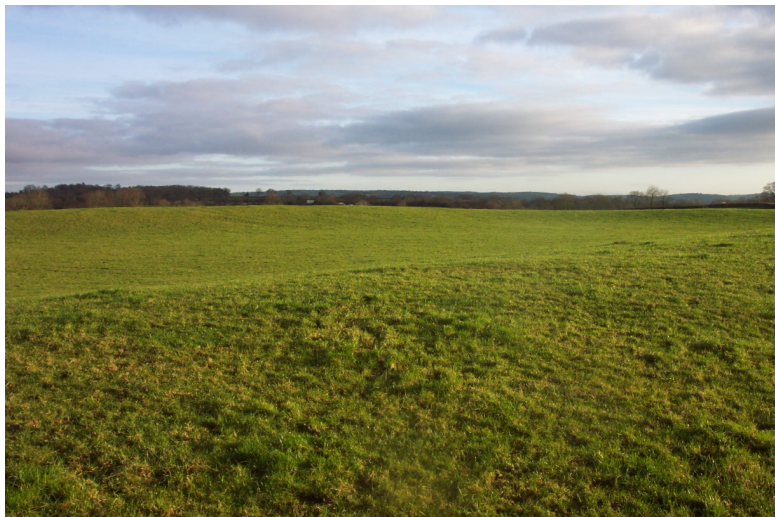
Plate 2- the earthworks of Y Gaer (PRN 3729) viewed from the southwest.

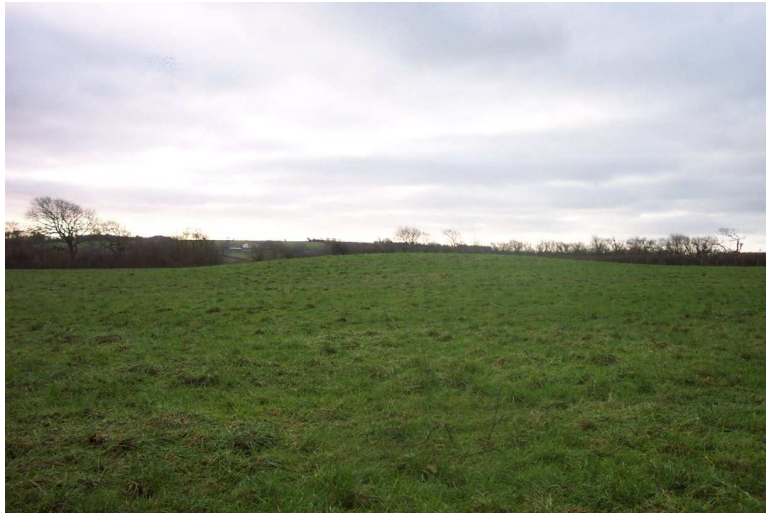
A well preserved round barrow standing some 0.75m high with a diameter of c.30m. It is situated on a flat area of low lying land in a poorly drained pasture field.

The mound was found to be in a stable condition, with no breaks in the ground surface, at the time of the archaeological farm visit. Pockmarks on the mound surface indicate that it is susceptible to poaching during wet conditions.

Plate 3- Bryn Dwyrain round barrow (PRN 3733) viewed from the east.

The management aim is to maintain a stable grass sward over the site, with no breaks in the ground surface.

The site should be monitored, in order to prevent poaching, which is potentially damaging to buried archaeological remains. If necessary, livestock should be temporarily excluded during wet conditions. Temporary electric fencing could be used to protect the site, and should be erected at at least 10 metres from the base of the barrow. The mound, and the area extending 10 metres from its base, should not be ploughed, subjected to any ground intrusive activities or used as a location for feeding livestock.

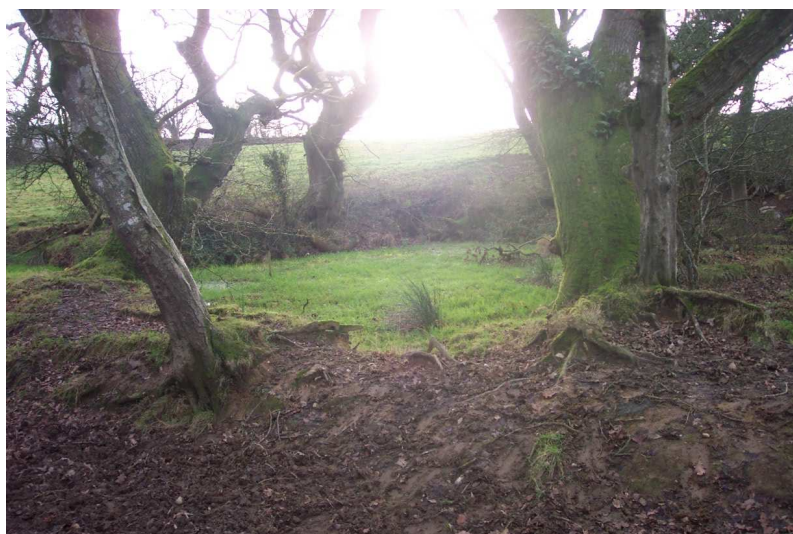
Plate 4- pond (PRN49829) viewed from the west

The pond should be retained as a visible historic landscape feature. Original pond banks should not be altered. The proximity of the pond to the holy well would have made it a focus for ritual activity, probably from at least the medieval period. Although not a typically Christian practice, votive offerings were sometimes left near to holy wells and there is good potential for the pond holding archaeological deposits. Pond dredging and other potentially damaging ground works are to be discouraged.

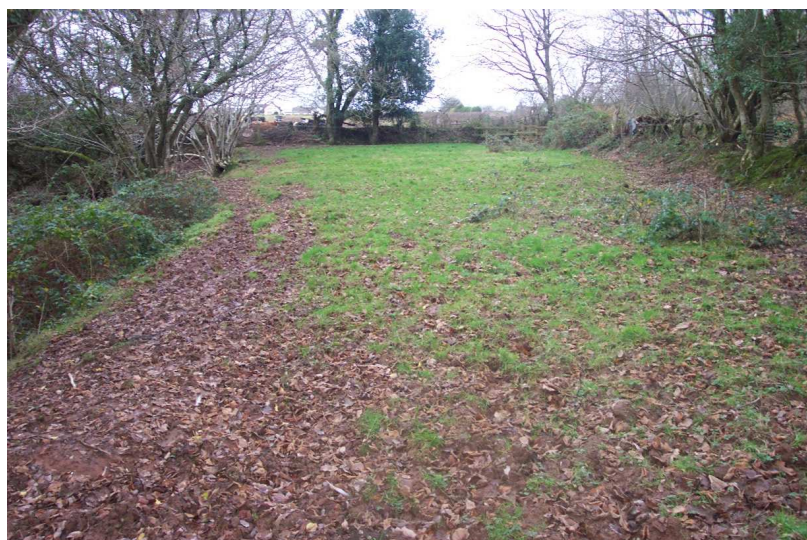
Plate 5- looking north across the ridge and furrow (PRN 49830) to the east of Sentence Castle. The outer ditch of the motte (PRN 3750) lies to the left of the picture.

The earthworks lie within the scheduled area of Sentence Castle motte. The management aim is to establish a stable grass sward with no breaks in the ground surface. In order to prevent damage by poaching, cattle should be excluded from the site during the wet winter months.
