TIR GOFAL MANAGEMENT PLAN: HERITAGE MANAGEMENT INFORMATION (HE2)

**Prepared for:
Hendre Farm**

**Tir Gofal Reference No
W/13/4432**

Cambria Report No. 2005/20

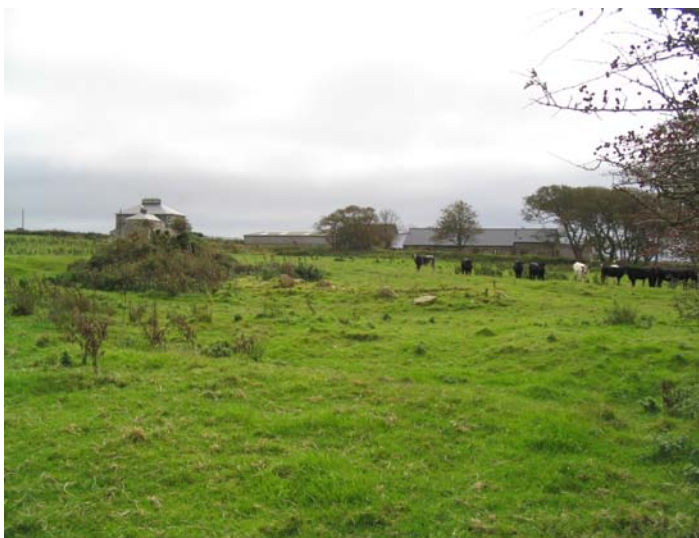
Name (& PRN)	Period/Site type	NGR	Status SAM/listing	Management required
1	HENDRE (39840)	Post Med deserted rural settlement	SM78332726	A	Specific
<p>A number of dwellings, field enclosures, and tracks marked on the Tithe Map (1841), but largely gone by the time the 1st Edition Ordnance Survey map was published in 1891. At the time of a field visit in July 1999 despite much vegetation cover, many earthwork features and remnants of stone walls, probable buildings and former paths/ tracks were in evidence which coincide with the tithe map evidence. During the archaeological farm visit, and also during a previous visit by Cambria Archaeology in 1999, the area was very overgrown with thorn and gorse, and this should be addressed.</p> <p>It has been argued that this deserted settlement site represents post-medieval squatter occupation on the edges of Dowrog Common. However, the remains are quite substantial, and there is place-name evidence to suggest that both Hendre farm and this site were occupied contemporarily (see PRN 51,748). Ludlow and Murphy (2000) have pointed out that in this area of Pembrokeshire, groups of post-medieval farm buildings often occupy the site of a medieval 'vill' or hamlet. This has given rise to the dominant settlement pattern of the area, represented by a high density of small nucleations or hamlets. Ludlow and Murphy also note an unusual arrangement of twinned farms characteristic of the area, which it has been suggested may be a tangible survival of a Welsh custom in which land was held not by individual ownership, but by two persons. It seems just as plausible that Hendre farm and the deserted settlement site were part of one of these twinned farm settlements. If this is the case, this may be a very important site archaeologically, and every effort should be made to protect and preserve the archaeological remains in this area for posterity and possible further investigation.</p>

Hendre deserted rural settlement (PRN 39,840) with Hendre farm in the background

During the archaeological farm visit, and also during a previous visit by Cambria Archaeology in 1999, the area was very overgrown with thorn and gorse. Scrub clearance is recommended for this site to enhance visibility. This can be followed by light grazing at times when the ground is stable (ie. not when the ground is waterlogged or very dry).

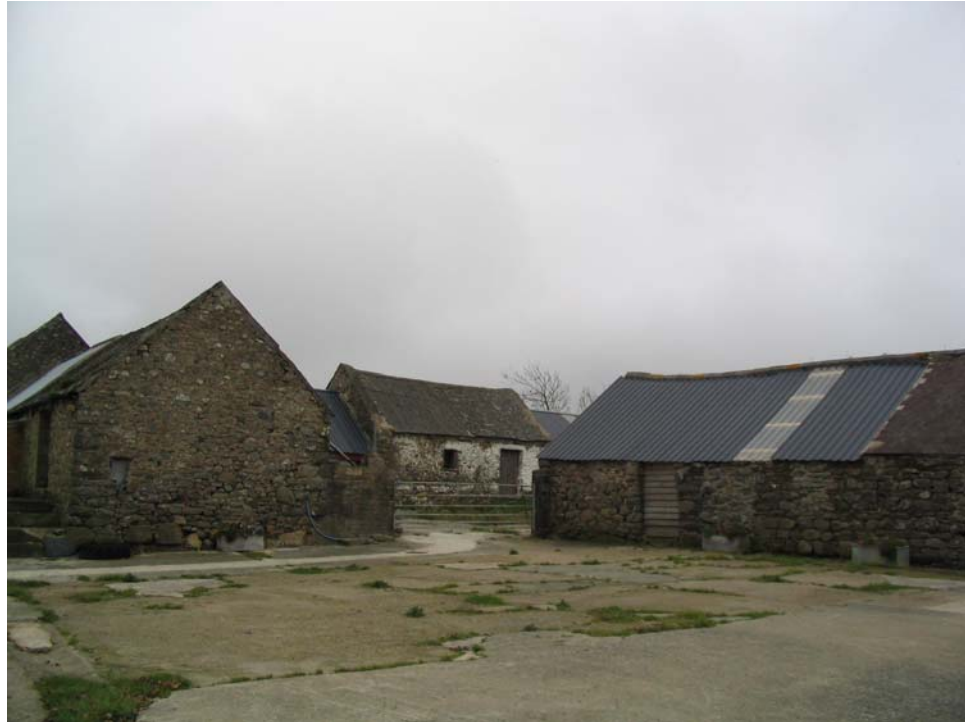
Hendre farmstead consists of a farmhouse, which is said to have been built in 1847 for Watts Williams (PRN 51,749). The farmhouse lies separately, slightly removed from a range of traditional rubble-stone outbuildings (PRN 51,750). The new farmhouse replaced an earlier one, which stood further west, probably in the area that the outbuildings still occupy. The archaeological potential of the area around the present Hendre farmstead is very high. The construction of the new farmhouse post-dates the parish tithe map for St. David's (1840-1) by about six years. However, the tithe map does not make it clear where on the site the earlier farmhouse lay. Various historic maps from the earlier nineteenth century show groups of buildings in the area of the present outbuildings, and to the north (the deserted rural settlement PRN 39,840). It is possible that the outbuildings actually incorporate at least parts of the former farmhouse within the fabric of

the current range. It is likely however, that there are below ground remains of earlier buildings in the vicinity of the farmstead. The western end of the farmstead occupies an area which may represent an earlier settlement site. Not only does the name 'Hendre' point to this possibility, but there is a field name which suggests that Hendre itself and the deserted settlement to the north were once occupied contemporarily, forming a small nucleated settlement. The meaning of 'Llain rhwng y ddwy dre' (the name given in the tithe apportionment to field north of the outbuildings) is literally 'blade between the two settlements/ townships'. Historic map evidence demonstrates that the settlement to the north had been abandoned by the mid nineteenth century, while Hendre itself has seen continued occupation.

Part of the range of outbuildings at Hendre viewed from the north-west

The archaeological potential of the area around the present Hendre farmstead is high, and Cambria

Archaeology should be informed if any ground-breaking works are carried out within the farmstead, or within its' immediate vicinity.

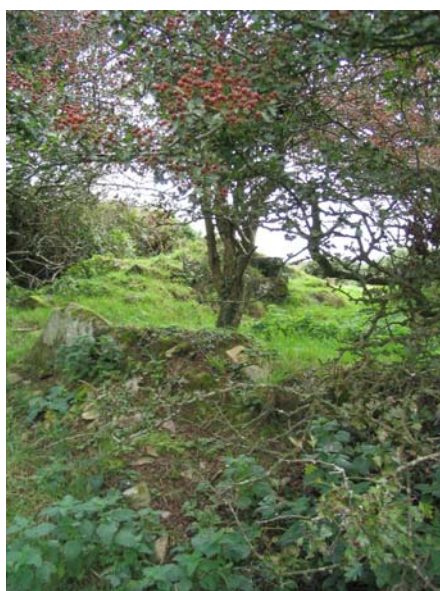
Site 2 on MAP 1

HENDRE ([51745](#))

In addition to the Generic Management Prescriptions listed above the following management is recommended.

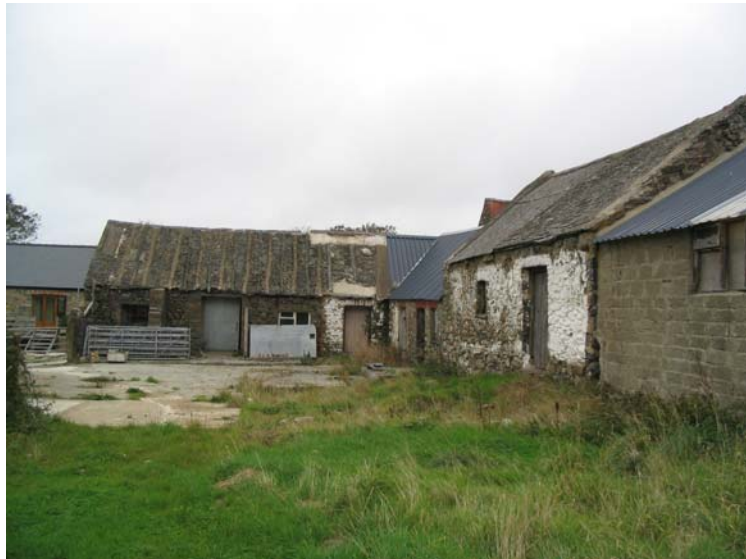
It is possible that these outbuildings actually incorporate at least parts of the former farmhouse within the fabric of the current range. One of the group of outbuildings has been converted by the present owners of Hendre, for residential purposes. The recently converted building lies on the northern side of the farmstead and is single storey, orientated east-west, and constructed of rubble stone. The owner has retained original door and window openings. This building is marked on the tithe map, but its' original function is unknown. The configuration of openings, and the lack of chimneys make it unlikely to have been the original farmhouse, although it may have been modified during its' history. The remainder of the traditional outbuildings are dilapidated and in urgent need of repairs, in order to maintain them in a weatherproof condition. This range retains a number of traditional features peculiar to Pembrokeshire, in particular the coating of concrete (probably replacing lime mortar) covering slate roofs. This sort of pointing is characteristic of vernacular buildings in Pembrokeshire. In exposed places it was a traditional means of preventing moisture penetrating between slates (from rain driven horizontally by the wind), and is becoming a rarity as it has been replaced by the use of roofing felt beneath slates. The east-west barn range (parallel to, and south of the renovated building) has a particularly interesting variety of pointing on the roof. There are evenly spaced 'ribs' running from the apex down to the eaves, presumably a way of encouraging run off. This building is single storey, rubble built, and occupies the north side of a square yard formed by two rows

of buildings, meeting at a right angle. The south elevation had become unsound in the past and is now supported by some make-shift buttresses. Attached to the east end of the row described above is the only two-storey outbuilding in the range. It is constructed of rubble stone, with access to the second storey gained via an external set of stone steps on the eastern gable-end. The front elevation faces north, and comprises a window opening (now bricked up) and door to the ground floor, and a window opening (with louvred panelling) and ventilation slit to the first storey. This probably represents a stable. Three buildings form the east side of the yard. These are all rubble built, with lime mortar between the joints and lime wash in evidence in some locations. There are variations in roof height: the central building in the row has a higher roof line, and consequently the roofs on the two buildings either side are butted up to this building. The two southerly buildings in the row have distinctive upstanding rubble-stone copings at the gable ends.

The three buildings forming the east side of the yard, showing lime wash on the central building, and east-west barn range in the background, with 'ribbed' pointing on the roof slates

Although these buildings have lost some of the integrity of their historic fabric, they form a distinctive historic component of Hendre farm, and every effort should be made to ensure that the important contribution they make to the wider historic landscape character of the area is retained.

There is evidence that lime-mortar and lime-wash were the materials used to weatherproof these buildings, and ideally these should be used in any repair work carried out.

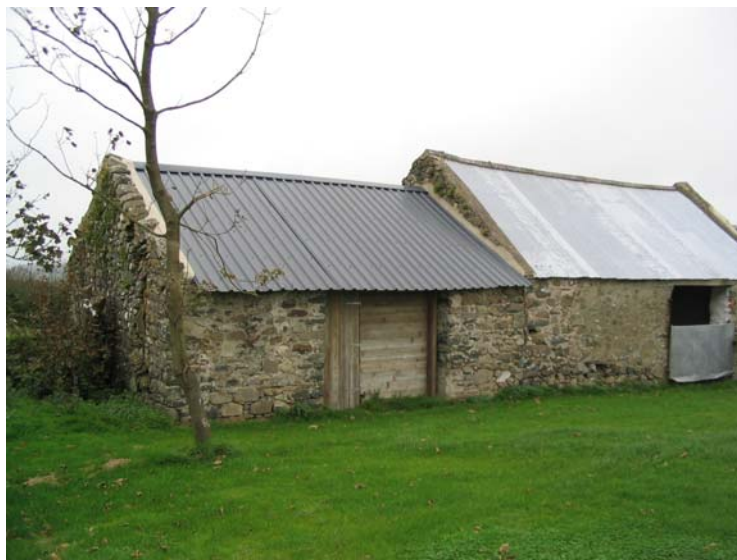
The extreme southern gable-end is deteriorating rapidly: it is bulging outwards, with lime mortar crumbling from the joints. It appears that the western elevation of this building has suffered from collapse, as it has been replaced by concrete breeze-blocks.

The rear of the row seen above, showing deterioration of the southern gable-end

The extreme southern gable-end is deteriorating rapidly: it is bulging outwards, with lime mortar crumbling from the joints. This needs to be stabilised.

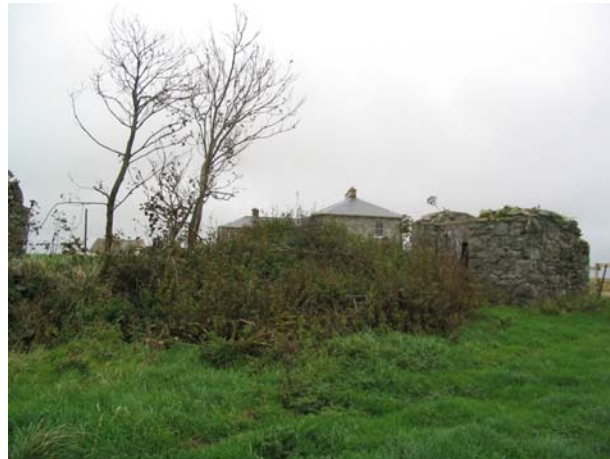
To the west of this L-shaped range, a long, low, east-west orientated rubble-stone building has had its' gable end modified to accommodate a wider entranceway. Areas of roofing on the entire range have been replaced in the past with a variety of materials, including some corrugated iron and corrugated plastic. It is assumed

that the original roofing material was slate with a mortar coating. However, in this context there is a historical precedent for corrugated iron, and this would be the preferred option for cheaply ensuring that the buildings remain weatherproof. To the south-east of the main barn range, but clearly associated is a small square stone building with very thick walls. There is a door opening with wooden lintel on the north-west elevation. There is no remaining roof structure, but the tops of the walls give the impression that the building may have been higher previously. The building appears on the more detailed maps of the later nineteenth century, although its' function is unknown.

Small square stone building viewed from west

It is assumed that the original roofing material was slate with a mortar coating. However, in this context there is a historical precedent for corrugated iron, and if re-slating were too costly, this would be the preferred option for cheaply ensuring that the buildings remain weatherproof.
