## **TIR GOFAL MANAGEMENT PLAN: HERITAGE MANAGEMENT INFORMATION (HE2)**

**Prepared for:  
Prouts Park Farm**

**Tir Gofal Reference No:  
W/13/4471**

**Report Number: 2004/79  
Project Record Number: 49845**

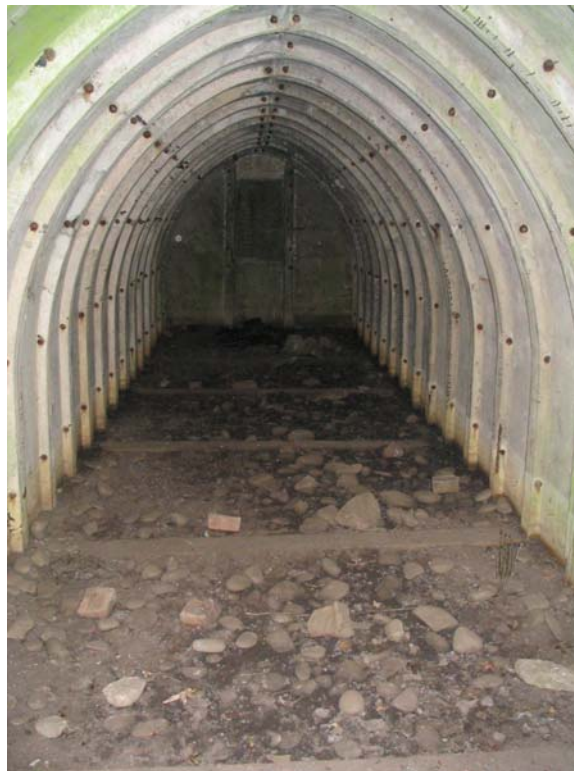
Name (& PRN)	Perion/Site type	NGR	Status SAM/listing	Management required
1	<b>TEMPLETON AIRFIELD</b> ( <a href="#">50764</a> )	Modern air raid shelter	SN08811142	B	Specific
A "Stanton" air-raid shelter. Prefabricated design, consisting of sections which could be bolted together to form different lengths. A main entrance at one end flanked by a brick blast wall mounded up by earth. At the other end is a chimney-type structure, the emergency exit. Covered over by earth. The air raid shelter is currently covered with thorn trees on the main body of the building.

*PRN 50764 – the interior of the Stanton Air Raid Shelter*

The aim of the management of this site should be to maintain a stable ground cover over the structure.

Although the building appears to be in a reasonably stable condition the size of some of the thorn trees growing over it are cause for some concern. In the event of any of these trees falling, there may be considerable damage caused. The thorn trees should therefore be cut off at ground level and their roots may be spot treated to prevent regrowth. The roots should be left in place, they should not be dug or pulled out. Where ivy has become established it should be cut through at root level and again the roots should be left in place and treated to prevent regrowth.

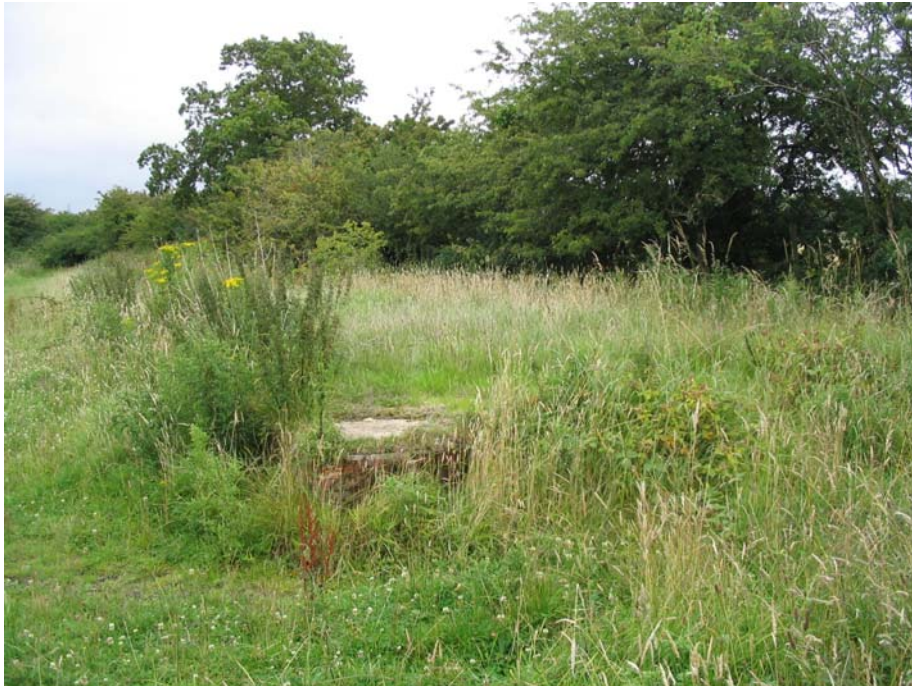
A low concrete and iron construction about 0.5m high. Unknown whether structure is a sunken building or hard standing for temporary building of which the top section has been removed. Largely grassed over.

*PRN 50767 – remains of Templeton airfield, perhaps a sunken building or a platform for a temporary structure?*
