Mountain Farm W/13/4527

Tir Gofal Farm Visit Historic Environment Report

Report No. 2004/23

REPORT NO. 2004/23
PROJECT RECORD NO. 49849

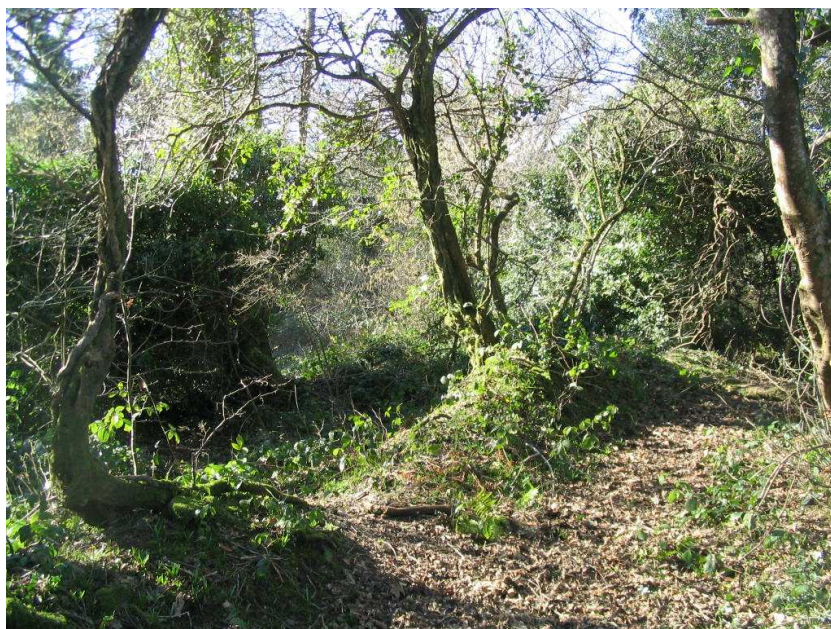
Plate 1 *Traces of an old field boundary (in the centre of the picture) and a pathway next to it. This runs past the cottage site, in an area of more open woodland.*

The cottage site is now set in an area of woodland which is full of colliery remains (PRN 50212). Just to the south of the cottage is a relict field boundary, visible as an earth bank. This runs for around 50m, roughly east-west.

Woodland management activities should be carried out with care, ensuring that vegetation is cut off at ground level and removed, rather than being dug or dragged out.

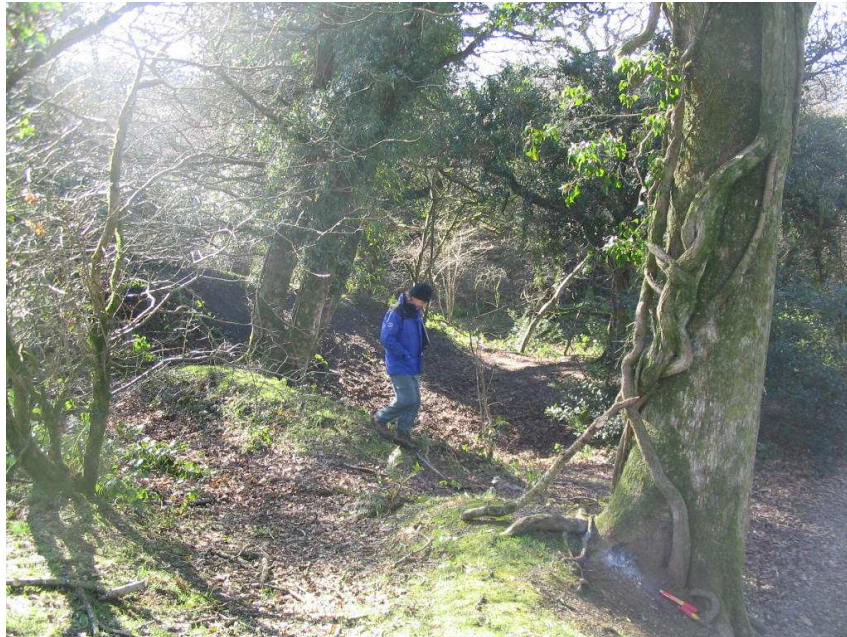
Plate 2 (above) *Area of open woodland, with clearly visible earthworks showing the locations of infilled shafts and spoil tips.*

West of the pond, in the centre of the area, the woodland is generally more open, and the undergrowth is also less dense. This area is dominated by a large, steep-sided pit which runs roughly east-west across the woodland. The base of the pit is generally open, and clear paths run down the sides. On the north side, beyond the pit, is a deeply pitted area covered with open woodland. A number of infilled shafts are visible, as are spoil tips and tracks between the features.

There should be no ground-intrusive activities or removal of material from any of the sites in this area. Vegetation and trees, where necessary, should be cut at ground level and the roots treated to prevent re-growth. They should not be dug or dragged out. Mature trees growing on the steep sides of the central pit and of the ponds should be managed to prevent them being vulnerable to wind throw. If these trees fall, they will cause significant damage to the earthworks. Ideally, these steep banks should be kept relatively clear, with young trees and saplings being removed.
