## **TIR GOFAL MANAGEMENT PLAN: HERITAGE MANAGEMENT INFORMATION ( HE2)**

Prepared for:  
Frondeg, Pencarreg, Llanybydder, Carmarthenshire, SA40 9QP

Tir Gofal Reference No  
W/12/4107, 4107a & 4107b.

Project Record No. 49858  
Report No. 2004/61

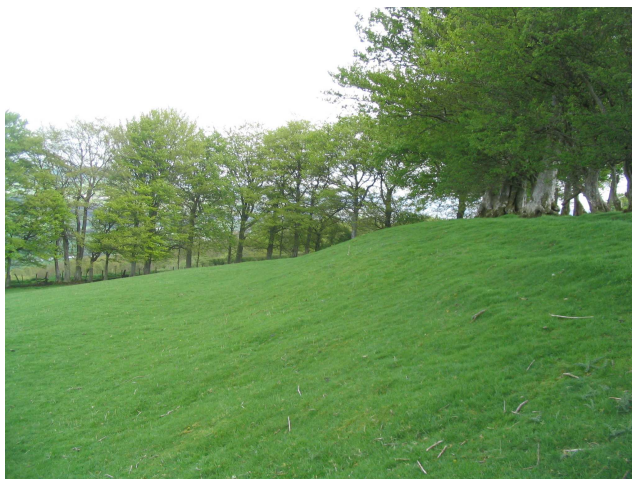
The outer earthwork defences are scarped on the W and N sides (to 3m) to enhance the defensive possibilities of the hillslope. A terrace on the down-slope side may represent an outer ditch. On the E, the defences consist of a pronounced earthwork bank (c.1m high x 3m wide) and outer ditch (c.4m wide x 1.5m deep). The S defences, on neighbouring farmland, were not seen. A narrow hollow way breaks the defences on the W side and may indicate an original entrance.

Stable pasture dominates, although grass cover is broken by scattered tree stumps in the E bank and ditch. The boundary bank, which formerly separated plantation from pasture, overlies these earthworks. The line of the W defences is perpetuated by the present hedge boundary. The monument was found to be in a stable condition at the time of the archaeological farm visit, with no specific management threats identified.

Earthwork defences on the north-west side of the enclosure. The line is now perpetuated by the present hedge boundary.

1. To remove the monument from future cultivation (including a 10m buffer strip).
2. Future management to involve the monitoring of trees growing on the outer enclosure banks. Unstable trees should be felled before being allowed to fall naturally (in order to prevent root bowl damage from damaging the profile of the earthworks and buried archaeological remains).
3. Tree stumps in the former plantation to be left in place, and not uprooted (in order to protect the profile of the earthworks and buried archaeological remains).

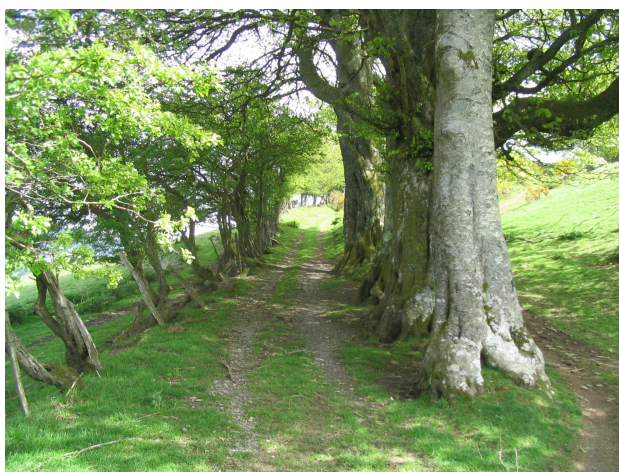
The trackway is visible as a hollow way (c.4m wide), sometimes flanked by outgrown hedges, for much of its length across farmland. Some sections are still used as a farm trackway. No specific management threats were identified.

A section of the trackway, now flanked by grown out hedges.

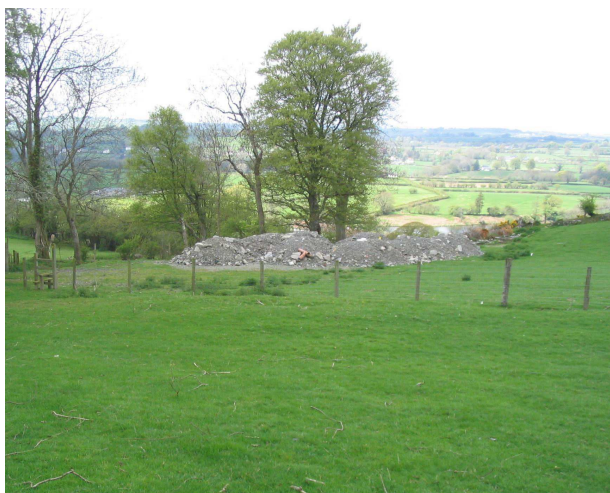
No on Map	PRN	Site Name/Type	Period	NGR	Importance (status)	Management
	50809	Cottage, Pen-llain	Post Medieval	SN53904527	B	General Prescriptions/ Whole Farm Code
<p>The former cottage of Pen-llain. No traces of the dwelling remain today other than some scattered stone and a level platform c.15m NE-SW by 30m NW-SE.</p> <p>Local residents remember it as a low, mud and stone walled building with thatch surviving beneath the corrugated iron roof, and a substantial gable fireplace with wicker chimney hood. It was apparently demolished some 15-20 years ago, after the elderly owner passed away. It is reputed to have its origins as a <i>ty unnos</i>. Its historic location, on the fringes of a large expanse of woodland (shown on the Ordnance Survey Old Series map of 1834) could well imply squatter encroachment on marginal land. Apparently no ownership deeds were recovered following its abandonment, further supporting this presumption. The cottage platform is now used as a location for storing rubble stone.</p>

The site of Pen-llain cottage today.

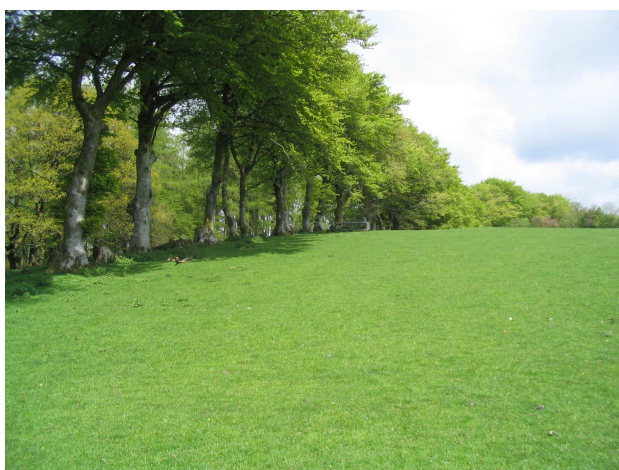
A long, curving shelter belt visible as two parallel lines of beech trees, set 20m apart. It climbs a steep hill to the north-west of Frondeg farmstead for 200m before continuing eastwards across neighbouring farmland for a further 500m. The present landowner believes that it was planted by his grandfather to provide shelter in this otherwise exposed location.

Part of the shelter belt to the north-west of Frondeg farmstead.
