Wenallt W/12/4144

Tir Gofal Farm Visit Historic Environment Report

Report No. 2004-54

Wenallt Tir Gofal Farm Visit Historic Environment Report

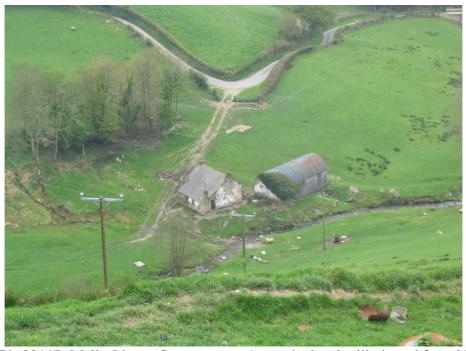
PRNs 50679, 22147- Melin-Llwyn-Gwyn, cottage/ cow shed and mill viewed from high ground to the west.

The remaining north gable and sidewalls of the building are now incorporated within a modern breeze block shed. No traces of the wheel pit or associated milling machinery or apparatus survive. The surviving rubble walls of the mill building are currently in a stable condition, although partially obscured by heavy ivy growth.

The ivy growth on the walls is a potential source of structural instability. Ideally ivy should be cut off at the roots, allowed to die and then removed. Stumps should be spot treated in order to prevent re-growth. This should be followed up by a programme of re-pointing and masonry consolidation in areas where masonry bonds have been weakened by intrusive vegetation growth.

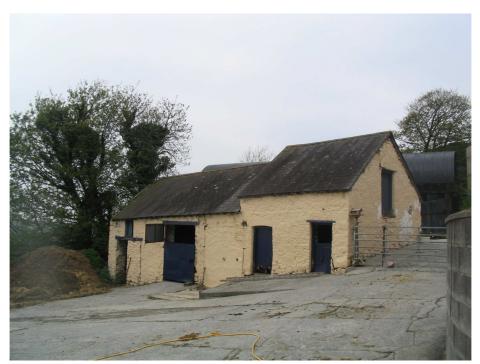
PRN 50672- the combination farm building on the west side of the yard at Wenallt.

The range is now partially modernised. It retains few original internal features, and doorways are mostly modified or partially blocked. Despite the alterations, the barn retains its historic character. It is currently in a reasonable condition although some roof slates are displaced, particularly around the south end.

The building should be maintained in a weatherproof condition. Ideally the roof should be restored using the same materials and techniques as those used originally. Materials should be considered on a like for like basis

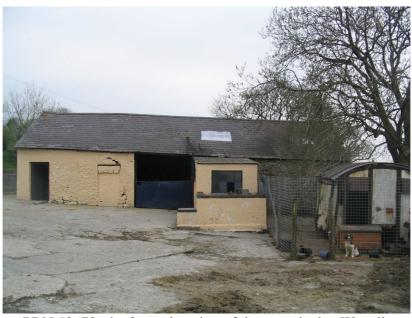
The cow shed is currently in a reasonable condition although there are missing and displaced roof slates above both the cow shed and lean to. Lime mortar bonds are eroded and masonry is becoming displaced in places.

PRN 50673- the front elevation of the cow shed at Wenallt

The building should be maintained in a weatherproof condition. Ideally the roof should be restored using the same materials and techniques as those used originally. Materials should be considered on a like for like basis. The building would also benefit from some masonry consolidation using a similar lime mortar mix.

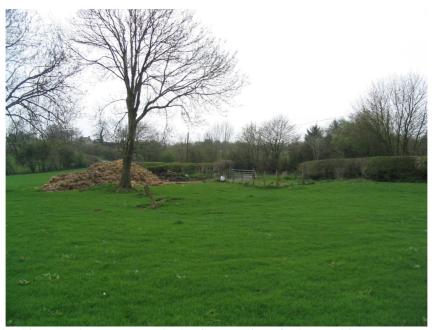
The site is now reduced to earthworks. The cottage remains consist of a low platform (c. $18 \times 6m$ E-W) with a low spread rubble wall visible at the east end. Only the wall footings (c. $8 \times 6m$ E-W) of the outbuilding to the north survive. The cottage enclosures have also been grubbed out, although the remnant ditches can still be made out.

PRN 50676- looking south west towards the former site of Clyn-cethin cottage and outbuilding.

Earthwork and buried archaeological remains of the cottage and enclosure should be protected from damage. The area specified should not be subjected to any ground intrusive activities or used as a location for feeding livestock. Heavy machinery operation should be avoided outside areas that are presently used for machinery access. The muck heap should not be allowed to encroach onto the cottage or enclosure earthworks.

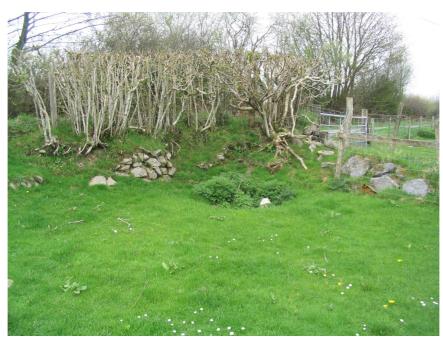
A well associated with the former cottage of Clyn-cethin (PRN 50676). It appears in the 1907 Ordnance Survey map but is absent from later map sources. It is now infilled and visible only as a shallow circular depression c. 1.5m in diameter. No associated structural remains were identified. The site lies within a pasture field.

PRN 50677- the well to the south of Clyn-cethin cottage

The well should be protected from damage and not infilled. No ground intrusive activities to be undertaken within 5 metres of the site.

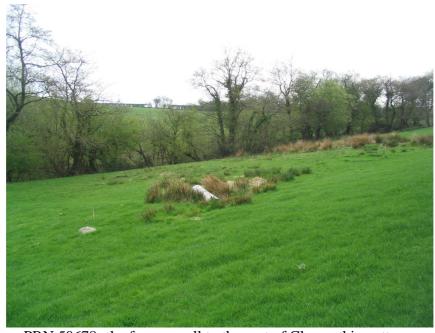
A well marked on the 1891 Ordnance Survey map some 90m east of Clyn-cethin cottage (now destroyed). It can be identified as an area of marshy ground today. No associated structural remains survive. The site now lies within a pasture field.

PRN 50678- the former well to the east of Clyn-cethin cottage.

The site should be protected from damage. No ground intrusive activities to be undertaken within 5 metres of the site.

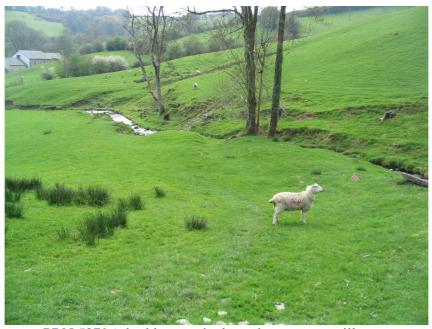
PRN 50796- looking south along the remnant mill race.

Earthwork traces of the mill race should be protected against damage.

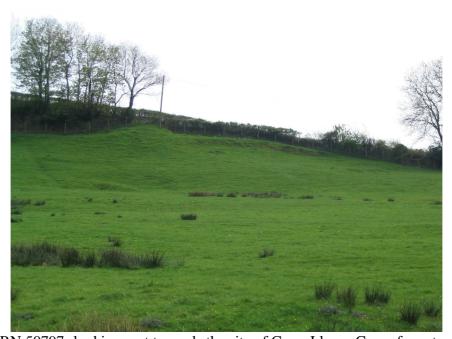
PRN 50797- looking east towards the site of Cwm-Llwyn-Gwyn farmstead.

Buried and earthwork traces of the farmstead should be protected from damage. The area including a 15m radius around the site should not be subjected to any ground disturbing activities or used as a location for feeding livestock.

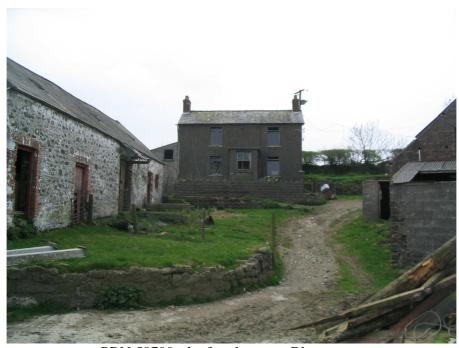
The farmhouse is now redundant but remains in a stable condition.

PRN 50799- the farmhouse at Blaen-cwm

The building should be maintained in a stable condition using materials and techniques that are appropriate to those of its original construction.

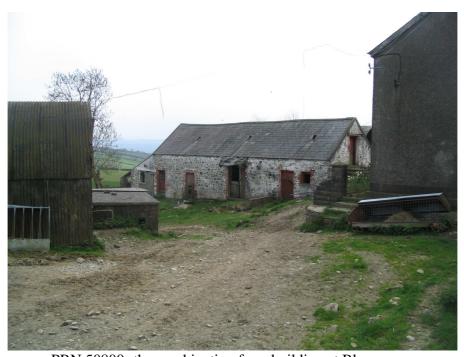
PRN 50800- the combination farm building at Blaen-cwm

It is now falling into disrepair. Many of the roof slates are loose and some are now lost. Localised lime mortar erosion is a concern and masonry is at risk of becoming displaced in places. The lean to is now ruinous and partially roofless.

The building should be maintained in a stable condition using materials and techniques that are appropriate to those of its original construction.
