TIR GOFAL MANAGEMENT PLAN: HERITAGE MANAGEMENT INFORMATION (HE2)

**Prepared for:
Maescadog**

**Tir Gofal Reference No
W/12/4248**

**ACA Report No. 2005/142
Project Record No. 49889
Prepared by
Philip Poucher**

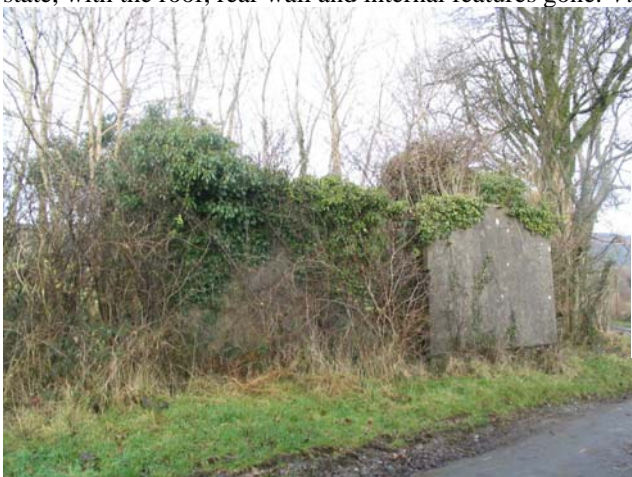
Name (& PRN)	Period/Site type	NGR	Status SAM/listing	Management required
3	CAPEL ABER-BOWLAN (21996)	Post Med/ Chapel	SN69603899	B	Specific
	<p>A ruined chapel building situated on the roadside at Aber-bowlan. The RCAHMW record the chapel as originally being built in 1850, marked as a Calvinist Methodist chapel on the 1st edition Ordnance Survey map of 1888. The chapel was apparently out of use by the 1950s, and is now in an overgrown and ruinous state, with the roof, rear wall and internal features gone. <i>Visited 13/12/2005 (PP)</i></p>

<p>North facing shot of the overgrown remains of the chapel site.</p>				
	SARN HELEN (E);SARN ELEN (3420)	Roman/ Road	SN75733490	U	Generic

It is not currently clear if this site lies within the farm holding, situated as it is on the roadside beyond the hedgeline. However, the aim of the management for this site should be the preservation and maintenance of the deteriorating structural remains of this chapel site, an important feature of the local historic character of this area. The gable walls and southern wall all stand close to their original height, but the rear wall has since collapsed and interior features have gone. The upstanding masonry is partly covered in ivy, thick in places, which could be causing structural damage or masking defects. The

whole site is covered in scrub and trees, some situated close to the upstanding masonry which could be putting pressure on the structural integrity of remaining features.

- Scrub and small trees should be cleared from around the site.
- Mature trees should be cut back to ensure branches do not cause problems to remaining upstanding masonry.
- Ivy should be cut back and treated on the walls of the structure. If it possible to remove any without causing damage to the remains structure then this should be done.
- Scrub and rubbish should be cleared from the interior of the structure which may reveal any remaining internal features.
- The walls may have to be capped to prevent further deterioration, this can be assessed once scrub and ivy has been removed.

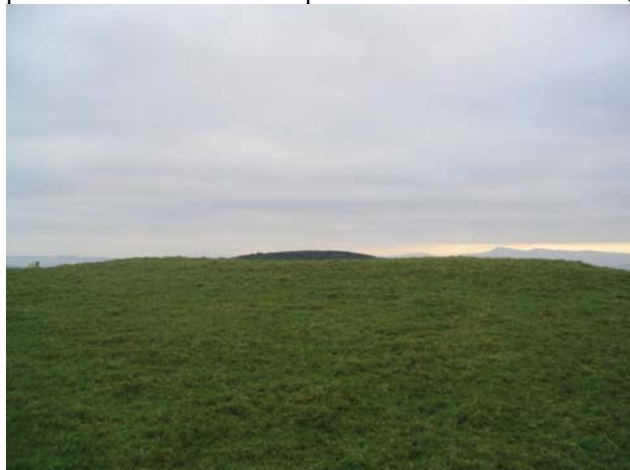
The remains of a round barrow lying within a field of enclosed pasture on a round summit above Nantiwrch. The barrow, built of earth and stone, is circular and measures c15.5m in diameter, up to 0.5m high. It has been denuded by ploughing and stone robbing in the past but the base of the barrow remains substantially intact. These sites can date from the Bronze Age (c2000 - 500BC). Originally it would have been a circular mound of earth or stone placed over the location of a burial. The burial may be a crouched inhumation in a stone lined grave referred to as a cist or it may cover a pottery urn containing cremation ashes. This site has been scheduled as a monument of national importance for its potential to enhance our knowledge of prehistoric burial and ritual practices. *Visited 13/12/2005 (PP)*

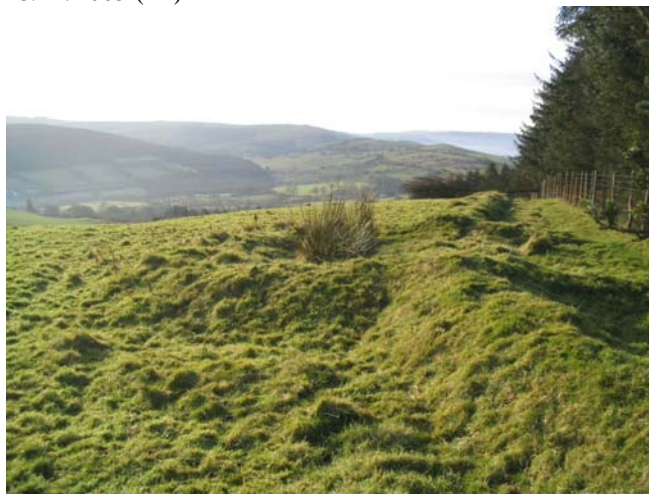
A small fold first recorded in 1983. The remains consist of a D-shaped enclosure formed by low grass covered banks c1.5m wide and 0.4m high. The whole feature is 4.2m wide, and c4.5m long although it is crossed by the old field boundary which forms a section 2.8m wide at the eastern end, with an entrance on the south side. The banks run beyond the old field boundary up to the current fence line, and when visited in 1983 it was believed to post-date the old field boundary which may have been 19th century in date. No feature is marked here on either the 1st (1888) or 2nd (1906) edition Ordnance Survey maps. *Visited 13/12/2005 (PP)*

SSW facing shot of the remains of the former sheepfold, crossed by the line of the old field boundary.

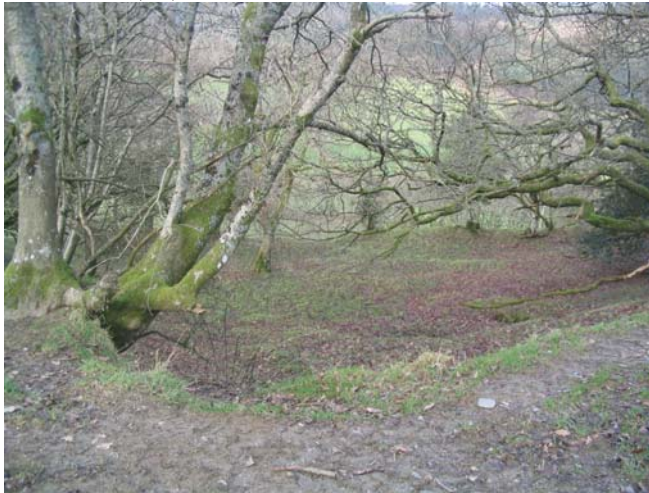
The site of a former dwelling. The site consists of a large level platform c30m by 30m cut into west facing slope to the north of the farmstead of Nantiwrch. The outline of a small rectangular building measuring c4m by 6m is clearly visible at the southern end of the platform. Possible banks and platforms to the north suggest another two structures, with the largest structure in the centre. The dwelling of Coed Cae is marked here on the old series Ordnance Survey map of 1831, and two structures are marked on the tithe map of 1844. The site appears to have been abandoned by the time of the 1st edition Ordnance Survey map of 1888 although the southernmost structure is still marked. The site is currently grass covered with trees growing along the former boundary banks, and a couple of mature trees established within the main site. *Visited 13/12/2005 (PP)*

NNW facing shot looking down onto the area of former dwelling PRN 55632.

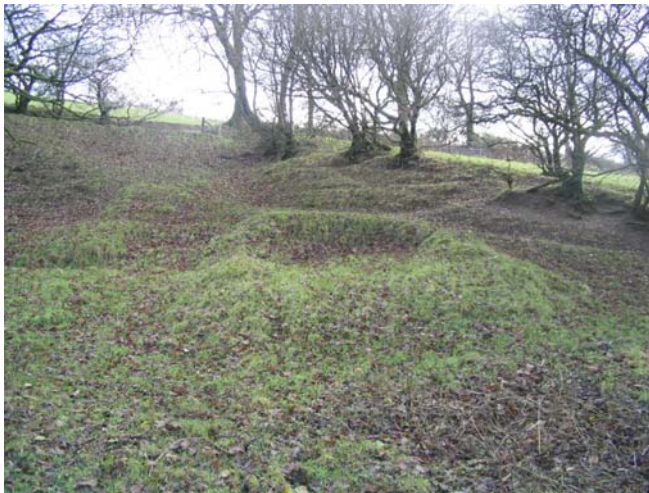
SE facing shot of the visible building remains within area of former dwelling PRN 55632.

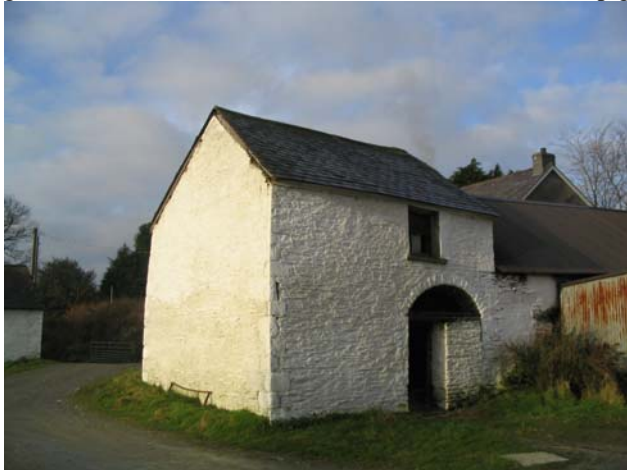
The walls of the cartshed are leaning at the top, causing instability and threatening the integrity of the entire easternmost barn range. The slate roof on the cartshed is also being affected. The westernmost range in a good stable condition but the slate roof on the attached pigsty is deteriorating. *Visited 13/12/2005 (PP)*

W facing shot of the former cartshed with leaning gable walls.

The aim of the management for this site should be to ensure the survival of the traditional buildings and maintain the historic character of the complex of traditional farm buildings as a whole. The lean in the gable walls of the former cartshed is a cause for concern, causing structural instability and threatening the integrity of the entire barn range. The roof of the cartshed and also the floor of the hay loft are deteriorating. The westernmost traditional barn range appears to be in a relatively stable condition, however the attached pigsty has a deteriorating roof, with missing and loose slates.

If possible it would be preferable to ensure the preservation of the traditional farm building complex as a whole. The leaning walls on the cartshed appear to be the main immediate threat to this survival and

if financially viable this should be repaired to stabilise the structure. The work required to stabilise or repair this structure and its cost should be assessed by an appropriately qualified builder. Repairs to the slate roof of the pigsty would also ensure its long term survival.

- Advice should be sought from an appropriate specialist on the scale and cost of work involved to stabilise and/or repair the structure of the cartshed.
- If possible the cartshed building should be stabilised and the roof repaired using appropriate methods and materials to keep it in character with the other building ranges.
- The roof of the pigsty should be repaired and made weather proof to ensure the survival of the fabric of the building, whilst using appropriate methods and materials to keep it in character with the other building ranges.

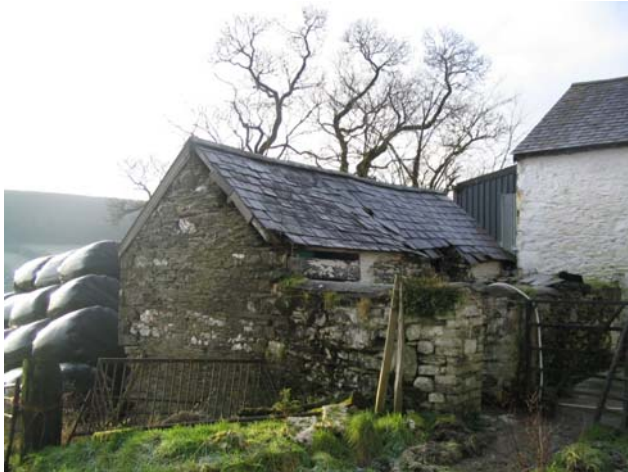
SW facing of the former pigsty at Maescadog farmstead.

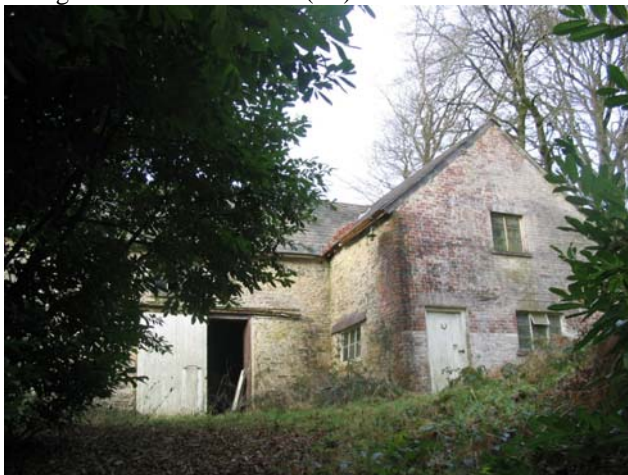
A former coach house standing adjacent to Albert Mount PRN 55623, and first marked on the 1st edition Ordnance Survey map of 1888. The building is L-shaped in plan, built of a mixture of stone and brick, with a modern breeze block wall to the rear. The roof is slate, with the remains of a chimney in the northwest corner. Externally the building appears relatively stable although the roof is beginning to deteriorate in places with some slates missing. The building is no longer in occupation, it appears to be used mainly for storage. *Visited 13/12/2005 (PP)*

NW facing of the coach house PRN 55624.

The aim of the management for this site should be the maintenance and preservation of this interesting structure, and its association with the adjacent dwelling of Albert Mount. The building appears to originally date from the 19th century but it has been subsequently altered and repaired, with some original stonework replaced by brick and breeze blocks. The structure now appears to be fairly stable, used mainly for storage. Externally the roof appears to be fairly stable although it may be deteriorating, some slates are now missing and loose and guttering has fallen away. The chimney at the northwest corner of the building is partly collapsed above the roofline. Much of the structure is surrounded by scrub, especially to the north, and a small amount of ivy has begun to establish itself at the northwest side of the building.

- Scrub clearance should be undertaken around the structure to improve the visibility of the site and prevent further growth establishing itself on the structure.
- Ivy should be cut back and treated.
- Work may be required to repair the roof to ensure the continual survival of the structure, using methods and materials appropriate to the character of the locality.
