TIR GOFAL MANAGEMENT PLAN: HERITAGE MANAGEMENT INFORMATION HE2

Prepared for:
Tirpant
W/12/4291

Report No. **2004/77**
Project No. **49899**

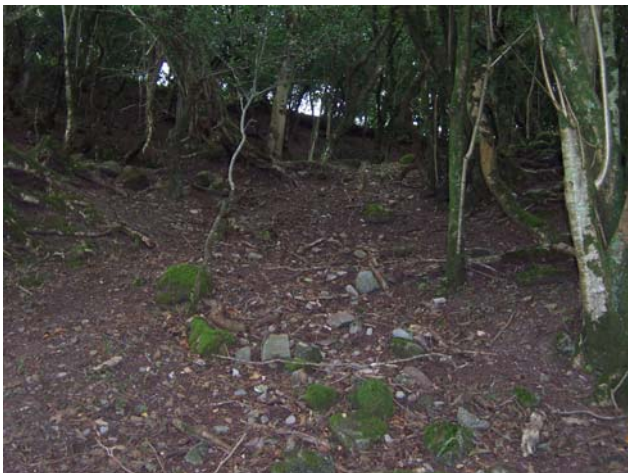
Name (& PRN)	Period/Site type	NGR	Status	SAM/listing	Management required
1	TIR PANT;TIR-Y-PANT (27454)	Post Medieval lime kiln	SN65211777	B		Specific
	<p>The fragmentary remains of a limekiln north of Tirpant farmstead. The kiln consists of a pennanular (horseshoe shaped) depression c2.5m in diameter, cut in to the hillslope, with drawing hole to the north. Traces of stone walling survive on the east and west sides of the kiln. This description is basically unchanged from the last visit to the site by Sambrook in 1994. The site lies on the edge of established woodland with a clear woodland floor. Some young coppice stools are interspersed between the mature trees. The kiln remains are relatively stable, with few signs of recent disturbance.</p>

Looking north to the remains of the lime kiln.					
2	TIR PANT;TIR-Y-PANT (27455)	Post Medieval lime kiln	SN65171776	B		Specific
	<p>A poorly preserved limekiln. The kiln remains comprise a stone and earth penannular bank c.2.5 in diameter, with drawing hole facing north and spoil spread downslope in that direction. This description is basically unchanged from the last visit to the site by Sambrook in 1994. The kiln lies in woodland with a clear woodland floor. Some young coppice stools are interspersed between the mature trees. The kiln remains are relatively stable, with few signs of recent disturbance.</p>

The kiln is in a stable condition but there is potential for uprooting/ falling trees damaging the kiln earthworks in future. The following might be considered.

Monitor existing trees around the kiln earthworks. Unstable specimens to be cut off at the roots before being allowed to fall naturally (this will prevent damage to the structure by falling trees and uprooting).

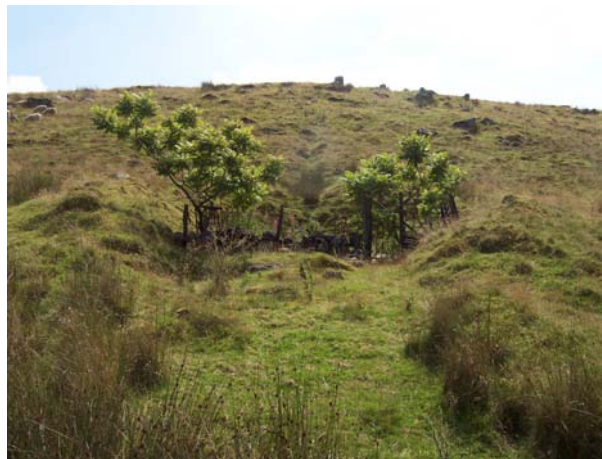
An Old Coal Level marked on the 1889 Ordnance Survey map on the north side of Careg Dwfn. There is no known association with any nearby mining activity and the level possibly represents trial workings. The entrance is now collapsed with further slumping upslope indicating the direction of the excavations. Spoil tips surround the entrance and a stone platform (4m x 4m) of unknown function lies to the south. The mouth of the level is fenced off and grassed over. Agricultural and domestic debris are now scattered about the site. Young ash trees are growing on the spoil tips.

The mouth of the coal pit, as seen from the north.

The management aim is to remove all debris in order to enhance visibility of the site.

The debris is currently masking the mouth of the level and the depth of mining excavations is not known. Work should only proceed as far as is safe to do so.

Please inform Cambria Archaeology if any mining remains are discovered during clearance works. These should be left in place and not disturbed.

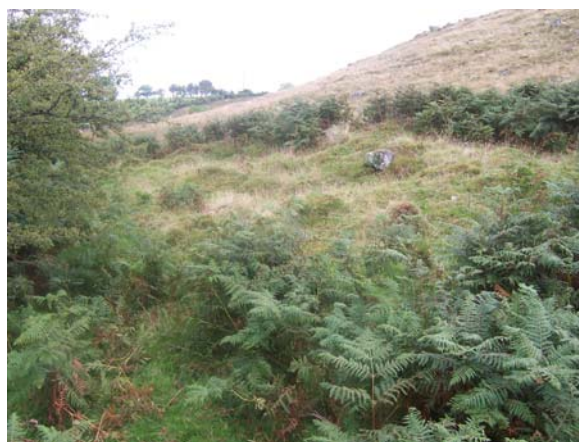
This description was given for the Deserted Rural Settlements Project. Site of an abandoned cottage or hafod? Survives as a rectangular earth and stone bank c.1.0m thick and 0.5m high enclosing an area 5.0m x 7.0m with a gap c.1.0m wide in its north corner probably an entrance way of some kind. Attached to this is another bank of similar dimensions which is "L" shaped and forms another rectangular enclosure but with its north-west side left open. Running off the south corner of the site is a low earth field boundary which proceeds downhill to the south-west for c.100m before turning northeast-north to join an existing field boundary c.20m away (Sambrook 2004). Some 5m to the north of the site is a shallow circular depression in the ground which may represent a pond. This description remains unchanged. Bracken is beginning to encroach on to this site, but is it otherwise under stable grass cover.

The earthwork remains of the long hut are at risk of becoming obscured by bracken.

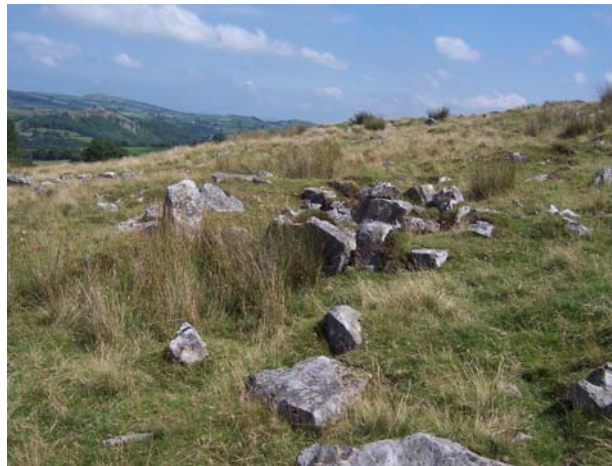
A sub-rectangular depression in hillside banked on three sides (east, north and west) by an earth and stone bank set into hillside on south. Measures 4.0m by 3.0m wall up to 1.0m high. There is a gap in the wall on the west side forming an entrance point (Sambrook 2004). The site was under stable pasture at the time of the archaeological farm visit. No specific management threats were identified.

The remains of the shelter as seen from the south-west.

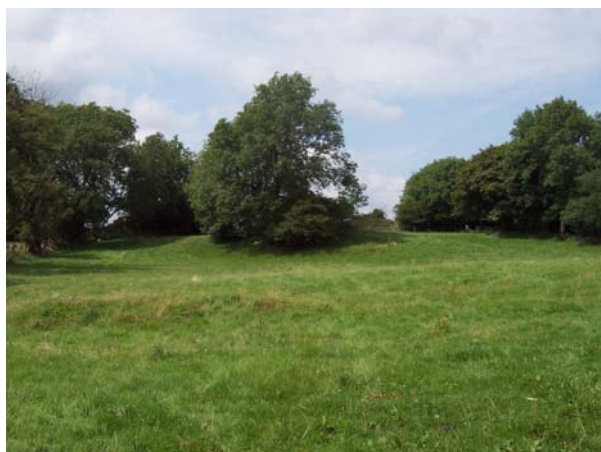
A ruinous circular kiln to the north of Careg Dwfn hill. It first appears on the First Edition Ordnance Survey map (1879). The kiln is set in to a mound, with the kiln pot (now infilled) in the centre. The pot is c.3m in diameter. A ruinous dry stone wall to 1m high on the south-west side of the mound marks the position of the drawing hole. Several mature and scrub trees are scattered about the mound which is otherwise under pasture. This description is largely unchanged from when the site was last visited by Cambria (Sambrook 1994).

The site of the kiln viewed from the south.

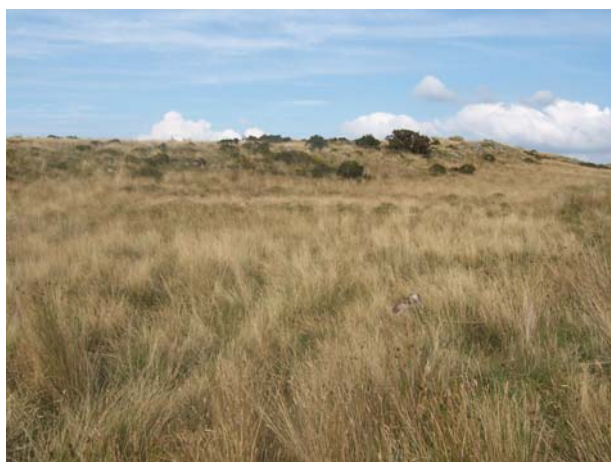
A poorly defined ring barrow 8-10m diameter, now partially vegetation covered that occupies a natural terrace on the south side of Careg Dwfn. The banks are 0.3m high and up to 1.5 wide with some stones exposed through the grass cover.

The poorly defined remains of the ring barrow, close to the summit of Careg Dwfn.

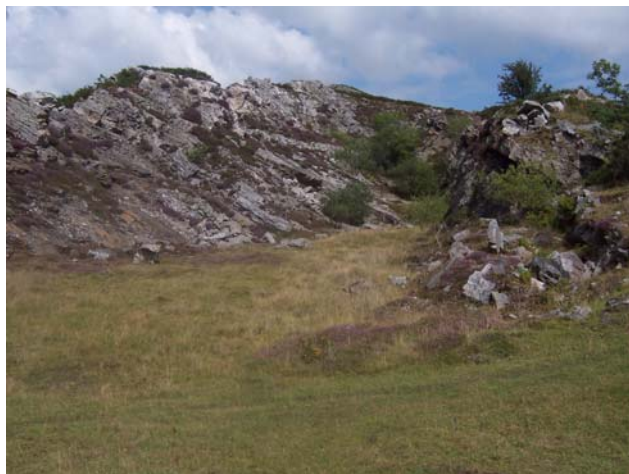
Disused silica quarry, quite extensive, exploiting millstone grit outcrop at west end of ridge known as Careg Dwn. No obvious remains of any related buildings or other structures save for metal posts and wooden sleepers used to revet a bank beside the track leading to the upper quarry workings at the western edge (Sambrook 1994). A similar revetment feature was identified on the side of a track which skirts the south side of the quarry during the archaeological farm visit.

Substantial quarry excavations, viewed from the south-west.
