TIR GOFAL MANAGEMENT PLAN: HERITAGE MANAGEMENT INFORMATION (HE2)

Prepared for:
BRYNLLYS FARM
Borth, Ceredigion, SY24 5LZ

Farm Visited on the
27th May 2004

Tir Gofal Reference No. W/11/4180, 4180a.
Project Record No. 49901
Report No. 2004/68

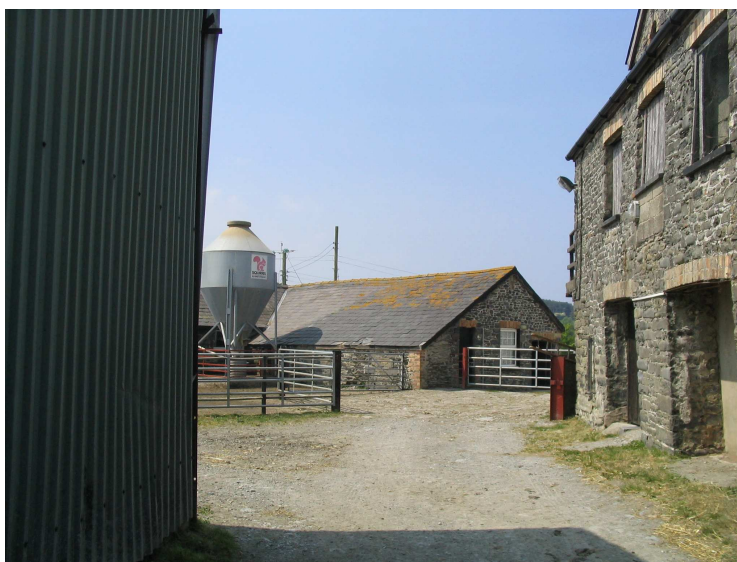
A formally planned farmstead, with the farmhouse detached from outbuildings to the west. It represents a mixed agricultural economy in a series of purposely designed buildings formally arranged around two yards. Historic maps suggest that this arrangement was not established until the later nineteenth century.

Recent years have seen a number of modifications to the farmstead. Despite the loss of some traditional buildings, it retains good historic character and the late nineteenth century layout of two separate farmyards remains basically intact. Some traditional farm buildings in the south of the complex are to be converted for commercial use. As such they fall outside of the Tir Gofal Scheme. Buildings to the north (PRNs 51060, 51061), around the rectangular yard are unaffected by these developments. It is hoped that these will be restored under Tir Gofal.

Farm buildings at Brynlllys.

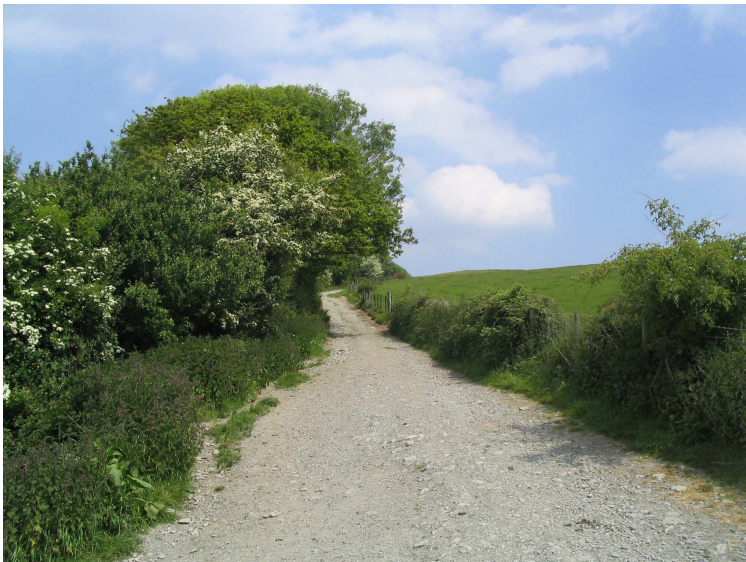
No on Map	PRN	Site Name/Type	Period	NGR	Importance (status)	Management
	51057	Trackway	Post Medieval	SN61998875; SN62188880; SN62318882	C	Generic
<p>A well defined trackway accessing fields to the east of Brynllys farmstead (PRN 51054). It first appears on the 1 inch to 1 mile Old Series map of 1837 and remains in active use today as a farm trackway (c.8 m wide). It is flanked by outgrown hedges to each side.</p>

Looking east along the trackway.

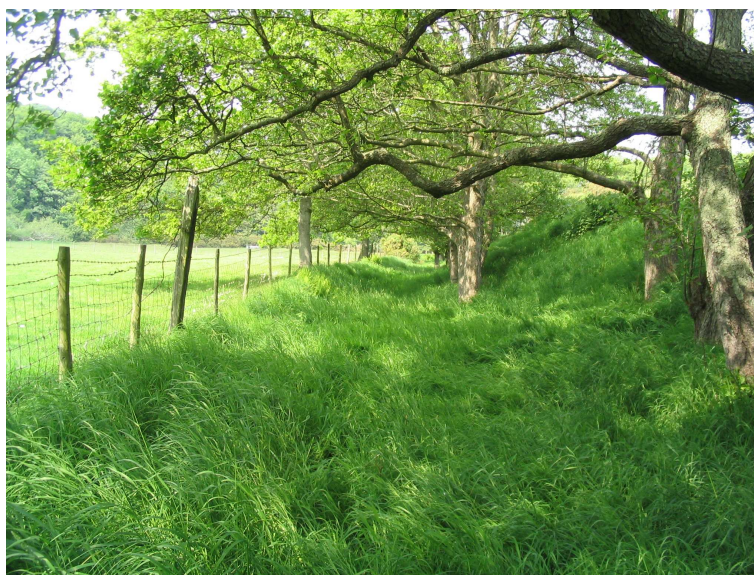
The earthwork remains of an old leat serving Felin Newydd corn mill (PRN 16108). It first appears on the Old Series map of 1834 and remains on recent maps. It is sourced from the Ystwyth just below Pen-y-graig farmstead and continues north to Felin Newydd corn mill, extending for just over 300m in all.

The leat is dry but retains its profile (c.2.5m wide by 0.5m deep). Traces of stone lining appear at intervals along its length. The earthworks lie on the margins of a pasture field and are grazed occasionally by sheep. The northern 50m, outside of the application area, were not seen during the archaeological farm visit.

Looking north along the dried up leat.

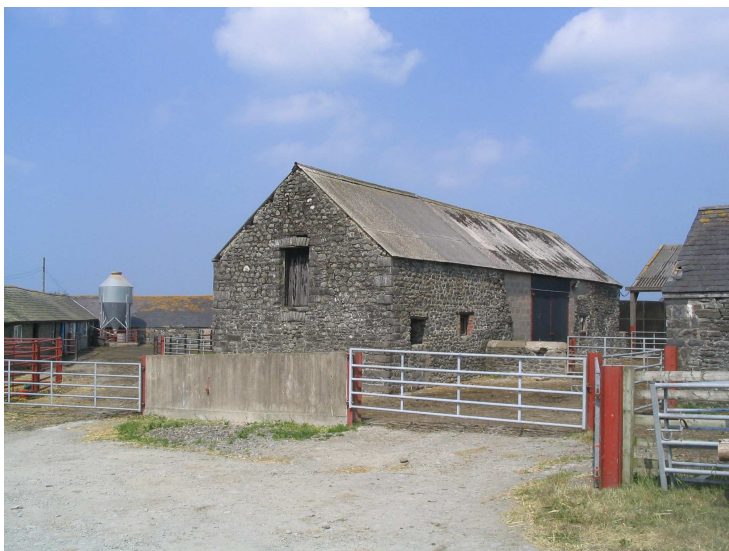
No on Map	PRN	Site Name/Type	Period	NGR	Importance (status)	Management
1	51060	Combination Farm Building	Post Medieval	SN61998876	B	Specific prescription (see below)
<p>An early nineteenth century threshing barn, with lofted stable at Brynlllys farmstead (PRN 51054). It is truncated at the north end where it formally joined other agricultural buildings to complete an L-plan with attached long east range. It is typical of a type of agricultural building, built to serve a variety of purposes, which began to appear in western areas of Wales from the beginning of the nineteenth century.</p> <p>It is of stone rubble construction, originally with a slate roof (now corrugated asbestos) and stands to two storeys. The barn in the north is modernised and few original openings remain. Two narrow doors (now blocked) pierce the east wall north of the threshing floor. The characteristic threshing doors are now lost; having been replaced by metal panel doors and breeze block infill, following partial rebuilding. None of the historic internal arrangements or fittings survive. The attached stable occupies the southern third of the building. It is entered in the west wall by a narrow wooden panel door, which opens onto the feed passage. An opposite doorway in the east wall is now blocked. Stalls are arranged facing the long axis of the building. Window openings are placed north of the doors. The east window is also blocked. The loft was not seen during the archaeological farm visit. Access is gained internally from the threshing barn. A loading door pierces the S gable end opposite.</p> <p>Despite modifications detracting from the buildings original appearance, its original function can still be discerned and it retains good historic character. It divides the two farm yards at Brynlllys and makes a significant contribution to the group value of the farmstead as a whole.</p> <p>The range is currently in a reasonable condition but is at risk of degenerating if maintenance works are not undertaken. Water entering through the roof is promoting dampness and decay of timber in the roof and floor joists. This is advanced in the stable where floor joists are rotted through above the feed passage. Lime mortar bonds are loose and weathered in areas and there is a risk of masonry becoming displaced.</p>

The threshing barn and lofted stable, viewed from the east.

51060 Combination Farm Building

To return the roof to a stable, watertight condition (this will prevent water ingress from promoting dampness and leading to further degeneration of timbers). Existing roof timbers should be retained as far as practically possible during the restoration. Slate is the preferred roofing material and will return the building to its original historic appearance.

Re-point areas of unstable masonry (As a general rule pointing is required when mortar is weathered back to a depth equivalent to joint width or is very loose). This should be undertaken with a similar lime mortar mix.

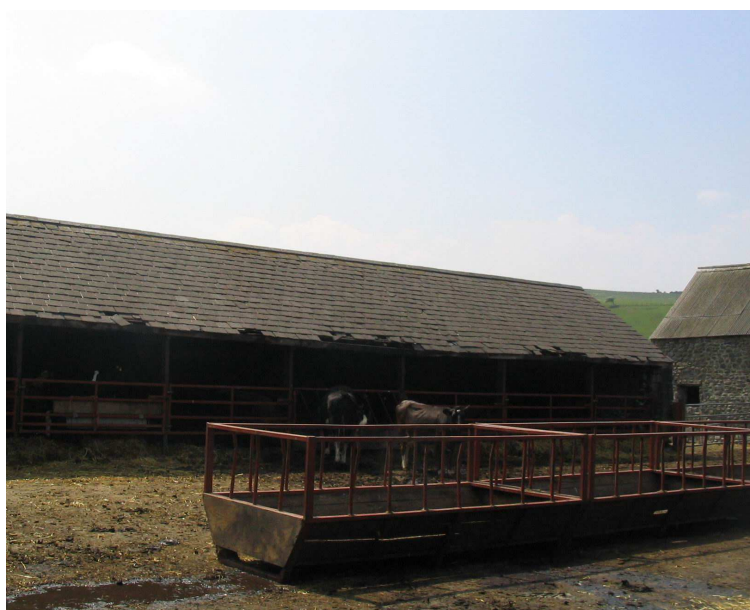
A long, low cow shed on the south side of the east yard at Brynlllys farmstead (PRN 51054). It first appears on the 1st edition Ordnance Survey map of 1888 and dates to the later nineteenth century. It is of stone rubble construction with roughly squared quoins and a pitched slate roof. The front wall has been removed to allow conversion to an open fronted cow shed and no original door or window openings survive. Despite alterations, the cow shed still contributes to the group value of the farmstead. It is currently in a relatively stable condition but a crack in the west gable end is a potential source of instability, not least because the wall plate is supported here. Some roof slates are displaced.

The cow shed has been modified in recent years.

51061 Cow Shed

To return the roof to a stable, watertight condition by reinstating loose and missing slates. Unstable masonry to be consolidated. Seek specialist advice if necessary. Re-pointing to be undertaken with a similar lime mortar mix.
