TIR GOFAL MANAGEMENT PLAN: HERITAGE MANAGEMENT INFORMATION (HE2)

**Prepared for:
Neuadd Yr Ynys**

Tir Gofal Reference No
W/11/4186

Report No. 2004/90
Project Record No. 49903

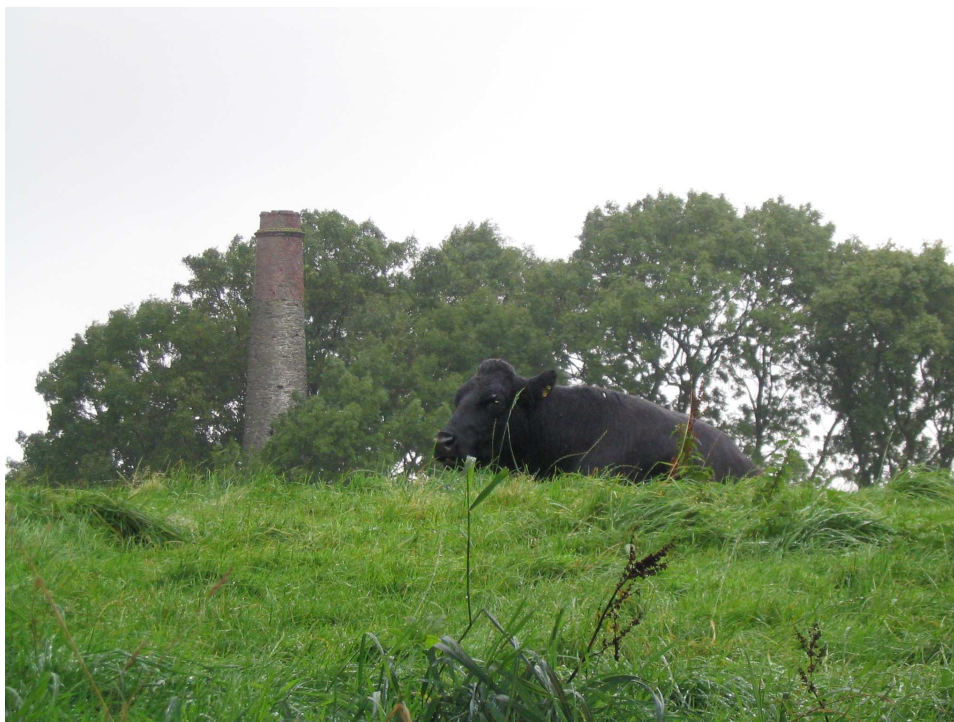
Llancynfelin Mine chimney; a prominent local landmark

A large circular chimney, mostly stone built with a brick top. The engine house which would presumably have stood adjacent to the chimney no longer survives. The chimney stands within grazed woodland. It appears in a reasonably stable condition, but the upper course of brickwork appears incomplete.

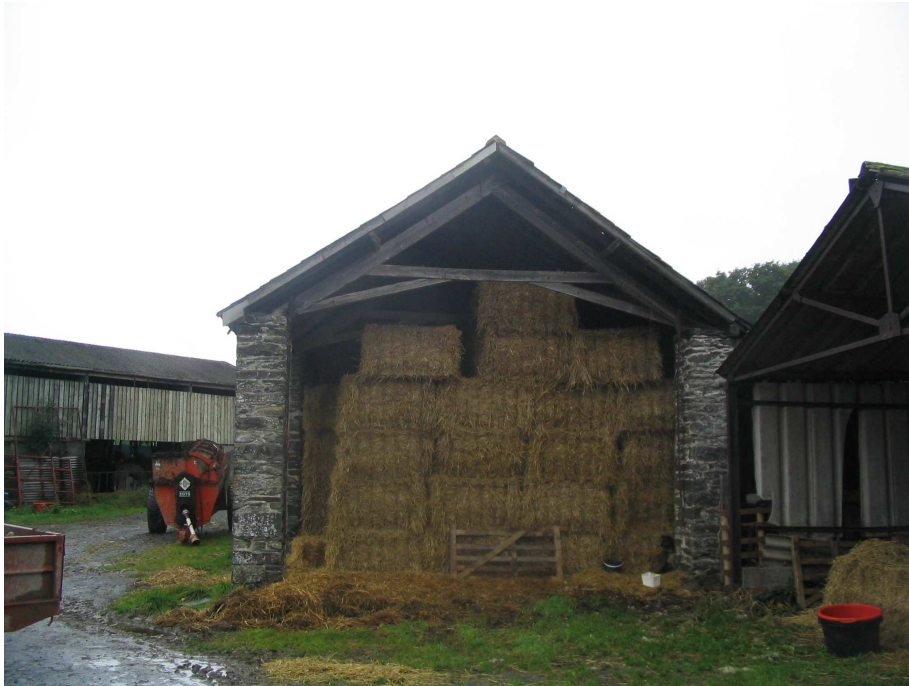
An open sided hay barn constructed with square stone pillars supporting a slate roof. The slates are laid with alternate slates missing. The building is currently in use as a hay and straw barn and is in fair condition.

PRN 51827 – this open sided stone hay barn has recently been listed.
