## **TIR GOFAL MANAGEMENT PLAN: HERITAGE MANAGEMENT INFORMATION (HE2)**

**The deserted farmstead of Blaen Gorffen**

**Tir Gofal Reference No. W/11/4270**

**ACA Report No. 2005/3  
Project Record No. 49913**

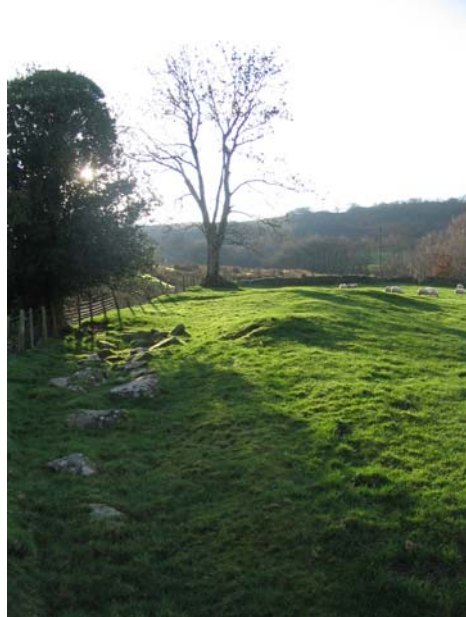
A cottage marked on the Caron Parish Tithe, 1842 and continues to be recorded on the 1889 and 1905 Ordnance Survey maps. There are no upstanding remains of this cottage site. However, the outline of the cottage enclosure is still visible and a quantity of loose stone lies near the boundary fence. An uneven ground surface in this area suggests that the remains of the ruined cottage lie just beneath the turf.

*The remains of a cottage called Pant Meini*

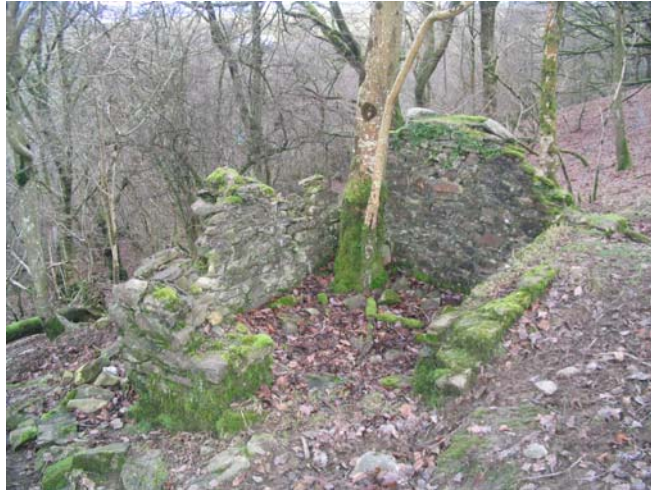
A powder magazine shown on the 1st edition (1889) Ordnance Survey map (sheet XXI.07) The walls of this powder magazine stand to a height of just over a metre. It is a small square, single cell, building. A large ash tree has grown up in the corner of this building.

*The remains of a powder magazine lies in the woodland above the mine shaft.*

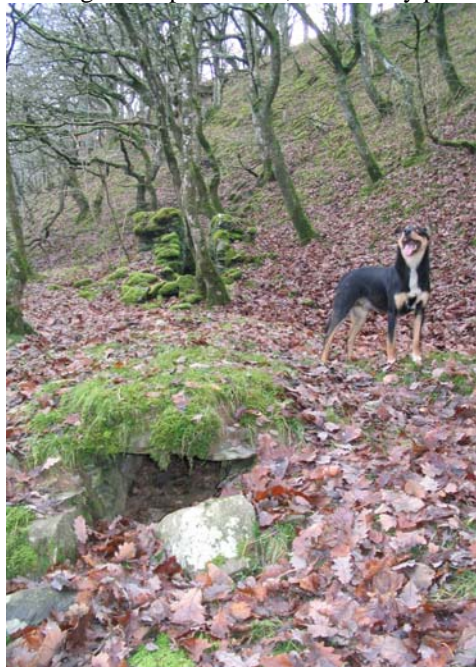
A masonry lined wheel pit lies on the valley floor adjacent to the stream, it approaches 2 metres in depth and approximately 0.4m wide. There are four vertical slots in the masonry lining. The pit is aligned towards the stream and a few metres down there is a stone lined culvert opening towards the stream. The wheel lies in woodland and small mature trees have grown up around it, which may pose a threat to it by tree fall.

*The exit for the tail race, taking water away from the wheel pit in the background.*

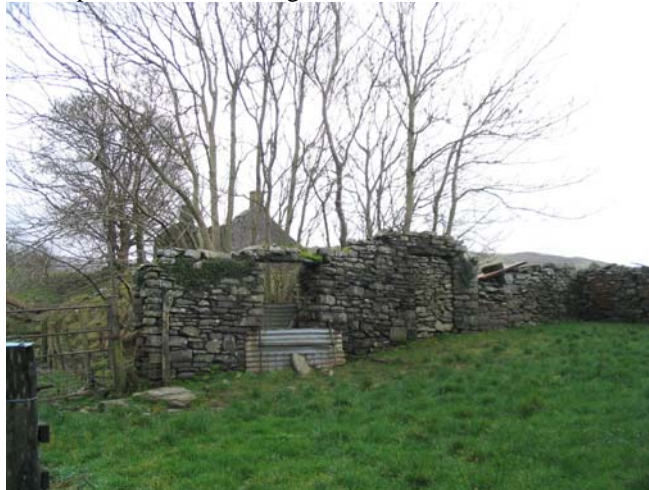
Ruined cow shed, parallel to cow shed and barn PRN 51886. West wall survives to door head height. Self seeded ash trees have grown up within the building.

*The remains of the cow shed consist largely of this west wall*

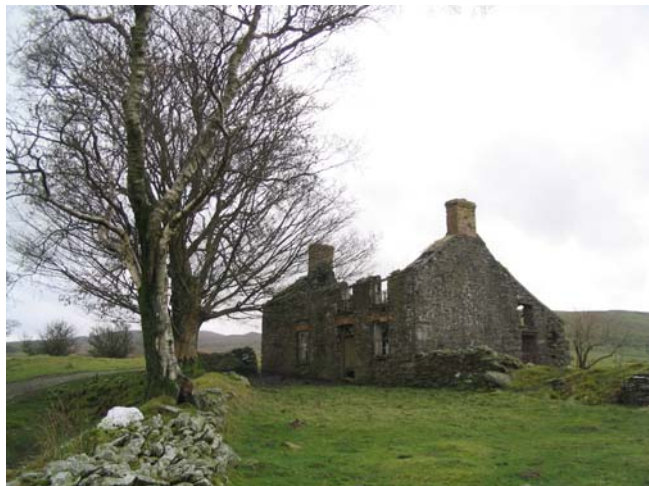
A ruined 19th century farmhouse. It is constructed in stone rubble and has the remains of a slate roof. The chimney stacks are yellow brick.

*The farmhouse at Blaen Gorffen was occupied until the late 1950s*

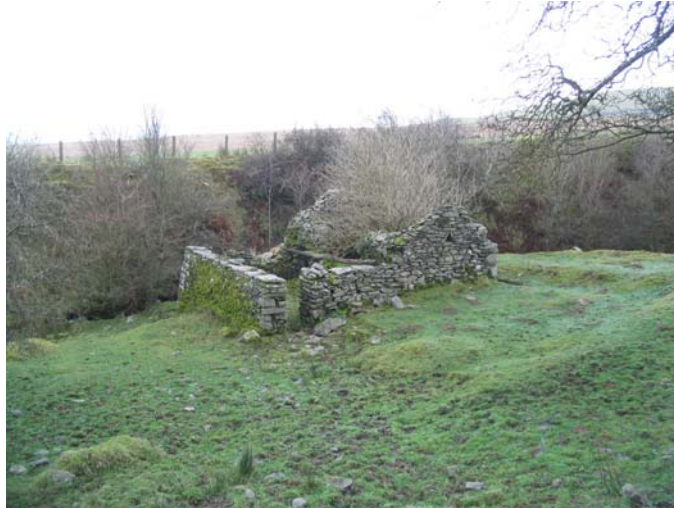
A stone built pigsty lies to the side of the Gorffen stream. The roof has gone completely but the walls stand more or less to full height. The yard lies to the west of the covered area.

*The pigsty at Blaen Gorffen and associated enclosure walls.*

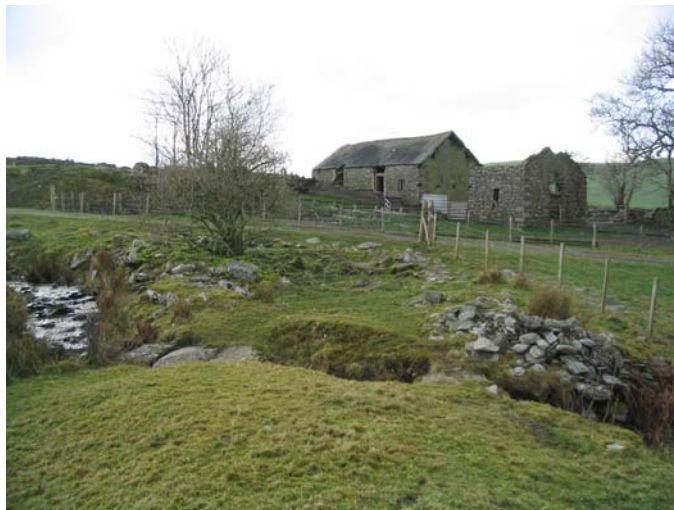
A footbridge constructed out of large slabs of stone are placed across the Nant Gorffen below Blaen Gorffen farmstead (four remain in place but there are spaces inbetween for several more). The stones are set on masonry revetment walls either side of the stream.

*The footbridge at Blaen Gorffen is constructed from massive stone slabs.*

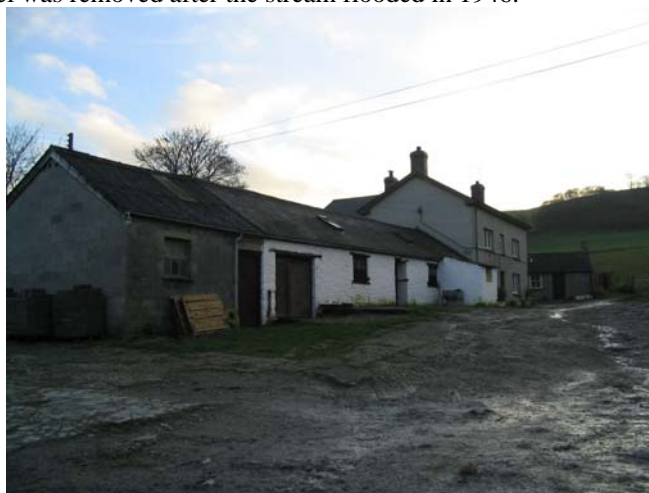
Bronmwyn Farmstead currently consists of the farmhouse and cow shed (51892) which form part of a continuous range of buildings. Above the farmhouse is a small outbuilding (51893) and opposite, not quite parallel, is the barn and stable (53132). At the lower end of the farmstead, on the other side of the stream is a shelter shed (53133). The stream was diverted above the farmstead and leat carried water to a water wheel situated between the cow shed and stream. This is clearly shown on the 2nd edition Ordnance Survey map (1905). The water wheel was removed after the stream flooded in 1946.

*Bronmwyn Farmstead, with the cow shed (PRN 51892), farm house and outbuilding (PRN 51893)*

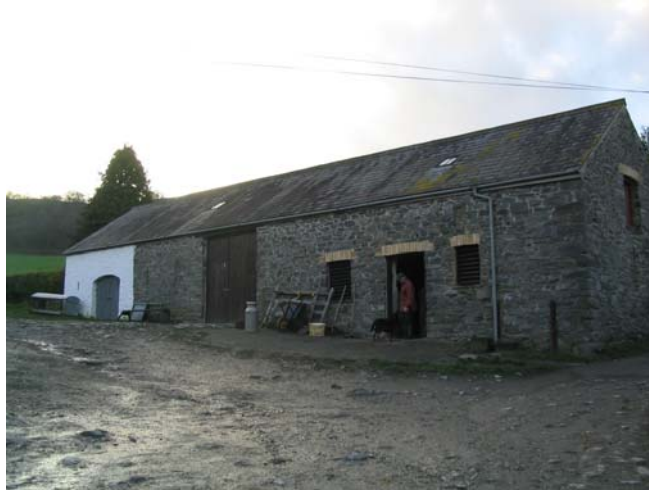
A long range including a lofted cart shed at the southern end, a barn with double doors to full height, and a lofted stable at the northern end. The stable retains wooden stall partitions and cobbled flooring. This building has recently been reroofed and is in good condition.

*The combination farm building includes a cart shed at the far end, a barn and stable.*
