TIR GOFAL MANAGEMENT PLAN: HERITAGE MANAGEMENT INFORMATION (HE2)

**Prepared for:
Ffwrnes Blwm**

**Tir Gofal Reference No
W/11/4289**

**ACA Report No. 2005/ 63
Project Record No. 49916**

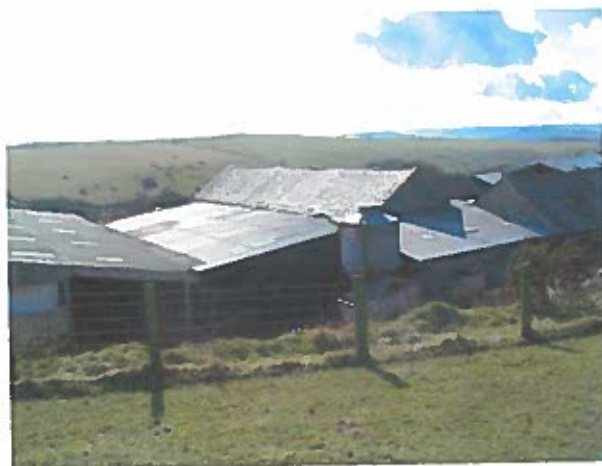
Looking south across Mynydd Gorddu mine showing damaged northern wheelpit, with modern shelter sheds in the background.

The northern wheel pit [15] has been damaged by the modern continuation of a trackway shown on historic maps. The pit has been partially infilled with stone rubble, and there is no trace of the crusher house marked to the west on historic maps. Further west the second edition Ordnance Survey map records six buddle pits [18] (for separating the ore from the gangue) arranged in two rows of three. The first edition Ordnance Survey map shows that this area was covered when the mine was in operation. There are currently no surface traces of the pits, but the ground is uneven, with some stone rubble suggesting potential for surviving below-ground remains.

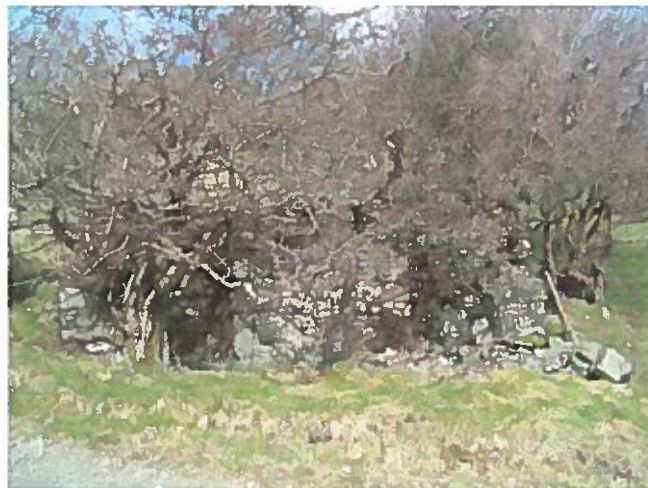
On the eastern side of the complex, is a small single-storey rubble-stone building, which was the explosives shed for the mine complex. The main part is single-cell, and measures approx. 4m x 4m, with a south-facing entrance. Annexed to the east side of the building is a small lean-to, measuring approx. 2.3m x 2.3m with its own south-facing entrance. The land-owner referred to this building as 'Ty Powdr' ('powder house'), and it is marked on the first edition Ordnance Survey map as 'magazine'. The walls of this building are substantial for its small size. Explosives sheds were designed in this way, with relatively flimsy roofs so that if an explosion occurred the blast was directed upwards rather than horizontally.

'Ty Powdr' the explosives shed for the Mynydd Gorddu complex, viewed from the south-east.

The landowner expressed interest in restoring the Powder House. This feature appears to survive largely intact apart from the roof. No original roof material survives, but there is a suggestion that it may have been made of corrugated iron. In this instance corrugated iron would be an appropriate replacement. Scrub clearance is required to remove thorn trees which threaten the structure. Consideration of an appropriate roof structure would be necessary prior to any rebuilding work commencing.

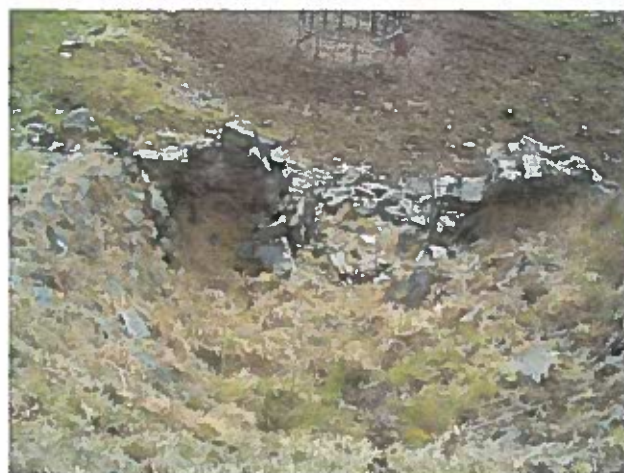
Further west, on the south side of the same track is a stone built structure [13], which the landowner believed to be a kiln due to the conical central arrangement of stones. The feature is more likely to be an ore bin or hopper, into which the mined ore was loaded to be fed down into the dressing process.

The ore bin/ hopper viewed from above.

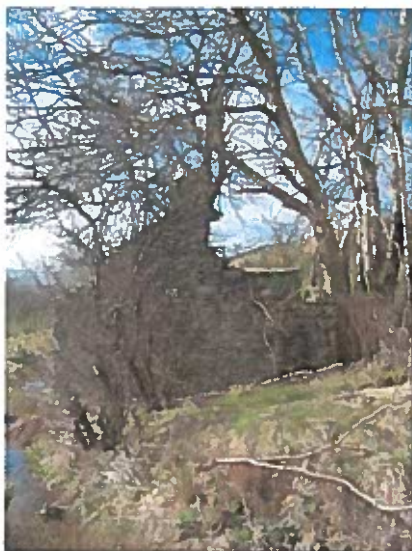
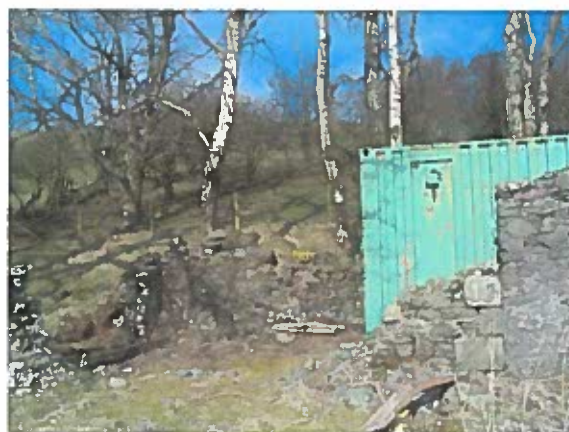
At the western edge of the complex is a building, which now houses a secure metal container [6]. It is single-storey, stone-built with two cells and is currently roofless. The walls are in various stages of deterioration. A straight joint is clearly visible in the front (southern) elevation, and the mortar on the eastern side of this joint is a distinctive dark grey (a colour probably derived from high mineral content). This suggests that two halves of the building were constructed at different times, and that the eastern part was constructed after the mine started to operate. The western portion of the building measures c. 8m in length x c. 4m from front to back, and has the remains of a chimney in the northern elevation. The eastern portion of the building has a chimney in the east gable-end, and measures 4m from front to back x c. 4m in length. The function of the building is not clear, but the incorporation of fireplaces suggests that it was used for occupation, and it may have been the mine office.

Two views of the building which may have been the mine office, and now houses a metal container.

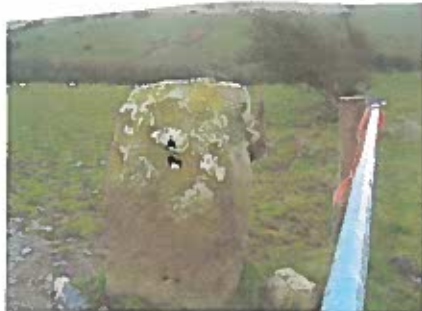
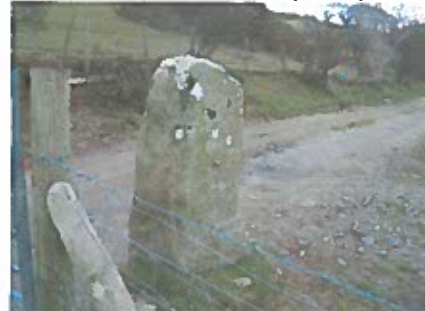
Large upright stone slab now used as gatepost for field boundary. The slab stands to a height of c. 1.6m, and is c.0.7m wide. The size and form suggest that it may have been created as a standing stone, but has been re-used as a gatepost. It is unclear whether the stone occupies its original location, but it may have been moved to the end of the field boundary to be used as a gatepost. Poaching around the base of the slab has lowered the ground level, and may be threatening the stability of the stone. *Visited 10/03/2005 (HGM)*

Two views of stone 53,097, showing poaching around the base.

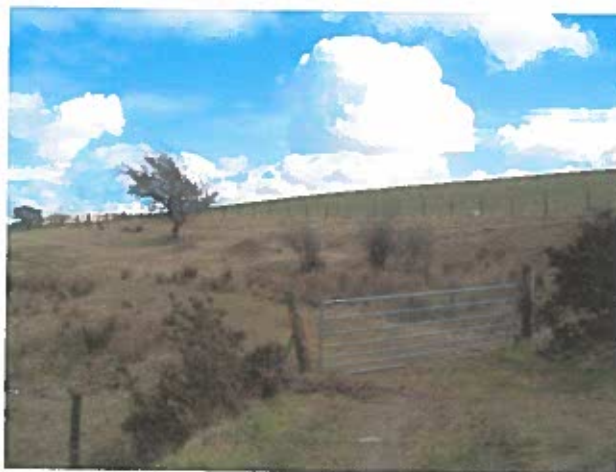
The site of a settlement marked on the 1778 estate plan known as 'Lletty March Melin'. Also indicated on the 1847 tithe map as 'Lletty'r March'. The settlement is no longer marked on the first edition Ordnance Survey map of 1887, suggesting it had been abandoned by this time. Although the site lies close to a stream, the 'melin' element is believed to have been a corruption of 'melyn' rather than an indication of a mill in the vicinity (so that the name translates as 'yellow stallion lodge'). The abandonment of the cottage coincided with the construction of the reservoir (PRN 30,694). The site of this cottage is now visible as a series of low earthworks in rough ground. No immediate threats to the condition of this site were identified, and it appears to have survived due to its location on unimproved, rushy ground close to the reservoir. However there were several small thorn bushes dotted around the remains. *Visited 10/03/2005 (HGM)*

The site of Lletty March Melin

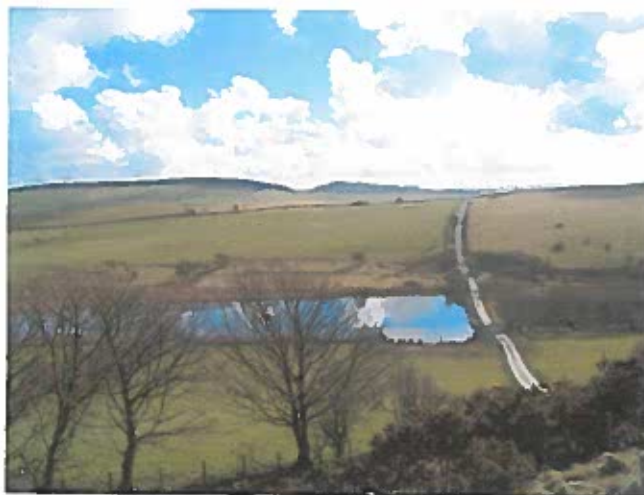
A reservoir associated with metal mining activities, situated above leats to Penycefn/ Court Grange and Mynydd Gorddu Mines. It is supplied with water from Afon Leri c. 2miles away via a leat. The reservoir is likely to have been constructed between 1849 and 1851, as part of a major capital investment programme in local mines. It is also possible that it was constructed between 1873 and 1882 when Penycefn/ Court Grange was re-opened, as well as Mynydd Gorddu opening in 1874. The reservoir does not feature on the tithe map of 1847, although the leats to the west are shown.

Reservoir 30,694 looking south

The first and second edition Ordnance Survey maps show the reservoir and dam with sluice, with a water level which is lower than the present level, surrounded by marshy ground. The dam now carries the access track to Mynydd Gorddu farm, and the water level has risen due to recent drainage works carried out by the landowner on surrounding land. *Visited 10/03/2005 (HGM)*

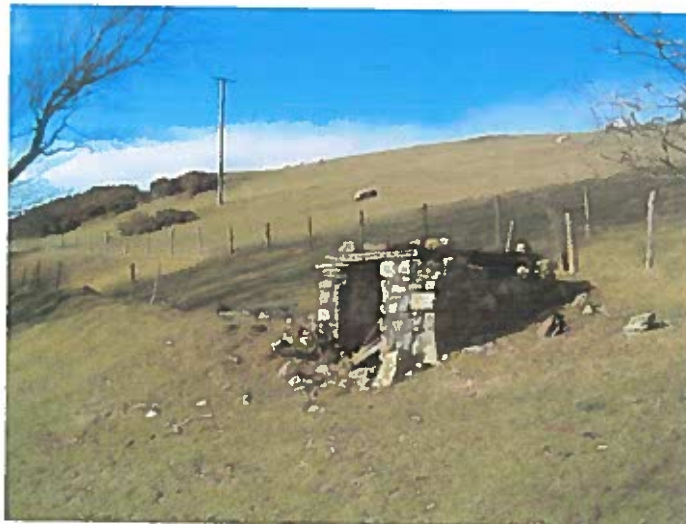
Small single storey stone building, built into south facing slope. Entrance on south elevation, offset to west side. Some stone has been dislodged from the walls, and the roof has collapsed. The building has corrugated tin laid over it, which are held down with stone from the walls. The landowner stated that this was a double-seated Ty Bach. The building is now used for storage. *Visited 10/03/2005 (HGM)*

The 'ty bach' (53,098)

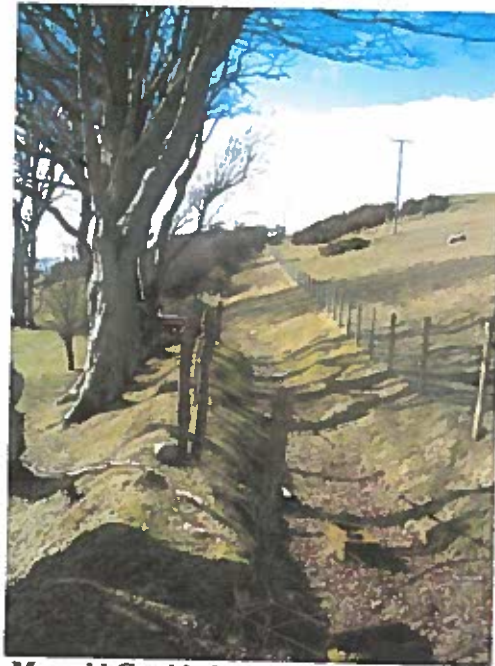
Prominent boundary bank which formerly divided open mountain land from enclosed land lower in the valley. The full extent of this feature is unknown, but it may run around the entire mountain. *Visited 10/03/2005 (HGM)*

Mynydd Gorrddu boundary bank (53,099)

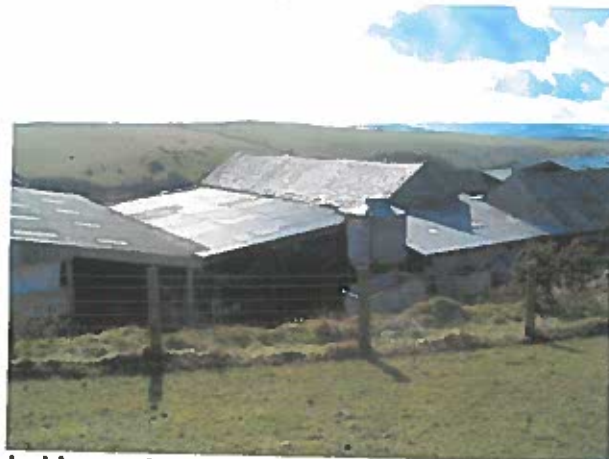
The traditional outbuildings at Mynydd Gorddu form three sides (south, east, and north) of a fold-yard. The 'beudy' (cowshed) forms the south side, whilst the 'cartws' (carthouse) and 'stabal' (stable) form the east side, and finally the 'sgubor' (barn), and 'beudy ucha' (upper cowshed) form the north side. All are built of local rubble-stone, and were originally roofed with slate.

Mynydd Gorddu farm looking southwest, showing traditional buildings and modern shelter sheds.

The landowner wishes carry out restoration on the traditional outbuildings at Mynydd Gorddu. The main body of the work will focus on repairing and replacing roof elements that are unstable.

Buildings on the north and south sides of the foldyard currently have corrugated fibre-cement on the northern pitches of their roofs. The roof on the south building forms a particularly prominent visual element of the historic landscape. It is therefore intended that slates will be utilised from the northern building, to replace the fibre cement element of the roof on the southern building in the range.

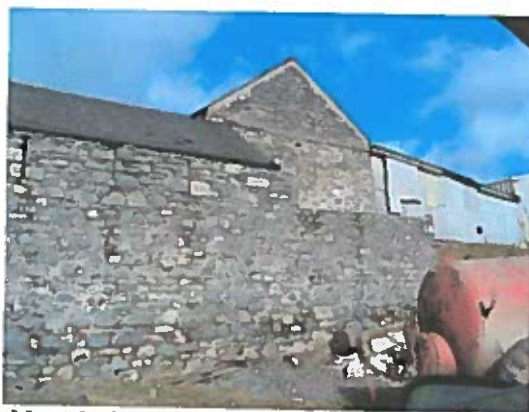
Cowshed on south side of foldyard, showing ventilation slits and gable end of carthouse with mortar scarring.

On the south side of the fold-yard, the single-storey cowshed is c. 22m in length, by 6.5m wide. The northern elevation of this building is single storey height, whilst the southern side forms a retaining wall for the hillslope, and extends downwards, so that the height of this wall when viewed from the south is double the height of the northern elevation. This aspect is seen from the road and the approach to the farmstead, and the double height wall is a particularly striking visual element of the historic farmstead. Beneath the eaves on the southern elevation is a row of narrow, evenly spaced ventilation slits. There is no eastern gable end to the cowshed. It is arranged so that it meets at a right angle with the eastern portion of the range (the carthouse/ cartws) half way across the breadth of the cowshed's eastern end. The southern elevation of the cowshed formerly continued to the east, to form a 'lean to' element against the southern gable-end of the carthouse. This is evidenced by continuation of the lower portion of the southern retaining wall on the cowshed, and a mortar scar at the height of the cowshed roof apex, on the southern gable end of the carthouse.

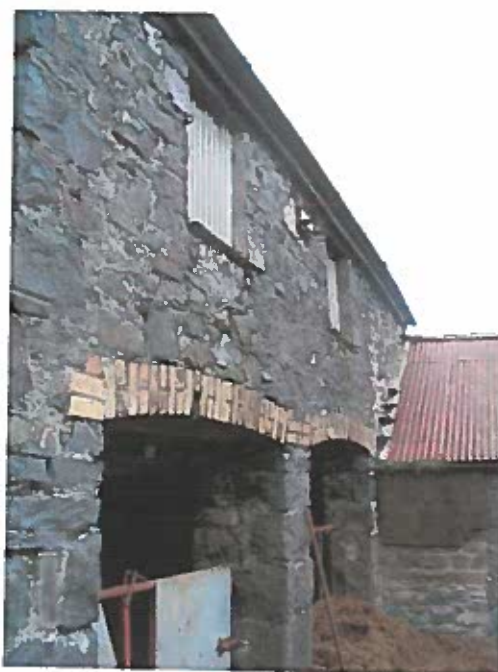
West elevation of the carthouse

The carthouse forms the eastern side of the foldyard. It is two-storey and built of rubble-stone. The east elevation is almost entirely concealed by modern livestock shelters. The west elevation incorporates two brick arched entrance-ways, and a second storey hay-loft with an external entrance, which appears to have been accessed by ladder from the outside.

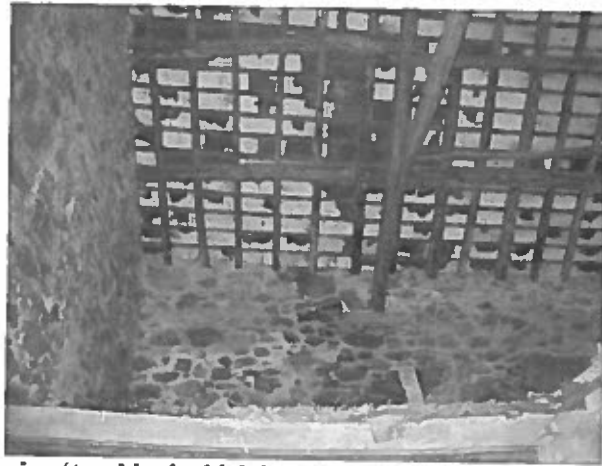
Inside the carthouse showing 'torching' which is a distinctive feature of the roofs at Mynydd Gorddu

There is evidence that all of the outbuilding roofs originally had torching (lime mortar infilling between the batons and rafters) under the slates, and it is a distinctive element of the roofs at Mynydd Gorddu. It survives in a deteriorated condition in many places where the original roof structure has remained intact. *Visited 10/03/2005 (HGM)*

Torching (the use of lime to infill spaces between batons and rafters) is a distinctive element of the underside of the roofs at Mynydd Gorddu, and ideally where slate roofs are to be repaired or replaced, torching should be re-instated, as this will help retain the distinctive historic character of the buildings.
