## **TIR GOFAL MANAGEMENT PLAN: HERITAGE MANAGEMENT INFORMATION (HE2)**

**Prepared for:  
Morfa-Uchaf**

**Tir Gofal Reference No  
W/11/4302**

**ACA Report No. 2006/4**

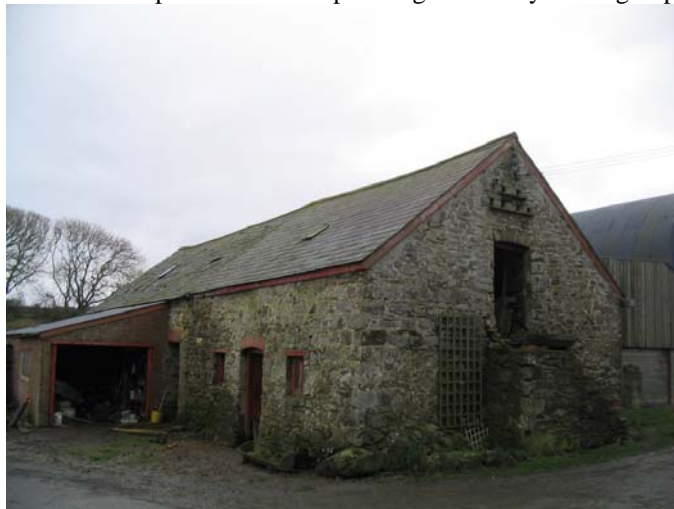
**SE facing shot of the detached barn to the south of the farmhouse.**

- Slates are missing from the roof of the detached farm building to the south of the farmhouse, and the roof is apparently beginning to separate at the apex. This roof structure should be repaired and missing and loose slate reattached using materials and techniques appropriate to the farmstead complex as a whole.

This farm is already within the Tir Gofal agreement and the amount of work suggested above would probably exceed the funding available within Tir Gofal. If all the works suggested are therefore not possible then it may be advisable to prioritise the repair of the roof of the detached farm building to the south of the farmhouse.

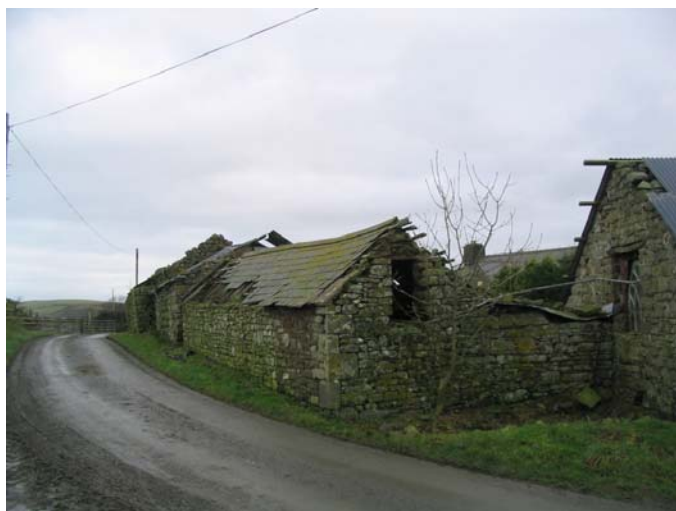
**NE facing shot of part of the L-shaped range of farm buildings. The deteriorating roofs are clearly visible.**

The aim of the management for this site should be to ensure the survival of the traditional buildings and maintain the historic character of the complex of traditional farm buildings as a whole. The roofs of all the traditional farm buildings are in varying degrees of deterioration, and as a result the buildings can be used for little other than storage. The rear wall of the northernmost part of the L-shaped range of farm buildings is also visibly bowing.

- The corrugated iron roofing of the large southernmost barn forming the lower section of the L-shaped range appears to be in the best condition of all the traditional farm buildings. However, this roofing is beginning to deteriorate in places on the northern side, and some sheeting is missing from the southern side allowing weather to penetrate the building. The missing and damaged sheets should be replaced with appropriate materials to maintain a weatherproof covering.

- Sheets of corrugated iron are missing from the two northernmost barns of the L-shaped building range, holes are also appearing and the edges deteriorating. Damaged and deteriorating sections on this roof should be replaced with appropriate materials.

- The rear wall of the two northernmost barns is visibly bowing. The structural integrity of this wall line should be investigated and consolidation undertaken if required. Care should be taken to consolidate using appropriate materials and techniques as this area of walling appears to be drystone built.

- Slates are missing and the underlying timber roof structure is deteriorating on the southernmost of the 3 adjoining barn buildings within the L-shaped range. This roof should be repaired/replaced as necessary to ensure the survival of this range, using materials and techniques appropriate to these traditional farm buildings.
