TIR GOFAL MANAGEMENT PLAN: HERITAGE MANAGEMENT INFORMATION (HE2)

.....Gwarcwm Isaf, Taliesin, Machynlleth.....

.....49921.....

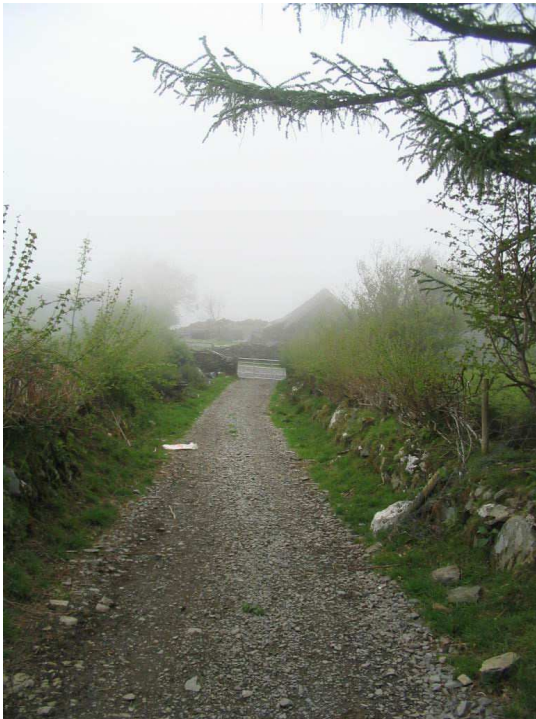
No on Map	PRN	Site Type/ Name	Period	NGR	Importance (status)	Management
	50952	Trackway	Unknown	SN6675 9159	B	Generic
<p>Trackway running south from the western side of the farmhouse. It runs along-side the farmhouse garden and is flanked by earth banks on either side, which are lined with massive stones. At the end of this short stretch, the track turns ninety degrees to run almost directly west towards Bryn-Yr-Arian mine. The trackway is still in regular use and has been recently gravelled.</p>

View of trackway, looking north towards farmstead

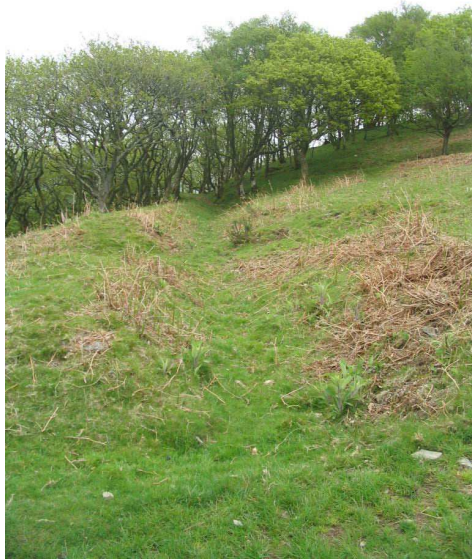
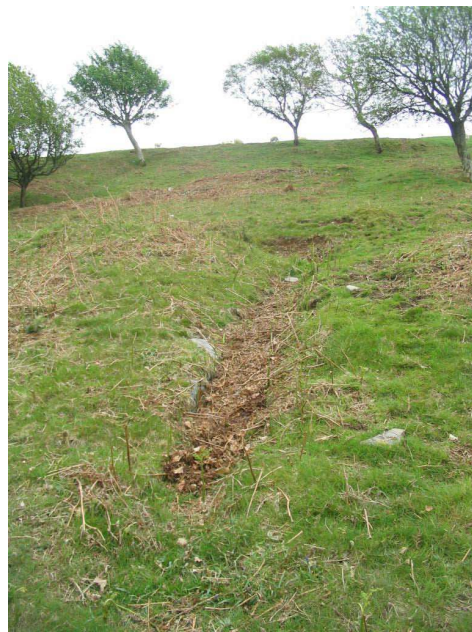
Numerous channels, some of which were stone lined were observed, criss-crossing the area marked on the attached map. The individual elements of this system of smaller leats were too numerous to accurately locate without a full survey, and do not appear to be marked on historic maps.

A number of these smaller channels run down a relatively steep gradient. This could represent evidence of a process known as hushing, where water stored in a dam was released down a hillside along a vein of ore, tearing out the weathered rock to expose the solid rock and vein, and by a process of natural separation.

At the time of the farm visit these features seemed generally stable. The major threat to the complex's long-term stability is through poaching by livestock. The stocking levels are being decreased through the winter months under Tir Gofal, and this should lower the risk of damage. These are important elements of the mining process and care should be taken to maintain their visibility.

Plates showing elements of leat system on hillside to south-east of wheel-pit (prn 50955)

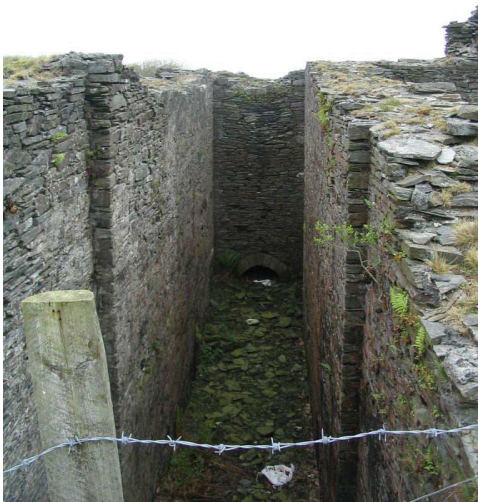
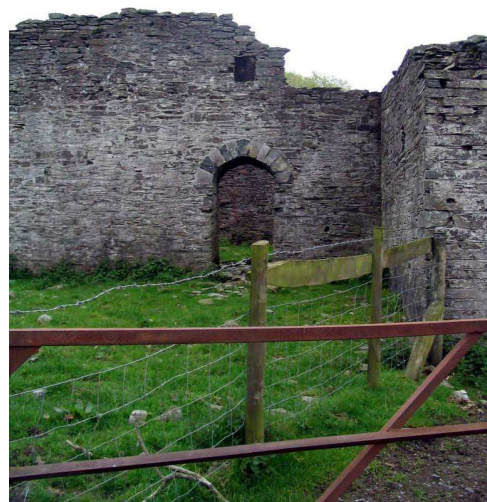
This cruciform building incorporates a central wheel-pit, with two annexes on either side, one of which Bick suggests housed a crusher. It is constructed of rubble-stone, with massive thickness to the walls. The wheel-pit would have housed a water-wheel, which was fed by water diverted from the Clettwr via the leat system (prn 50953, 50954). On the north-east end of the wheel pit is an arched water out-let (now blocked with debris).

The wheel-pit, and its' south-eastern annexe.

At the time of the site visit, the area to the north of the wheel-pit/ crusher house had been used as a location for feeding livestock. This issue should be resolved by proposed lower winter stocking rates under the Tir Gofal scheme.

There was also evidence of some damage due to machinery tracking across the area. It is important to be aware that the entire area covered by the mine complex is archaeologically sensitive, and that heavy wear in this area may cause damage to sub-surface features.

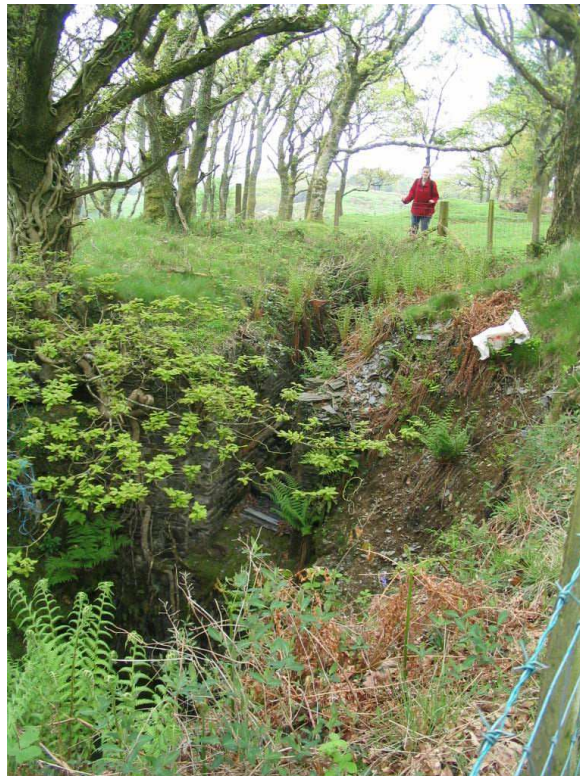
Main shaft with stone lined housing for pumping rod. A rock cut shaft of unknown depth, with stone-lined channel running off to the north-east. The channel appears to have housed the south-western end of a pumping rod (marked on the first edition 25" Ordnance Survey map, but not on the second edition), which was attached to the wheel-pit and crusher-house at its' north-eastern end. Currently fenced off with wire and post fencing.

Shaft with channel on far side to house the pumping-rod (prn 50962)

This shaft potentially poses a danger to people and livestock, and although it is securely fenced at present, if there are any plans to encourage access for educational purposes, this situation may need to be re-evaluated. There is also a small problem with visibility, as there is currently some over-hanging vegetation around the top of the shaft. Clearance of this vegetation to improve visibility would be desirable if this can be achieved whilst complying with full health and safety requirements.

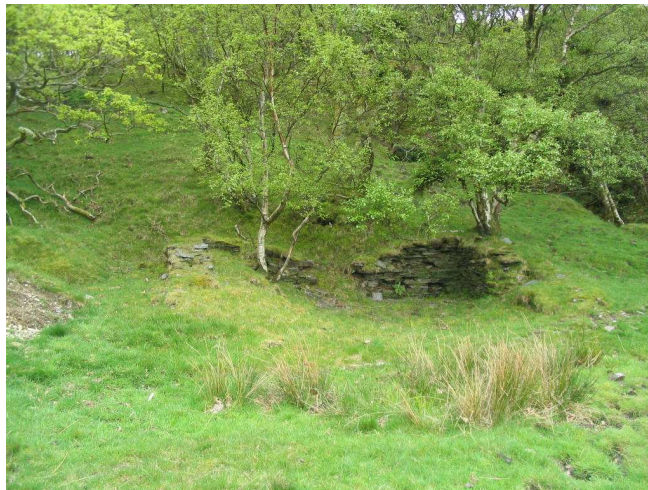
A small rubble-stone building, c. 6.7m x 3.8m, built into the side of the hill, marked on historic map sources. There are now only three low walls remaining, so it is difficult to establish what the building's original function was. It is about the right size for a magazine (a place for storing explosives for use in the mine), although perhaps too close to the entrance of the mine for this explanation (explosives tended to be kept well away from tunnel entrances), so it may have been a workers' hut.

The walls of this building may be at risk from tree-fall if trees are not removed from the vicinity.

Small building, possibly a workers' hut, or magazine.

6. Remove any dead and unstable trees from the vicinity of archaeological and historic features with care, leaving roots to rot *in situ*. Ensure that machinery does not cause further disturbance. Agree with the Project Officer a suitable method for repairing any damage caused, for example, by wind-throw.

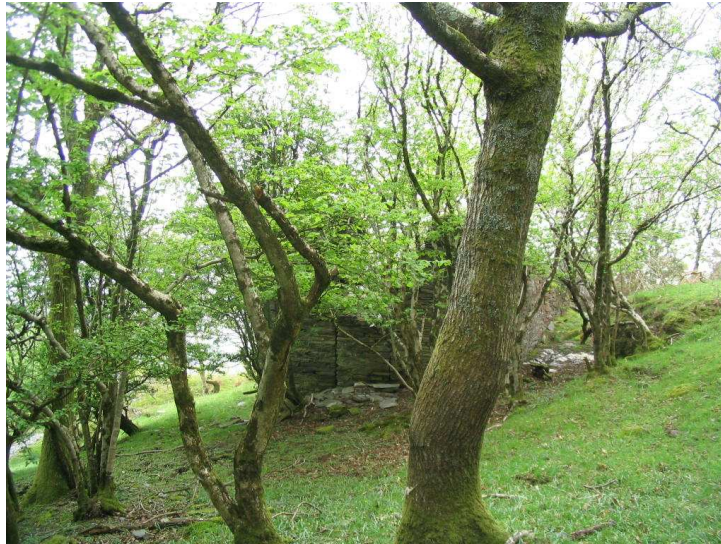
A single storey building constructed of rubble stone overlooking spoil heaps and level/ adit on lower area of mine workings. One doorway and three window openings to the front (south-west side), with, one doorway to the rear (opposite front doorway). Rock cut gully/ pathway terraced into hill-slope at rear. Chimney at north-west end, with fireplace internally. Also, blocked doorway with remains of timber lintel at south-east end. Internal partition wall of rubble-stone construction. Traces of render internally. Function unknown, seemingly domestic, possibly a Miners' bunkhouse? At time of site visit, very overgrown with large over-hanging Ash tree, also hazel and thorn both internally and externally. Tree growth potentially very problematic for the survival of the building.

Building 50961 viewed from the east, showing blocked off doorway, and vegetation posing a threat to the structure.

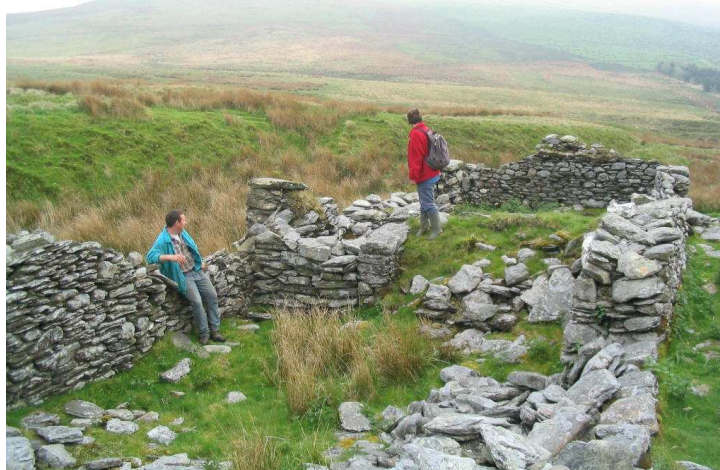
This formerly substantial dwelling is marked on various historic maps including the tithe map. It is built of rubble-stone, with walls in excess of 1m thick in places. It lies parallel to the stream with three distinct internal areas; the highest (north-east) end is terraced into the hill-slope, whilst the south-west end is lower. The central section incorporates a fire-place at the south-west end of the room, which is big enough to have housed an angle-nook. To the left of the fire-place is a blocked doorway, which would have let into the south-west room of the building. The walls of this building now survive to an average height of c. 1.5m.

It is possible that this building represents a modified long-house, where people and animals were all housed under one roof. The lower end may have been the byre, whilst the central room was for human habitation, and the room built into the hillside may have accommodated a dairy. However, this is difficult to establish with certainty from what now remains of the building.

Blaenclettwr Fawr, looking south-west, showing large fire-place, and blocked in doorway on the left hand side.

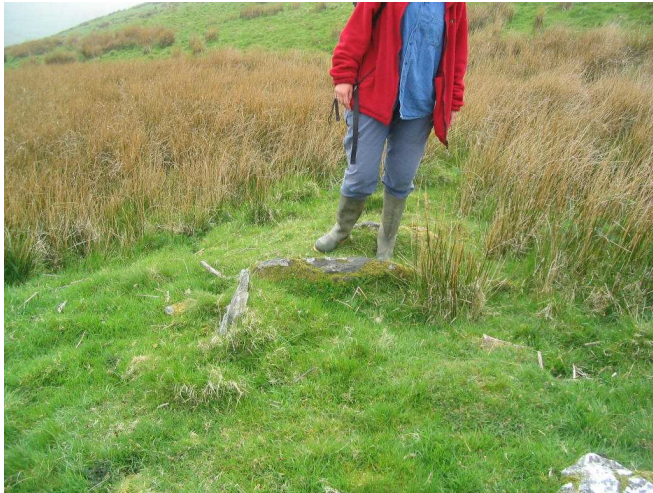
No on Map	PRN	Site Type/ Name	Period	NGR	Importance (status)	Management
	50967	Round barrow – Cist burial	Bronze-Age/ Iron age?	SN6988 9231	B	Generic
<p>A cist burial, identified by the farmer, probably dating from the Bronze-age/ Iron-age. The upper portions of two large, flat slabs, arranged at right-angles could be clearly seen, and formed two sides of a probable cist burial. Surrounding the arranged stones, are the remains of a mound, containing a high percentage of loose stone. Cist burials and cist cemeteries are common in the Atlantic region from c. 600 – 100BC. The stone lined cist contained a burial and sometimes grave-goods, and was covered by an earth or stone mound.</p>

Stone-lined cist burial, with surrounding stone mound.

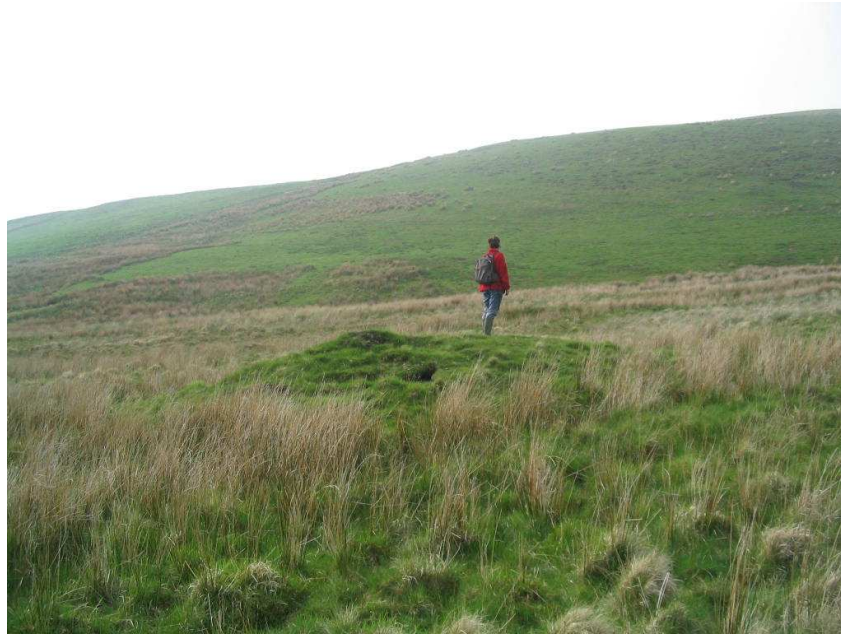
No on Map	PRN	Site Type/ Name	Period	NGR	Importance (status)	Management
	50968	Cairn?	Bronze-Age?	SN6969 9124	U	Generic
<p>Possible burial mound - A large pear-shaped mound, which could be a burial mound dating from the bronze/ iron age, but may be natural. At the time of the visit, a hollow eroded one side by sheltering livestock, had revealed some of the internal make up of the mound. In this area the mound consisted of dark peaty deposits, and no stones were visible.</p> <p>Given the number of cairns in the locality, it is highly plausible that this is not a natural feature. However, the lack of internal structure in the damaged portion suggests that the feature may be a glacial deposit. Deposits of debris left by glaciers during the ice age (known as drumlins) often form pronounced pear-shaped mounds.</p>

Possible second burial mound

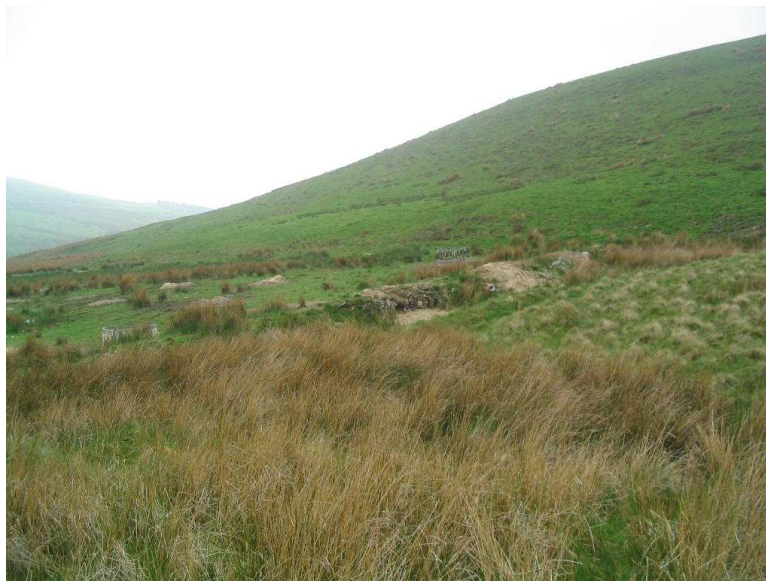
Field system with earth and stone-faced banks, includes stock funnel 50970. This field system is marked on the Ordnance Survey map of 1888, and appears to be associated with dwelling 9276 Blaenclettwr Fawr. On historic maps these fields enclose land on the northern side of Blaenclettwr Fawr. The banks are substantial, and are still a very prominent feature of the landscape in the area. They are not currently stock-proof, but in general they have survived in good condition. It was however noted that there was some erosion in an area where feeder troughs had been placed close to the banks, and the banks themselves have been used by livestock, for shelter.

Boundary bank showing area of erosion caused by sheltering livestock

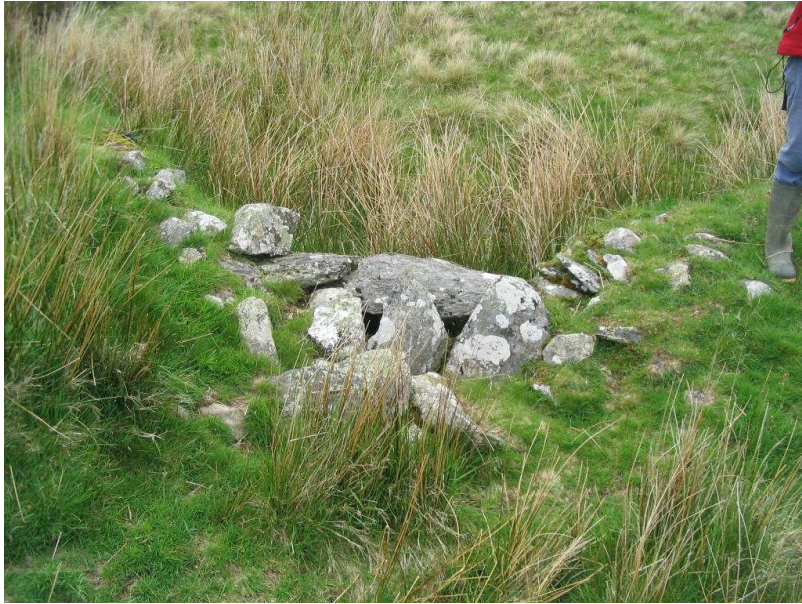
No on Map	PRN	Site Type/ Name	Period	NGR	Importance (status)	Management
	50970	Stock funnel	Post-medieval?	SN6986 9207	C	Generic
<p>A v-shaped funnel forms the approach to this stone-built gap. The gap is part of a field-boundary bank associated with Blaenclettwr Fawr. The opening may have been used for counting stock as they were brought down off the mountain.</p>

<p style="text-align: center;">Stock funnel</p>
