Cwmgloyne MPP 13

Historic Environment Report

Report No. 2003/135

Cwmgloyne
Historic Environment Report

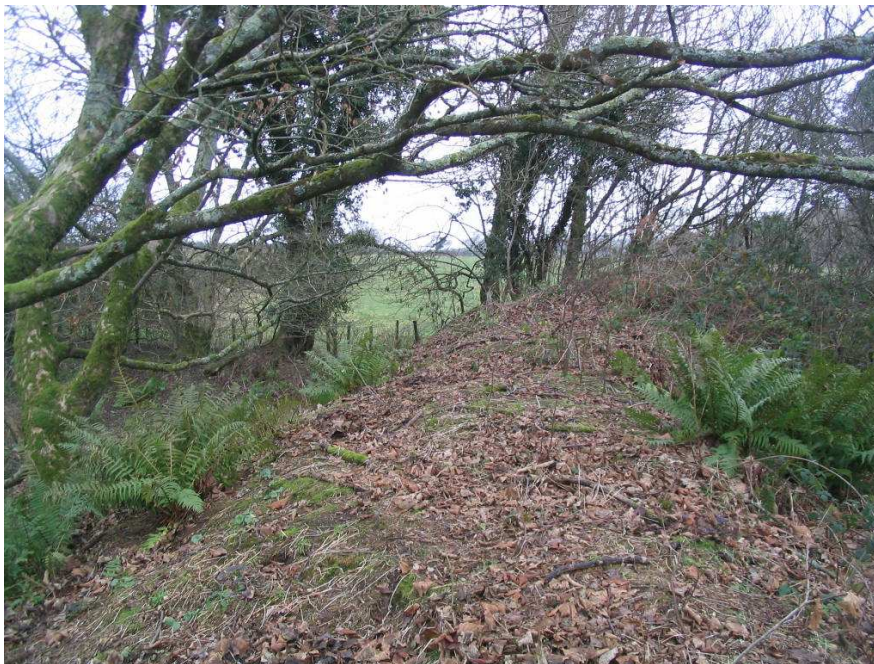
PRN	963	Site Name	CWM GLOYNE	Grid Reference	SN10383967;
Site Type	HILLFORT	Period	Iron Age	Site status	SAM Pe 306

Large oaks and sycamore trees predominate in the interior of the hillfort, with a ground cover of grass. However, the hillfort is heavily overgrown with trees and brambles in some areas, making access almost impossible. In addition along the northern area of the site, along the earthwork defences are a number of badger setts.

Prn 963 – the western defences of the hillfort and the annexe (Prn 964)
to the left of the picture

The future management of the site should endeavour to maintain the present woodland cover over the site. Some areas may benefit from some selective thinning, particularly over the defensive banks, which would promote the growth of selected oaks and develop a high forest canopy.

Where there is currently a dense cover of brambles it would also be beneficial to encourage the establishment of a woodland canopy, which would shade out bramble and scrub growth.

Any works on the monument should only be carried out when ground conditions are dry. Felling or cutting should be to ground level and the roots should be left in place to avoid disturbing the archaeological layers. Machinery used on site should not cause damage to the ground surface. Brash should not be dumped within the scheduled area, which includes the interiors, defensive banks and ditches.

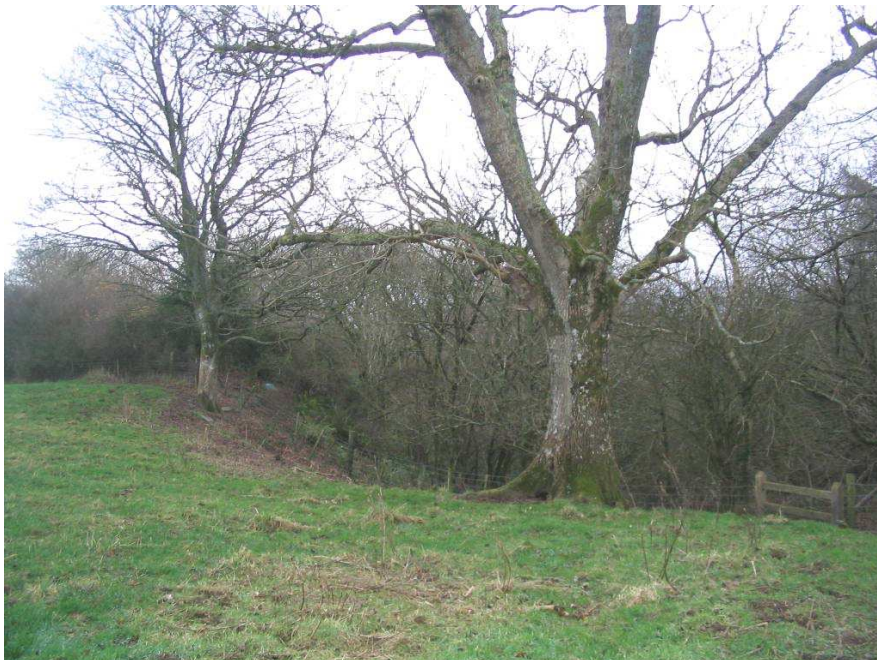
PRN	964	Site Name	CWM GLOYNE	Grid Reference	SN10323970
Site Type	HILLFORT ANNEXE	Period	Iron Age	Site Status	SAM Pe 306

The site visit found that the site was in a reasonably stable condition, with mature trees growing over much of the interior and an understorey of grass and low growing woodland vegetation. Where there is less woodland shading there are thickets of brambles.

Prn 964 – the annexe to the hillfort (Prn 963), viewed from the public footpath to the northwest.

The management aim for this site is to maintain the ground surface in a stable and undisturbed condition. It is also desirable that the site is maintained in a visible state, and kept free from scrub or bramble, to benefit the footpath which runs to the west of the site.

Management of the site should continue to maintain the high forest canopy which exists over much of this site. If any coppicing or felling is carried out it should be carried out when ground conditions are dry, and roots should always be left in place, in order to cause as little ground disturbance as possible. Brash should be removed from the scheduled area.

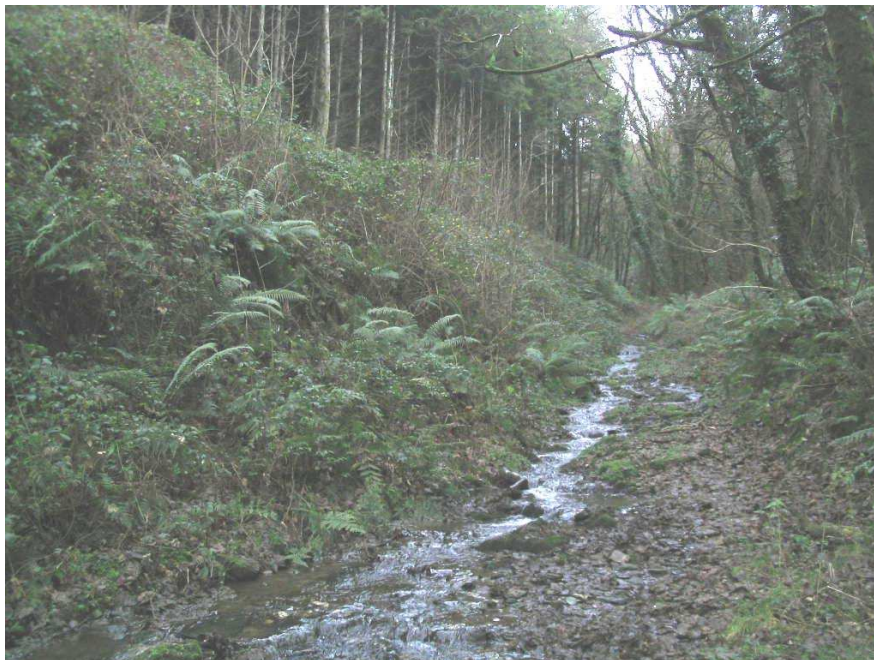
PRN	50017	Site Name	Grid Reference	SN10203920; SN21033947; SN10663992
Site Type	DRIVEWAY	Period	Post Medieval

This was the earlier drive which was used to approach Cwmgloyne mansion. It is shown on the both the tithe maps of Bayvil and Nevern Parishes and is clearly indicated on the 1st and 2nd edition Ordnance Survey maps of 1891 and 1907. The entrance to the driveway is marked on the west side by the small lodge Prn 50022, and a gateway 50023. The driveway winds its way up the west side of the Gloyn although in one section the driveway appears to use the stream bed itself. The drive does not appear to be surfaced but cut into the natural geology.

Prn 50017 – the Gloyn valley, in this section the driveway appears to use the bed of the stream.

Any works to the drive should take efforts to be sympathetic to the historic background of this route which was used as a picturesque approach to the mansion of Cwmgloyne.

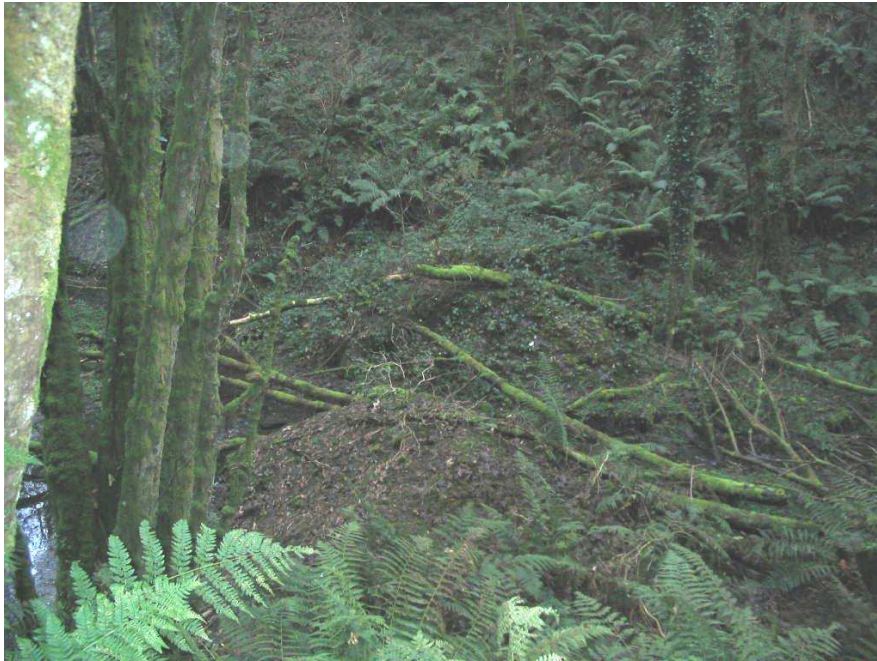
PRN	50019	Site Name	Grid Reference	SN10553976
Site Type	DAM	Period	Post Medieval

The remains of a dam and its associated pond are visible towards the upper end of the valley. The dam is now breached and no water is retained behind it. The revetment stands to approximately 1.3 metres high and is battered to either side. The widest point, at the base, is 5-6 metres across. The central portion, which presumably held some kind of sluice, has collapsed. What remains indicates that the structure is largely stone and earth built, with some masonry visible to suggest the framework of a possible sluice.

Although breached, the dam wall is still visible and forms a substantial landscape feature. However, there are the remains of several young fallen saplings which lie scattered over the revetment wall and also within the breach. Not only do these fallen trees obscure the dam but also they could cause further damage to the structure, particularly when the stream rises and becomes more forceful.

Prn 50019 – a large dam has been created in the upper reaches of the Gloyn,
although it is breached in the centre

It is recommended that the fallen trees are removed from the breach and the vicinity of the pond in order to avoid damage to the masonry and earth structure of the dam. Some selective felling of the weaker standing trees to encourage the establishment of stronger individual specimens may help to avoid haphazard tree fall in the future.

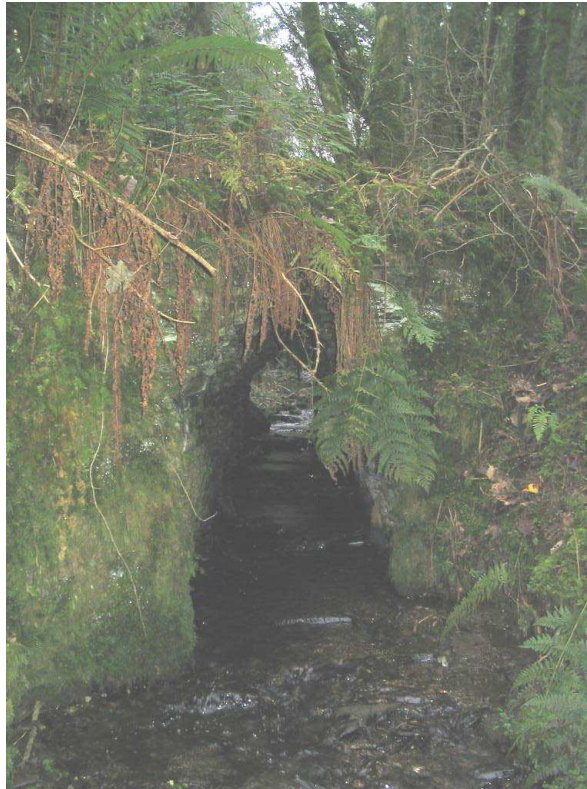
Up stream from the dam Prn 50019 is a crossing point over the stream. The ground level here is significantly higher than the stream and a magnificent masonry culvert channels the stream beneath a trackway crossing the valley bottom. The culvert is apparently constructed with drystone masonry, with the roof of the culvert corbelled to achieve a pointed arched roof approximately 1.5 metres high. The trackway crosses the stream obliquely, in a southwest to northeast direction, although there are clear traces of a trackway continuing up the west edge of the stream to Cwmgloyne house.

Prn 50020 – a fine stone built culvert with a corbelled roof channels the Gloyn just below the entrance to Cwmgloyne mansion.

The trees growing out of the masonry should be cut off at ground level and the roots left in place, the stumps should be spot treated to prevent regrowth. The roots should only be removed if there is an opportunity for the masonry to be consolidated with similar materials used in the original construction.

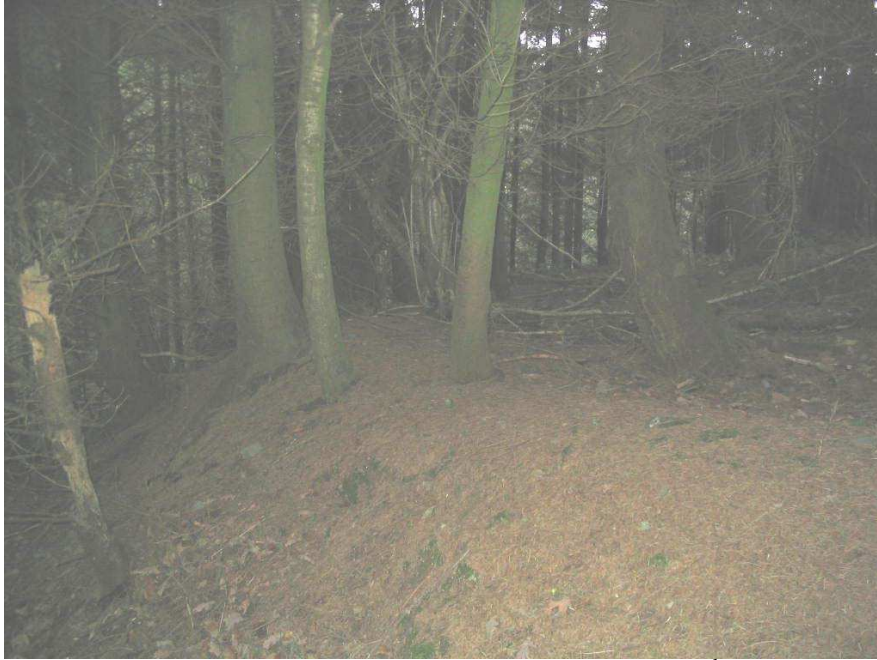
PRN	50021	Site Name	Grid Reference	SN10613987
Site Type	ENCLOSURE	Period	Post Medieval

A relic sub-rectangular enclosure approximately 40 metres by 35 metres is identifiable on the 1st and 2nd edition Ordnance Survey maps of 1891 and 1907. It is not apparent on the tithe map of 1845 of Bayvil Parish. The enclosure is visible as a low earthwork bank approximately 3metres wide at its base and no higher than 0.25 metre on the interior. The natural ground surface slopes away on the northeast, southeast and southwest sides. The western edge of the enclosure projects into the adjacent field. Within it there are the remains of some coppice stools although the area is now planted with conifers.

Prn 50021 – an sub-rectangular enclosure is marked on the 1st and 2nd edition Ordnance Survey maps and can still be identified on the ground by low earthwork banks.

The ideal management of this site would be to retain the earthwork banks undamaged. Extra care should be taken when harvesting the conifers that damage is not caused to the ground surface and that the profile of the banks is retained. Ideally any works in this area should be carried out in dry conditions. The tree roots should also be left in place and not grubbed up.

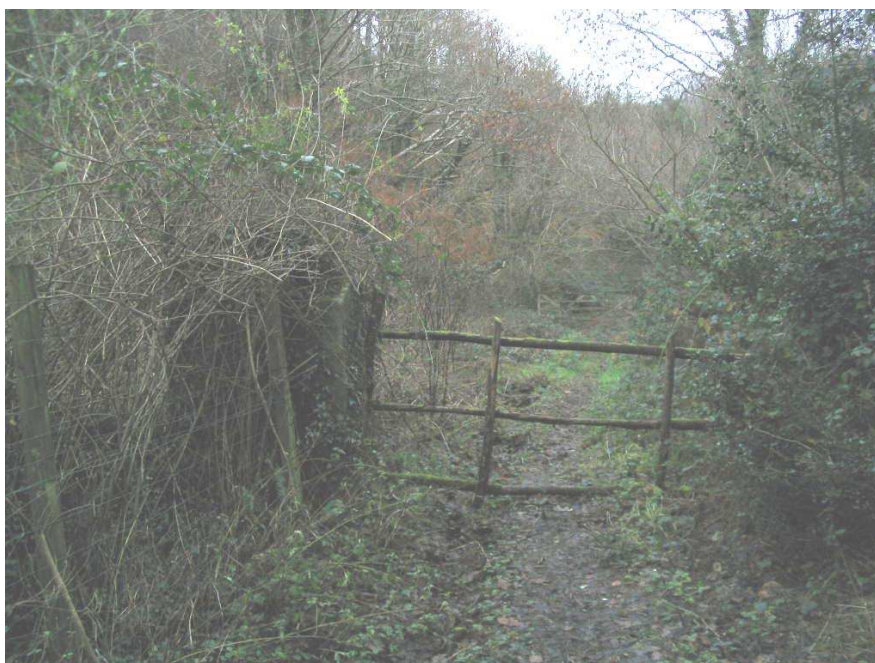
PRN	50023	Site Name	Grid Reference	SN10193919
-----	-------	-----------	----------------	------------

Slightly to the north of the lodge are two substantial square stone gate piers which survive to either side of the drive marking the approach to Cwmgloyne mansion. Both piers are heavily overgrown and obscured with ivy. The original gate has been removed and a rough wooden gate is positioned in its place at present.

Prn 50023 – the old stone gate piers which mark the entrance to the old drive which leads up to Cwmgloyne mansion and also lie on the existing footpath, are now heavily overgrown and easily missed.

The vegetation which engulfs the gate piers should be cleared away to improve their visibility.
