# **Great Canaston MPP 21**

## **Historic Environment Report**

Report No. 2003/136

Great Canaston  
Historic Environment Report

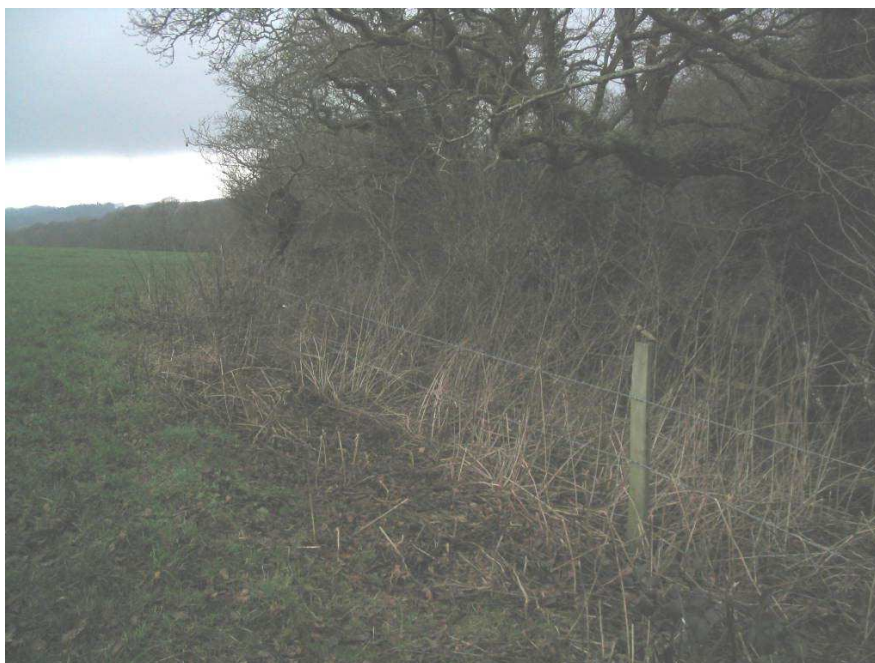
<b>PRN</b>	<b>50028</b>	<b>Site Name</b>	<b>Grid Reference</b>	<b>SN07621465</b>
<b>Site Type</b>	<b>CLAY PIT</b>	<b>Period</b>	<b>Post</b>	<b>Medieval</b>

The clay pit lies just beyond the post and wire fencing which now encloses the enlarged area of Atheston Wood. The site is now quite densely grown over and apparently occupied by badgers. However, an extraction pit still seems to survive.

Prn 50028 – the earthwork remains of a clay extraction pit survive just beyond the modern fence line.

Retain as a historic landscape feature.

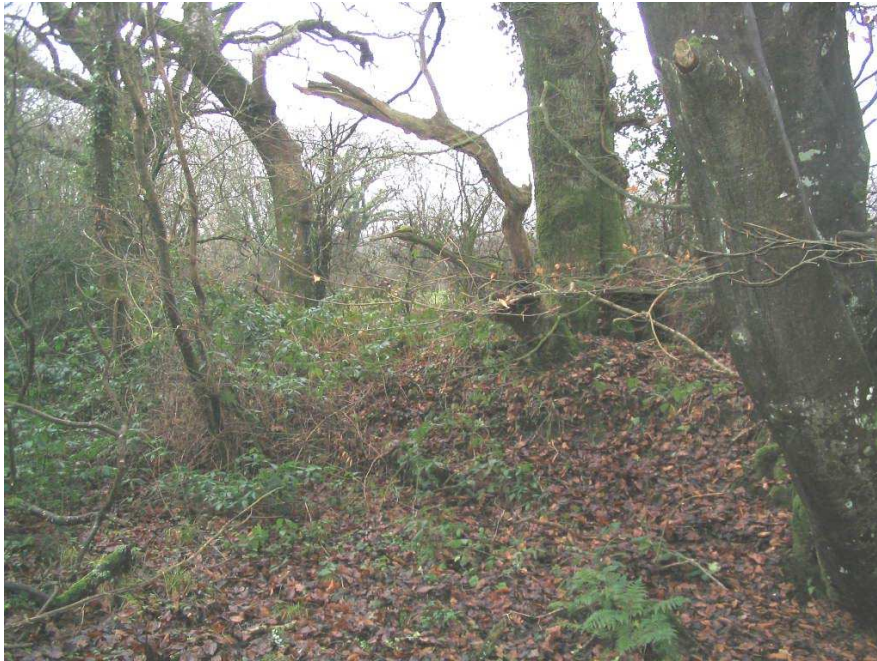
<b>PRN</b>	<b>50029</b>	<b>Site Name</b>	<b>ATHESTON WOOD</b>	<b>Grid Reference</b>	<b>SN07551476; SN07471482; SN07651459</b>
<b>Site Type</b>	<b>BOUNDARY BANK</b>	<b>Period</b>	<b>Post Medieval</b>

The current boundary of the woodland is wooden posts with a double strand of barbed wire. However on the southwestern edge, below the current field boundary is what appears to be the earlier boundary. A substantial earth bank with large regularly spaced oaks survives along the southwestern edge of the wood, running parallel with the current boundary but sometimes diverging from it. This boundary extends around the northwestern edge of the woodland and probably extends around the whole parcel. At the southern end the bank is wider and flatter, approximately 3.5 metres wide at the base and 0.5 m high on the up slope (southwest) and 1.2 m on the downslope, here the oaks appear to be spaced between every 5-6 metres. Towards the north end of the wood the boundary appears to be more pronounced, commonly over 1 metre high with almost vertical sides.

The boundary banks which are still evident on the ground today are recorded on the tithe survey of 1843, however they may be much older. Indeed the field pattern of this area is probably derived from the medieval system of strip fields which is particularly evident to the north of Little Canaston Farm.

Prn 50029 – a large earthwork bank appears to be the former woodland boundary, lying within the line of the modern fence.

The management of this area of woodland should take care to retain the evidence of previous boundaries. These are clearly visible on the edges of the woodland and previous divisions shown on the tithe map and the 1<sup>st</sup> edition Ordnance Survey map may still survive within the wood itself. These boundary banks will be particularly susceptible to damage from machinery and care should be taken to avoid tracking over banks, existing access points should be used where possible.
