# BURRY PORT SOUTHERN DISTRIBUTOR ROAD, CARMARTHENSHIRE

## ARCHAEOLOGICAL INVESTIGATION, 2004

RHIF YR ADRODDIAD / REPORT NO. 2005/26  
RHIF Y PROSIECT / PROJECT RECORD NO. 50027

Paratowyd yr adroddiad hwn gan / This report has been prepared by Neil Ludlow & Tom Jamieson

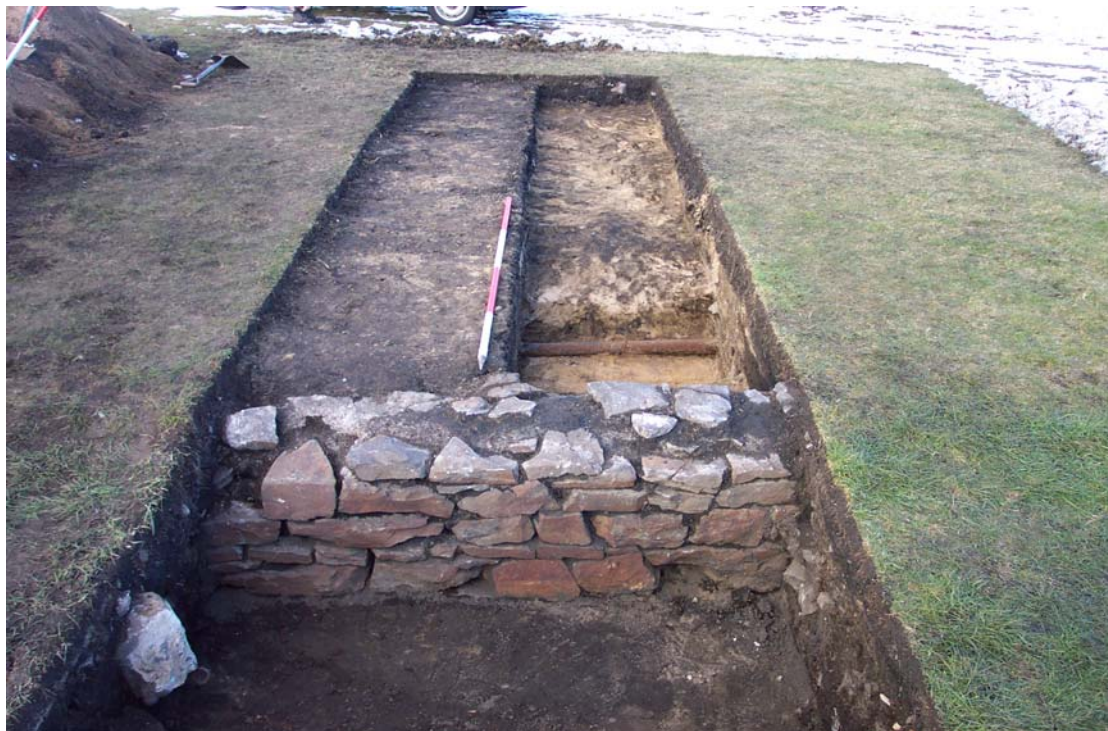
*Fig. 6 - Photo of evaluation Trench 01, from the south.*

That part of Trench 01 within the sluice pond itself, which remained open until the 1980s, was excavated to a depth of 0.70m. This exposed the top of a mid-greyish brown silty sand, (116), which was mottled in appearance and which contained very little in the way of inclusions other than very occasional small fragments of slag. As this layer was only exposed, and not excavated, its dimensions are not known. However it appeared consistent with a fill created by silt, and wind-deposited sand, that had built up in the sluice pond after its abandonment rather than being a deliberate fill. It was however overlain by a layer of dark blackish brown silty sand (103), 0.60m deep, which contained about 25% large angular fragments of building rubble including brick, concrete and stone, as well as 10% small angular fragments of slag, cinder and cement. Also present were frequent modern artefacts including pieces of railway sleeper, beer cans, crisp packets and plastic bottles. This layer was clearly created when the sluice pond was landscaped over in the 1980s. The building materials were probably residual, from the earlier demolition of the nearby buildings.

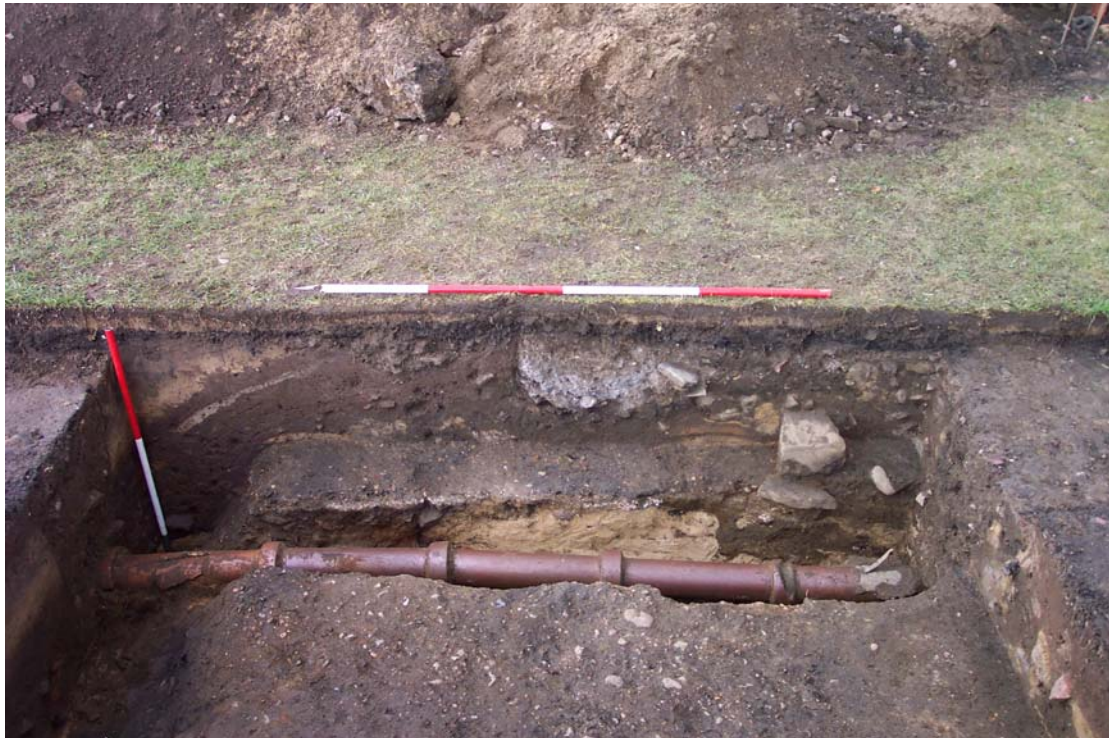
*Fig. 11 - Photo of evaluation Trench 02, from the east.*

After this area had been levelled off, a building was constructed, at NGR SN 4451 0062. This building may be the one that is marked, but not labelled, on the Ordnance Survey map of 1915 (see Appendix 1.4). Its foundation was created by excavating a linear ditch [207], to the necessary proportions, and filling it with poured concrete (206), demonstrating its late date. This foundation was still *in situ* in 2004, but as only the part that was within the trench was exposed, its dimensions or purpose are unknown. A shallow linear gully [215], 0.50m wide, 0.12m deep and filled with concrete or cement fragments, ran alongside the outside of this building and although its purpose was unclear it was possibly a drip gully. No flooring had survived in the interior of the building, but the internal deposit (212) contained frequent brick, stone and concrete inclusions, and so it probably relates to this building - or possibly its demolition - rather than to the earlier phase of landscaping.

At some point after the building had been demolished, a trench, [203], was cut through the whole of the area in order to lay a 5" (0.127m) ceramic pipe. This pipe runs from the north, in a straight N-S alignment, for about 6m before turning west to run on the same line as the old canal. This appears to be the same as pipe-trench [111] in Trench 01. It presumably carried waste water from the Power House (PRN 8672) and possibly drained into the then still open western end of the canal. Pipe-trench [203] had vertical sides, was 0.64m wide, and had been cut to a depth of 0.84m effectively truncating all the archaeology down to the natural sand beneath. This trench appears to have been dug by hand and backfilled with the spoil removed during its creation.

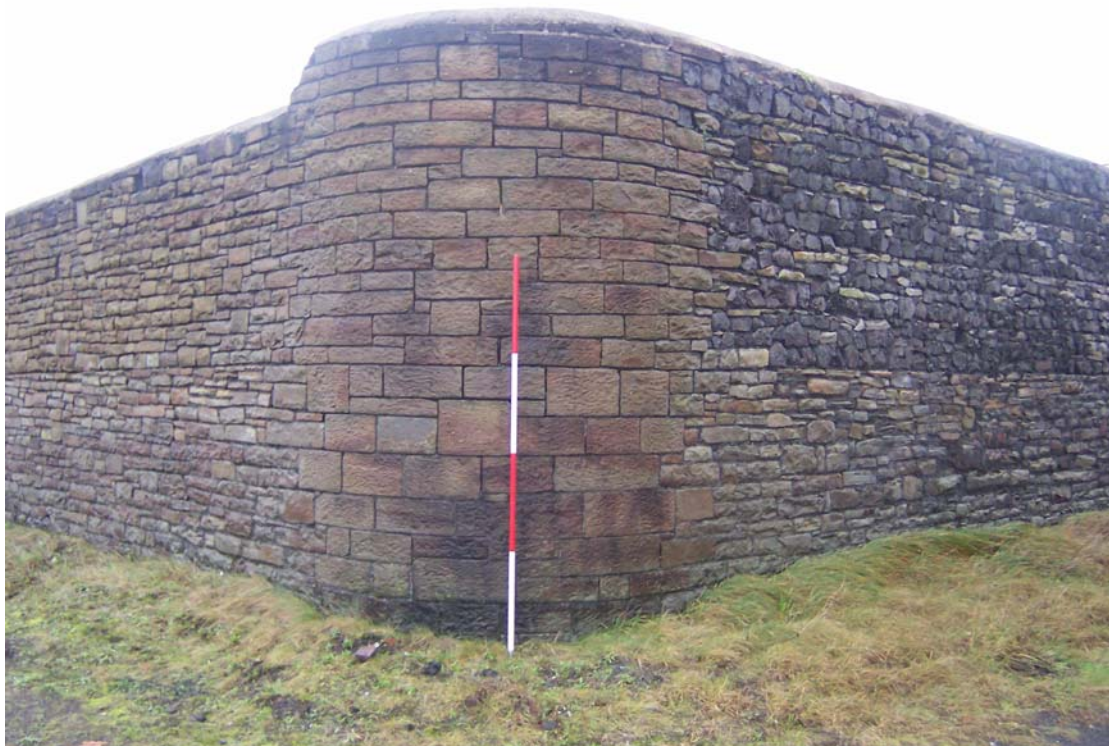
*Fig. 13 - Photo of the southwest corner of the Lead & Silver Works enclosure wall, from the southwest*

The original 1864 build was constructed from iron-rich, brown-grey sandstone blocks, probably Pennant Sandstone, bonded with a lime/slag mix mortar. Although the blocks were poorly-sorted in terms of size and shape, and randomly coursed, they were reasonably well-dressed, creating a good wall face. It was originally 0.60m wide. The southern, E-W section was constructed from the same material, although slightly cruder in appearance. The southwest corner was finished in well-dressed ashlar facework, creating a fine curving face (Fig. 13). The Phase 1 wall enclosure wall averaged, in 2004, 1.30m in height from the built up material against its base. However, judging from the evidence at the western entry, where the tarmac surface probably reflected original levels, the wall was originally 1.70m in height.

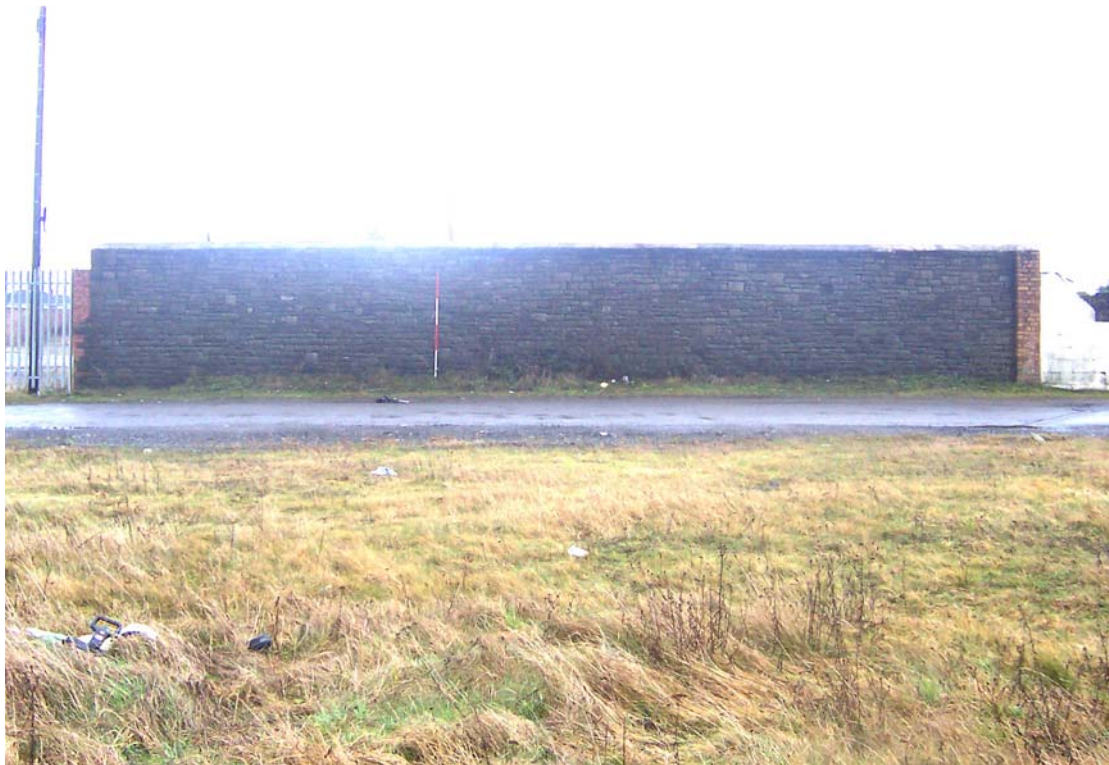
*Fig. 14 - Photo of the west wall of works Building A, from the west*

The northern half of the western Phase 1 wall (a length of 19.30m) was much higher, rising to 2.80m above present ground level as opposed to 1.30m (Fig. 14). It represented the west end of the former, main Lead and Silver Works building (Fig. 12, Building A), which was clearly contemporary with the wall, ie. from 1864, and which is shown on all editions of the OS map from 1880 until the mid 1953, by which time it had gone (Appendix 1). It was a large building, aligned E-W and measuring 100m by 20m, with a number of adjoining structures to the south by 1880. In 2004, the northwest corner of the building was represented by a line of internal quoins, which corresponded with the truncated end of the present wall. However, there was no corresponding toothing for the southern wall of the building, and this side may therefore have been (at least partly) open. There were no original openings in the west wall of this building. Within the enclosure, an area at the north end of this building was represented by an E-W concrete floor; however, this was only 3m wide and probably belongs to a later phase, possibly even after the building's demolition. The enclosure wall, in 2004, terminated at a secondary, red-brick stop corresponding with the northwest corner of this building, but the truncated masonry above indicated that the Phase 1 wall originally continued north at a height of 1.70m.

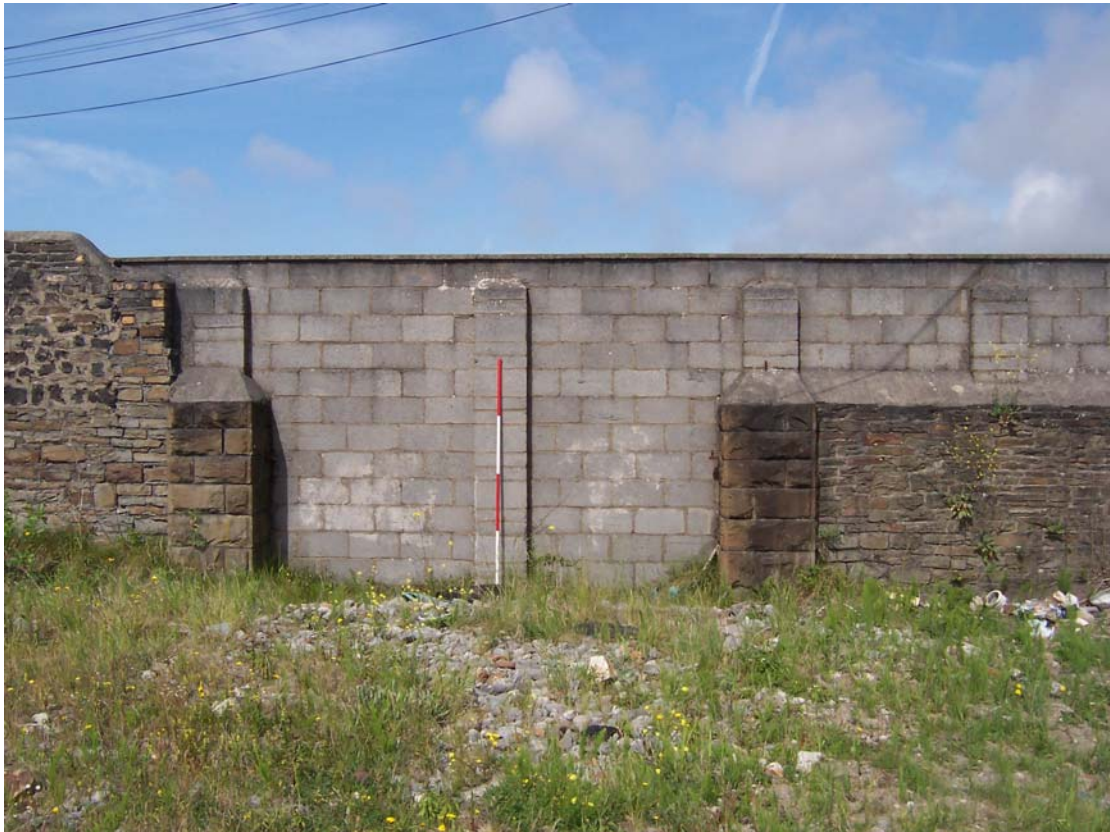
*Fig. 15 - Photo of the Phase 1 western entry to the works, from the east*

There appeared to be only two Phase 1 openings in the enclosure wall. Towards its southern end, and 9.25m south of the former works Building A, the western, N-S section was pierced by a fairly elaborate entry lying between 9m and 13m from the southwest corner (Fig. 15). This was an original feature, from 1864, and was 3.96m wide, flanked by large gate pillars built from well-dressed ashlar blocks. Both gate pillars still had large iron gate hooks indicating a double gate with two 6ft gates. A tramway can be seen to enter the works enclosure, through this entry, on the Ordnance Survey first edition map of 1880 (see Appendix 1.2), but possibly not on subsequent maps.

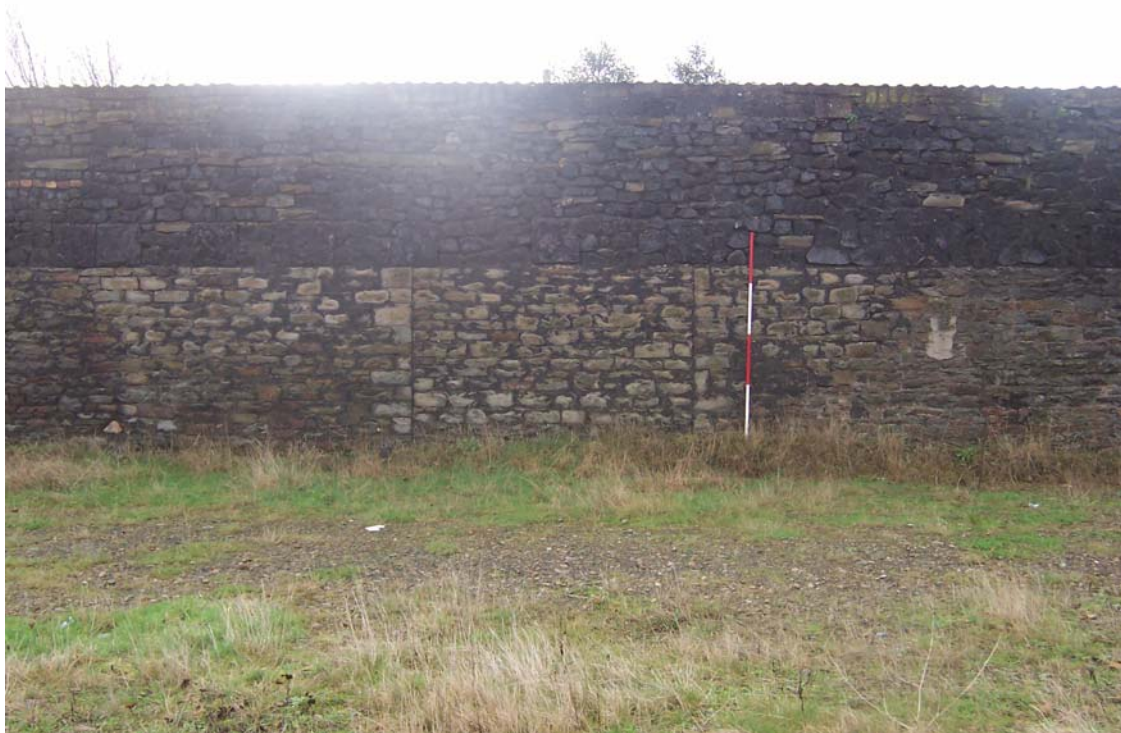
*Fig. 16 - Photo of the Phase 1 southern entry to the works, from the north*

The southern wall featured a single entry, 16.30m from the east end of the wall (Fig. 16), which was smaller than those to the west being 1.83m (6ft) wide. The stops were in crude sandstone ashlar without pillars or gate-posts. This entry is not associated with any building on any edition of the OS map and appears to have been just an entry to the enclosure.

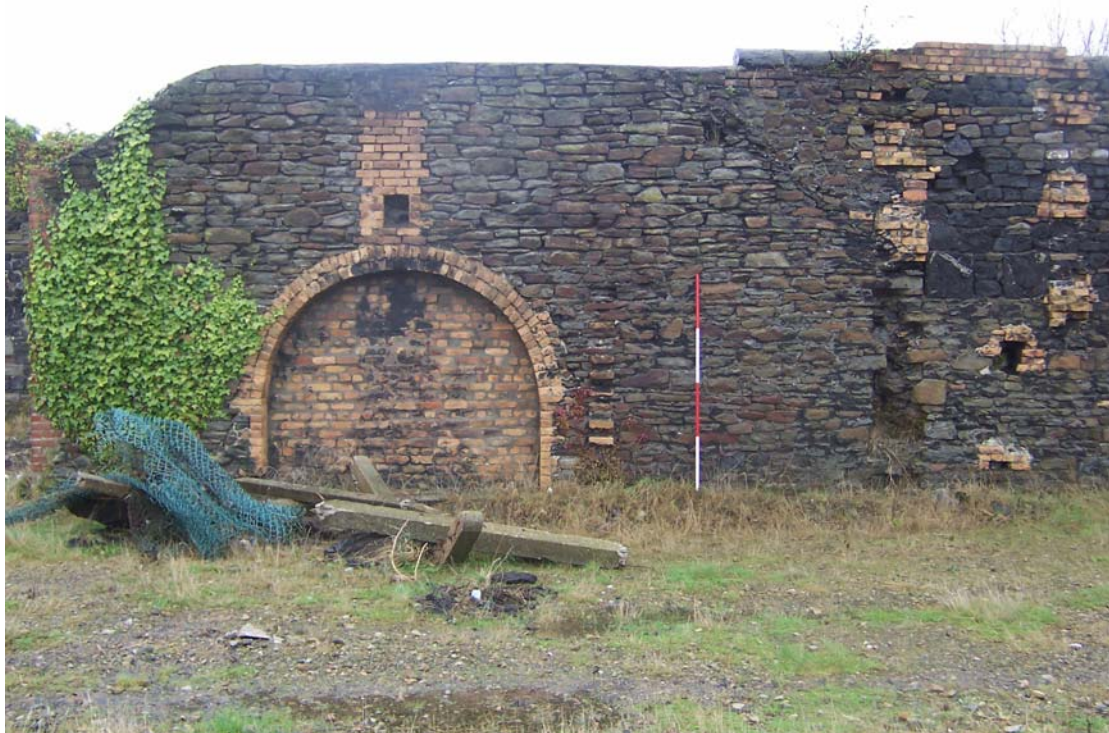
*Fig. 17 - Photo of south wall of works Building Bi, from the north, showing the Phase 2 heightening*

Phase 2 was represented by the raising of the majority of the enclosure wall to its 2004 height of 3m (see Figs. 17 & 18). The evidence suggests that it occurred prior to 1880, when a Phase 2 building appears to be shown on the Ordnance Survey map (Appendix 1.2).

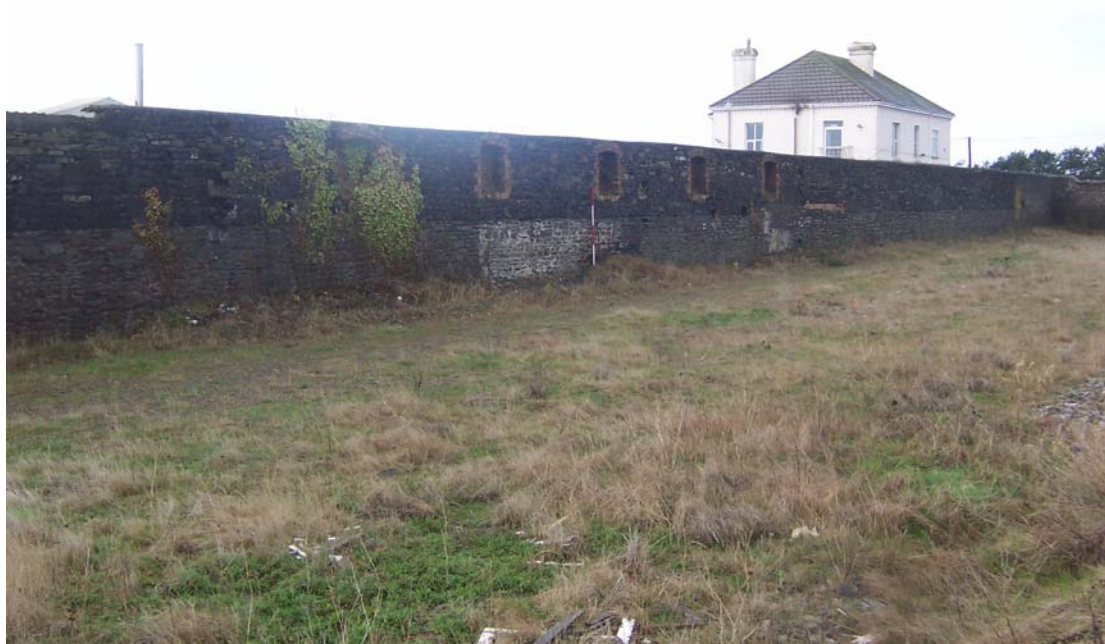
*Fig. 18 - Photo of south wall of works Building C, from the northeast, showing the Phase 2 heightening*

Building C was apparently divided into various areas by internal walls, but the only physical evidence on the ground or in the wall is for the easternmost area. This was over 20m in length, and defined by the remains of two N-S walls. These were keyed into the Phase 2, upper half of the enclosure wall, but were not evident lower down (where they butted the Phase 1 wall) or on the ground. In addition, this area of the building was lit by five windows in the Phase 2 upper half of the wall, with which they were clearly contemporary (Fig. 18). They were of a regular size, each being 1.17m high, and had yellow brick surrounds with segmental heads. It was evident that the building was roofed, at least in its later years, with corrugated iron sheeting, as the undulations from the sheets were preserved in concrete laid over on the summit of the wall. A series of seven sockets, similar to those in the building to the east (see above), evenly spaced about 4m apart, and approximately 1.50m above ground level, can also be seen inserted into the Phase 1 internal facework beneath the windows. They appear to represent some timber superstructure associated with the building, but are too low to be floor-joist sockets? They were subsequently blocked with yellow brick and lime mortar. A horizontal chase further west, at the same level, may be associated; it was also subsequently filled with yellow brick.

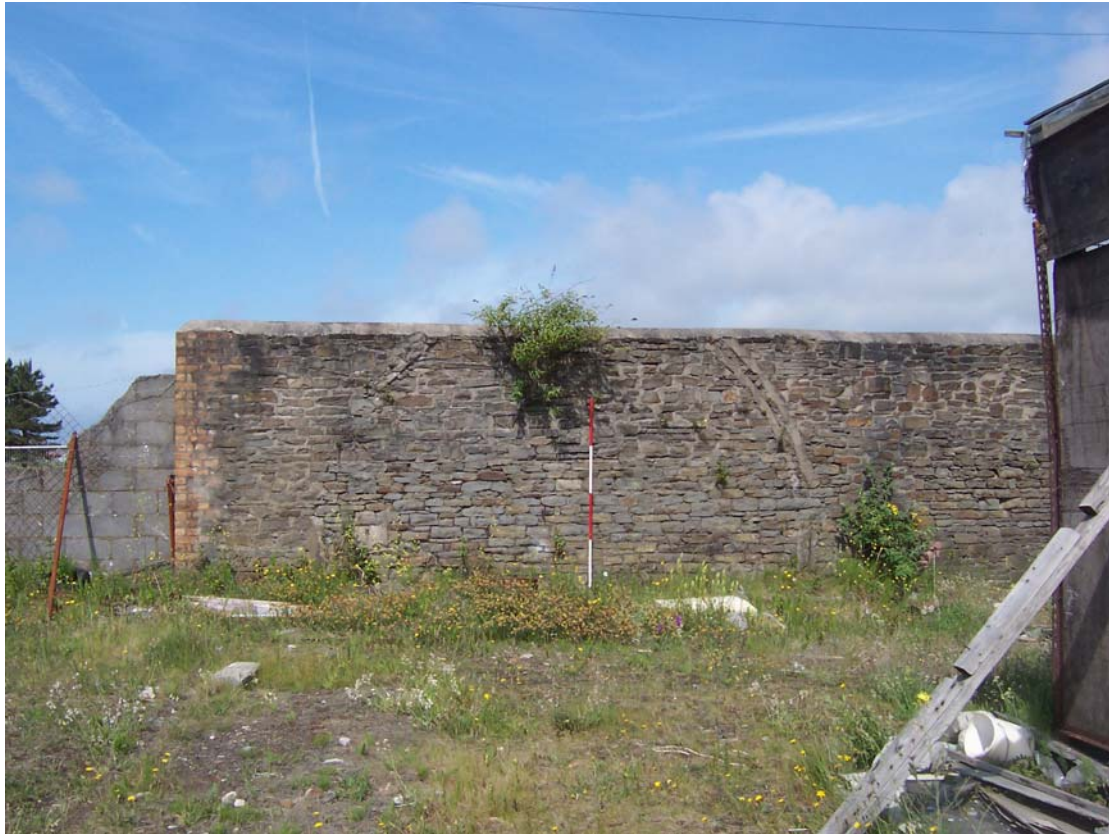
*Fig. 19 - Photo of the roof-crease for Phase 3 Building D, from the east  
(also showing Phase 3 western entry to the works, left)*

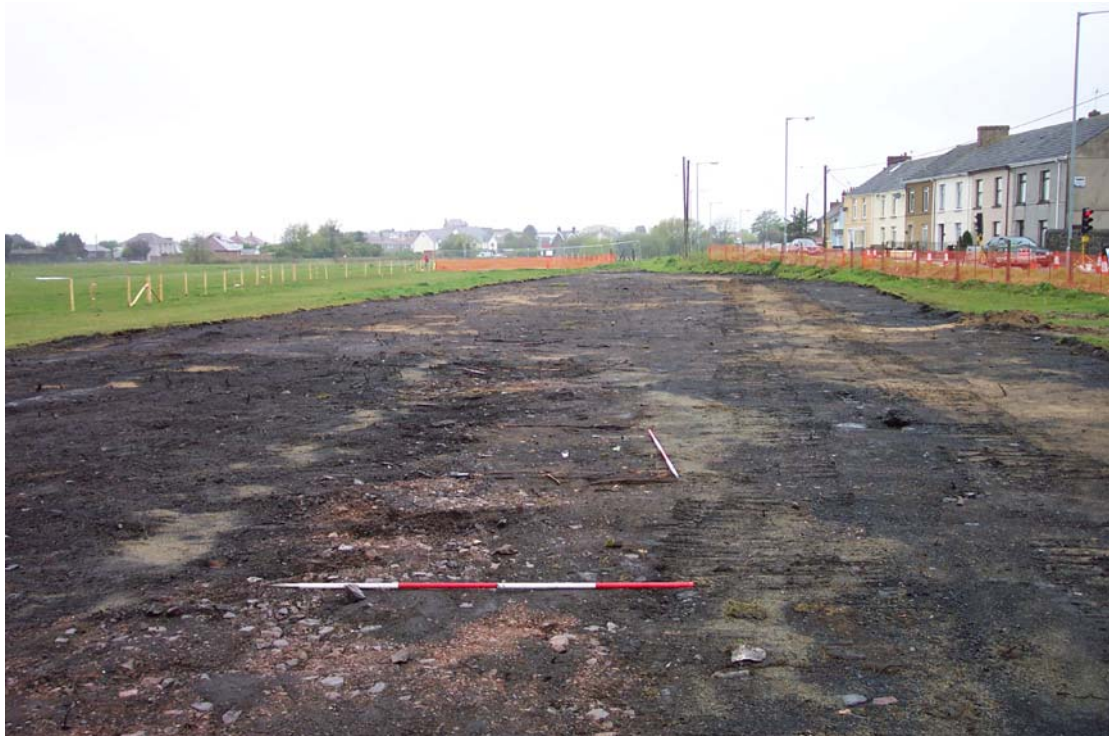
*Fig. 20 - Photo of ballast lines from the former Burry Port and Gwendraeth Valley Railway, at NGR SN 4445 0067, from the east, during turf-stripping.*

The evidence for the railway lines and sidings was, in 2004, mainly in the form of lines of ballast which indicated their route. These were observed before and during the turf strip for the scheme (Fig. 19), in the area north of the canal and sluice pond (NGR SN 4453 0067). The ballast appeared to have been laid directly on the underlying sand. There were also occasional areas of *in situ* railway sleepers, most of which were heavily deteriorated, and iron rail fixings were present randomly scattered throughout the site.

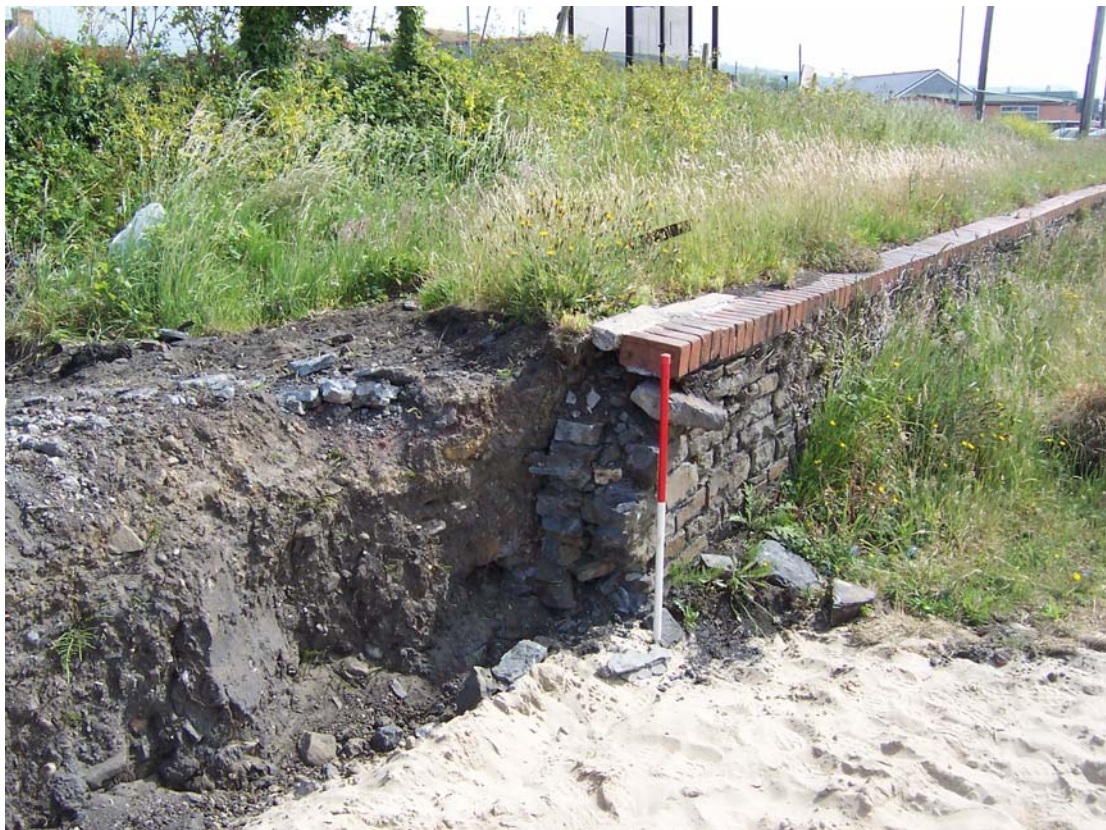
*Fig. 21 - Photo of the old railway platform, from the southwest*

Although the station had gone by 2004, the railway platform survived as an E-W revetted platform, 122m in length and averaging 5m in width. The retaining wall, on the south (trackside) side of the platform, was 1m high and 0.35m thick and constructed from brown-grey sandstone rubble, bonded with a lime slag mix mortar (Fig. 21). The rubble facework was poorly sorted for size and shape and randomly coursed, but was reasonably well dressed and created a good wall face, capped with red brick. This wall retained a bank of silty sand that contained about 25% stone including occasional iron slag fragments, and this material formed the platform. The platform was probably paved with large sandstone slabs up to 0.20m thick as there are several large fragments in the vicinity, but none of them *in situ*.

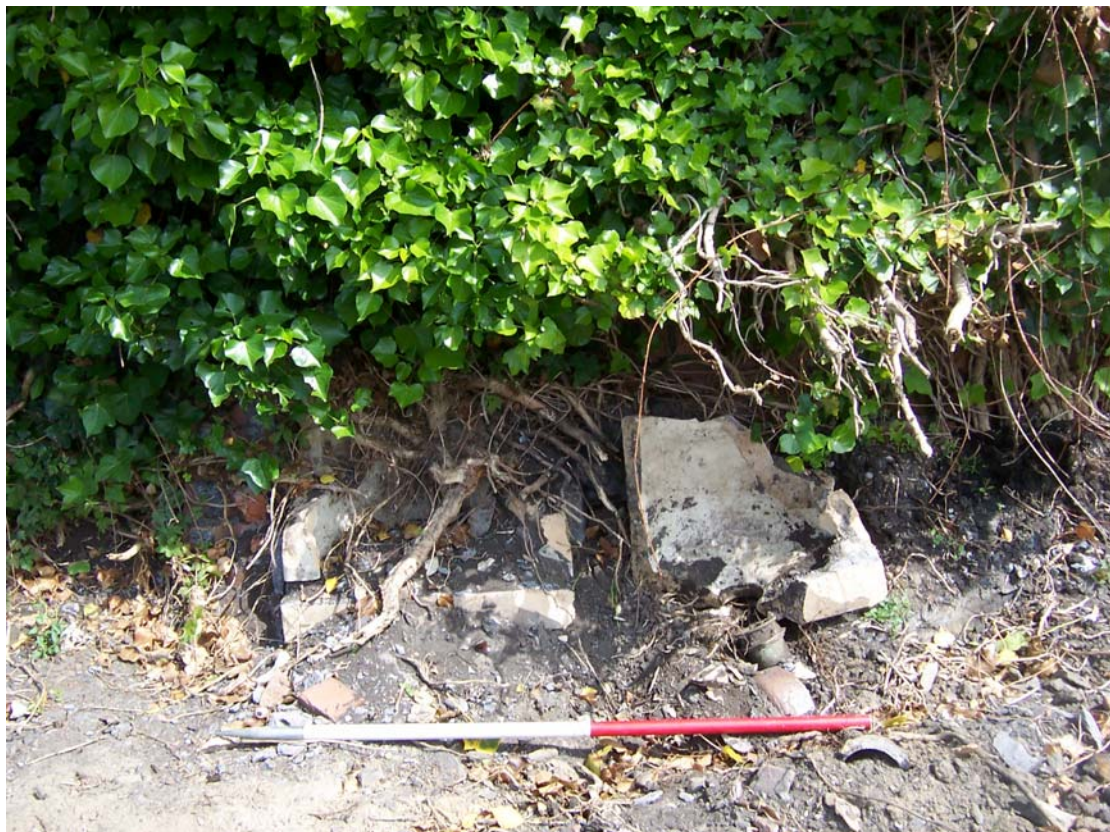
Fig. 22 - Photo of the railway platform urinals, from the south

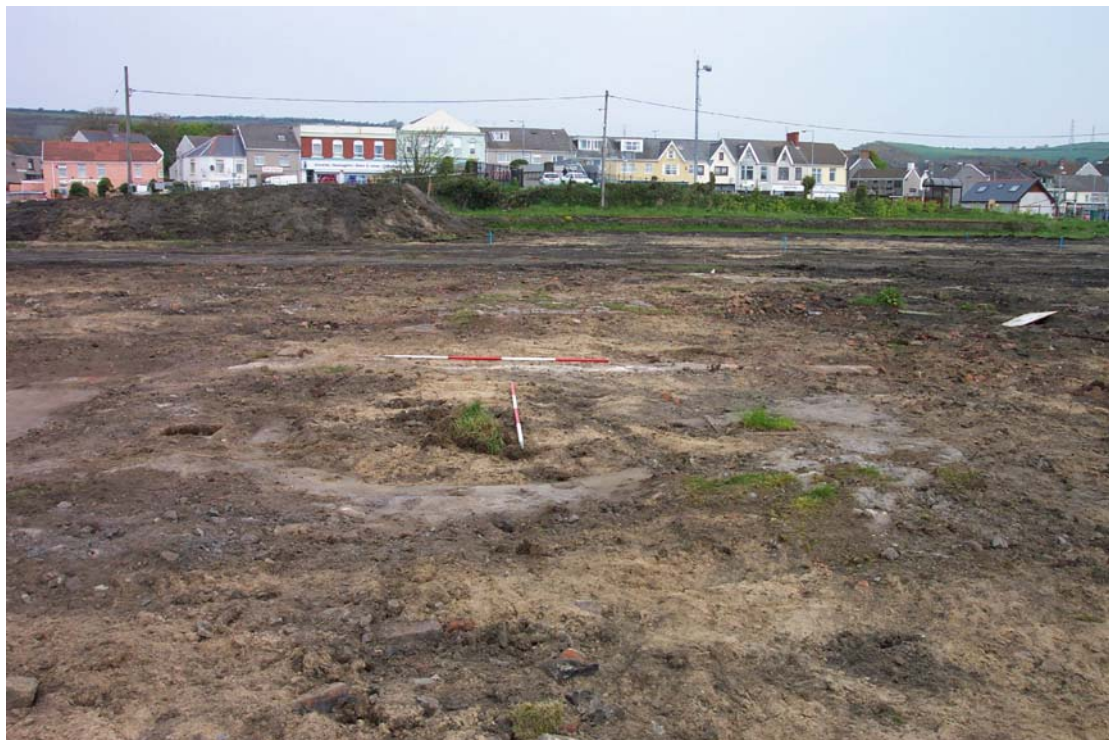
*Fig. 23 - Photo of the Power House foundations, from the south*

The footings of a second building, of unknown function, were exposed just over 4m west of the Power House itself. It measured 8m E-W by 4m N-S, and appears consistently on all Ordnance Survey editions from 1907 to 1953 (Appendix 1), without any apparent change in size. However the archaeological evidence seems to indicate that it may have had a complex history. The east, west and south wall footings, in yellow brick, were observed. The north side was open, with a concrete slope or entrance ramp. However, there were also the remains of an E-W footing, possibly representing the internal wall of an earlier phase when the building may have been twice as wide. Much of this area had been truncated by a large, shallow pit which extended over much of the site. Lying up against the south side of the building was a square area of dark contaminated sand, measuring 6m x 6m, that may represent an external yard or the floor of a slightly-built annexe.

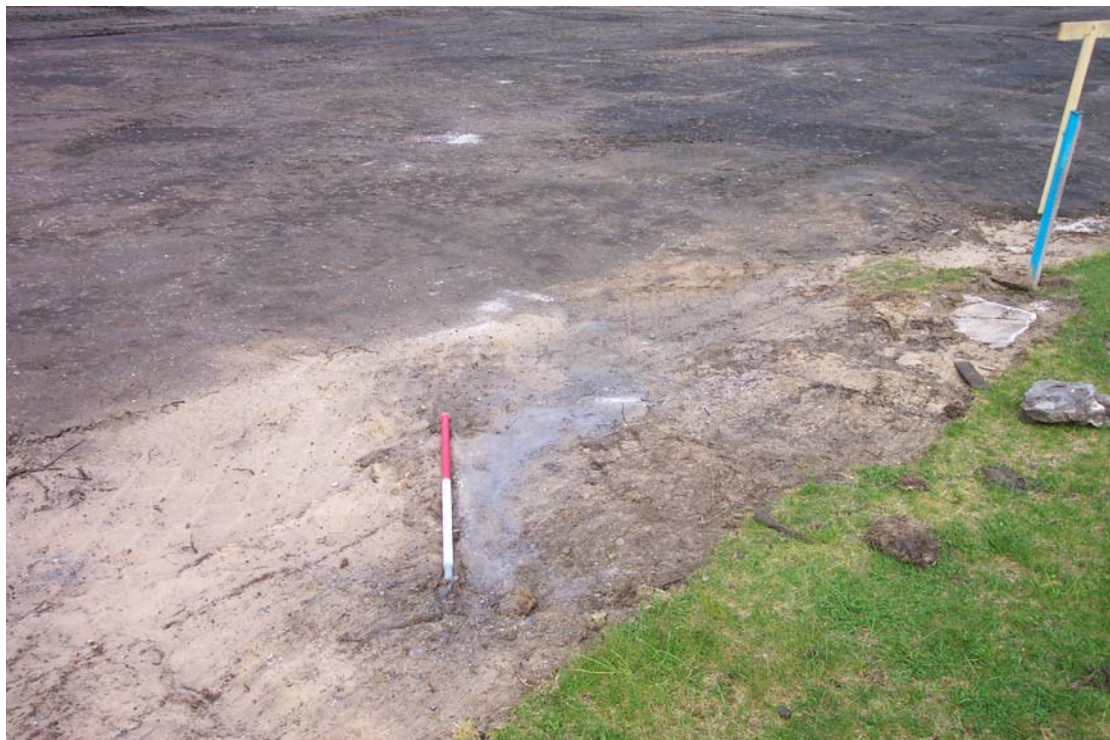
*Fig. 25 - Photo of the Engine Sheds west wall, from the north*

The Engine Sheds were also built by the Burry Port and Gwendraeth Valley Railway. It was a large building of irregular plan, averaging 20m N-S and 35m E-W at its greatest extent, lying immediately northeast of the sluice pond. The building was demolished in the mid 20<sup>th</sup> century.

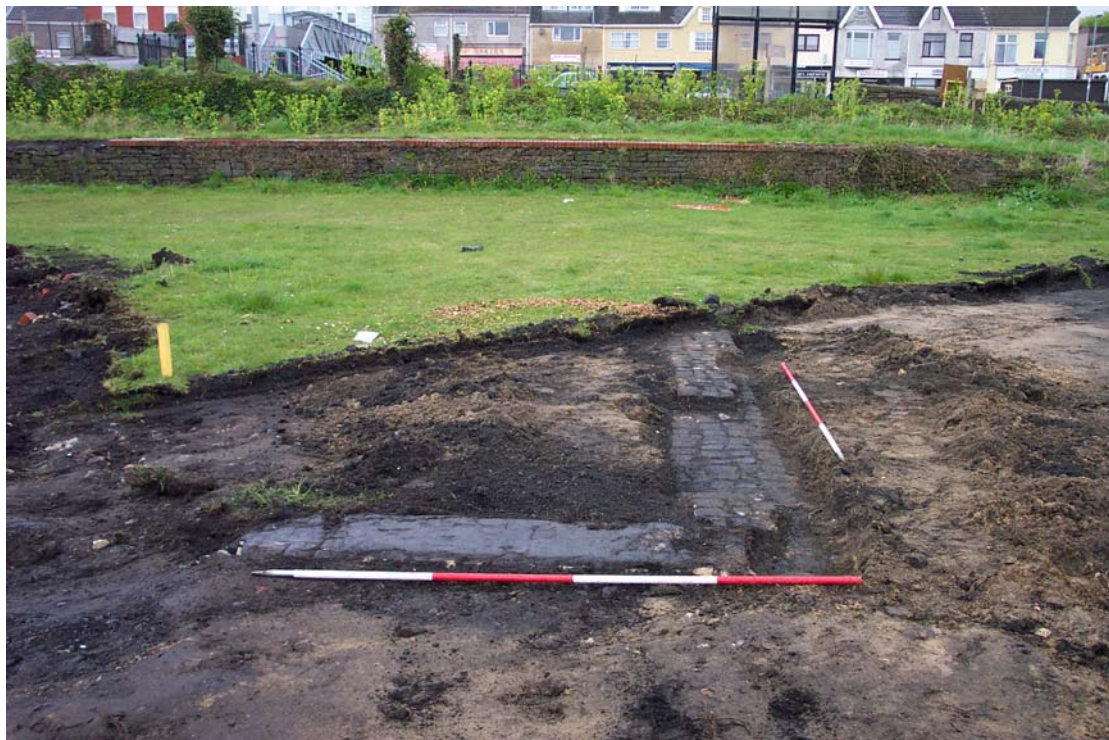
*Fig. 26 - Photo of the southeast corner of the Goods Shed foundations, from the south*

Although the Goods Shed had been demolished to below floor level, approximately 80% of the foundation survived. This was constructed from sandstone blocks, dressed to the size and shape of bricks. It survived to a depth of at least two courses, but there was no evidence of any form of bonding material other than oily sand. One more foundation course had survived in the southeast corner, and this was finished with a thick, dark grey layer of mortar on which the above-ground walling was presumably constructed. None of this walling survived, but the surrounding area featured a rubble deposit comprising pale yellow brick, slate and thick window glass, which gave a suggestion of the materials used in the building's construction.

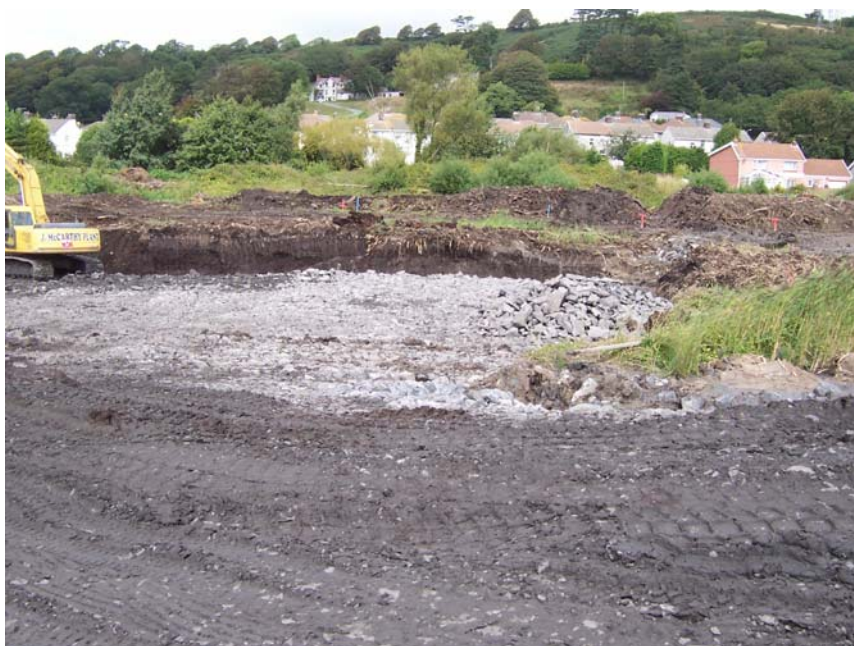
*Fig. 29 - General view of sample area, facing northwest*

Bulk palaeoenvironmental column samples, in the form of a monolith with a core depth of 1.5m (Fig. 28), were taken during the excavation of a balancing pond through salt-marsh deposits near Moreb, towards the east end of the road line, at NGR SN 4575 0102 (Figs. 2 and 28). The sample was taken from the northern side of the pond cutting, which was 1.6m deep, through a 1.25m depth of peat, overlying a leached, pale grey peaty silty clay. The peat was overlain by a thick clay deposit (Figs. 28 and 29).
