A487 (T) GLANDYFI ROAD IMPROVEMENT ARCHAEOLOGICAL DESK BASED ASSESSMENT

MARCH 2004

REPORT NO. 2004/38
PROJECT RECORD NO. 50447

A487 (T) GLANDYFI ROAD IMPROVEMENT
ARCHAEOLOGICAL DESK BASED ASSESSMENT

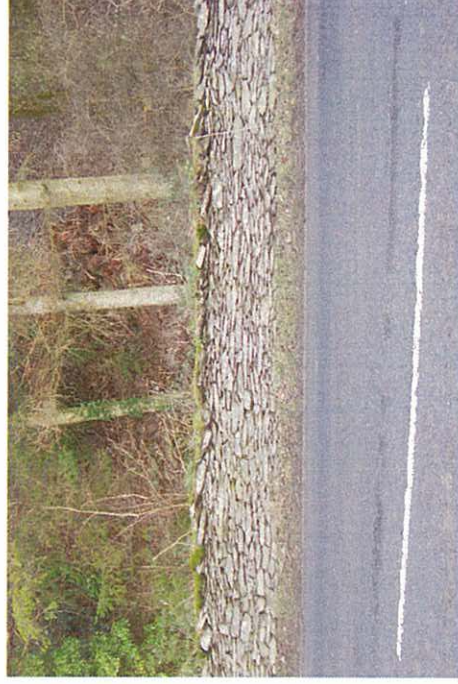
Photo. 2: Dry stone wall on east side of road.

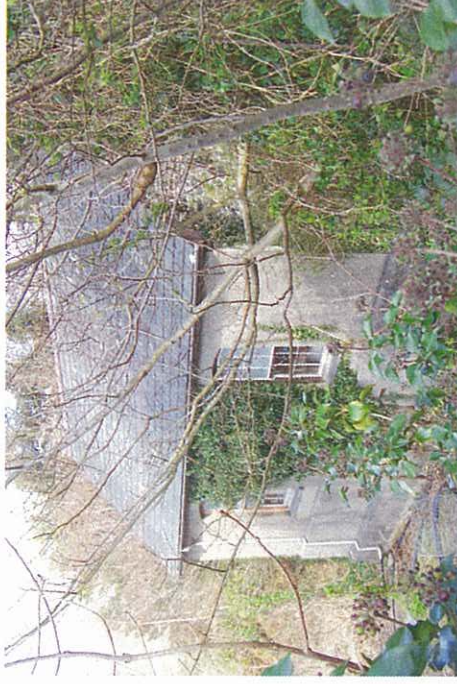
Photo. 6: PRN 17657 Ysgoldy Glandyfi (SN69629703).

Record Number: 17657 **Grid Reference:** SN69629703
Site Type: Schoolhouse **Period:** Post Med
Name: Ysgoldy Glandyfi
Site Status:
Description: A Calvinistic Methodist Sunday School and chapel built in 1868. Now used for storage.

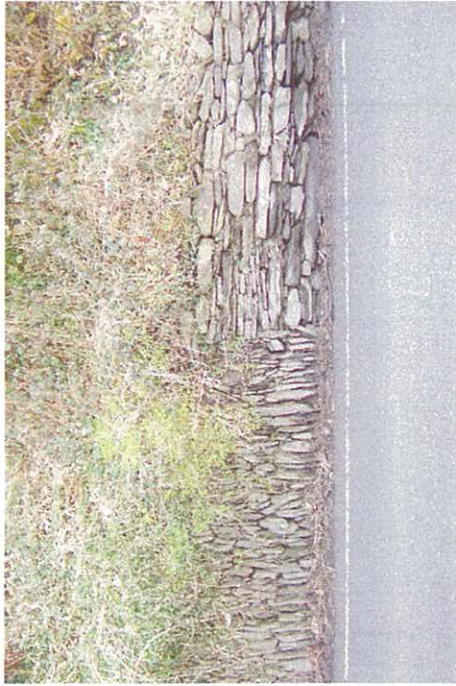
Photo. 7: Example of variation in construction of walls.

As with the previous PRN, the original dry stone walls on the eastern side of the road are of local significance and of regional character. Wherever possible, the onus should be on retention of the original walls, or repair and replacement using the same materials and techniques, so that their local distinctiveness is not lost. This is especially desirable on the stretch of wall between Park Terrace and the driveway entrance to Glandyfi Castle. Ideally significant changes in construction (such as is illustrated in photo 7) should be retained.

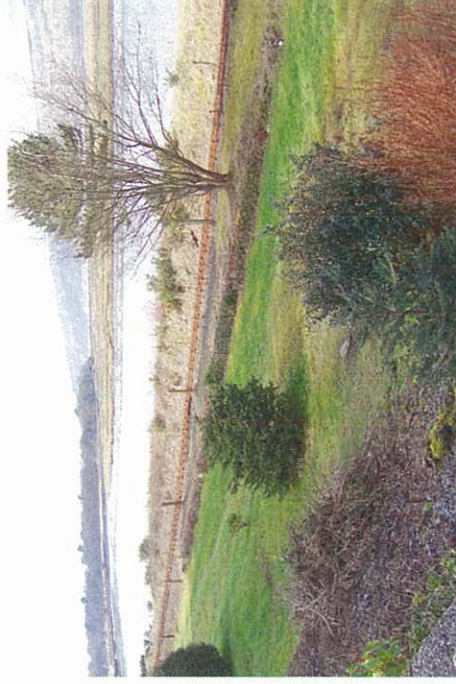
Site	Type	Location	Impact	Significance of Impact
PRN 6093	Cropmarks	SN699 973	None likely	4
The cropmark is sufficiently far from the road for it not to be impacted upon.				
PRN 8331	Lead Smeltery	SN695 970	None likely	4
The exact location of this feature is uncertain, but is probably outside the area of the scheme. It is therefore unlikely to be impacted upon.				
PRN 17632	Garreg Farm	SN696 970	None likely	4
It is understood that the road scheme will not directly impact upon buildings associated with this property. No likely impact is envisaged.				
PRN 17657	Ysgoldy Glandyfi	SN6962 9703	None likely	4
It is understood that the road scheme will not directly impact upon this building. No likely impact is therefore envisaged. Access to the building from the roadside should be maintained (see PRNs 50466 and 50467). See photo 6.				
PRN 19638	Glan-dovey Station	SN6951 9697	Definite	2
It is understood that the road scheme will be impinging upon the eastern edge of the station site. This area was occupied by railway sidings and loading area. A small building, reportedly associated with a weighbridge (PRN 50461), will be entirely removed. Other features associated with the station may also be encountered during any works in this area. See photos 8, 10 and 11.

Photo. 8: PRN 19638 Former railway sidings (SN69509695).

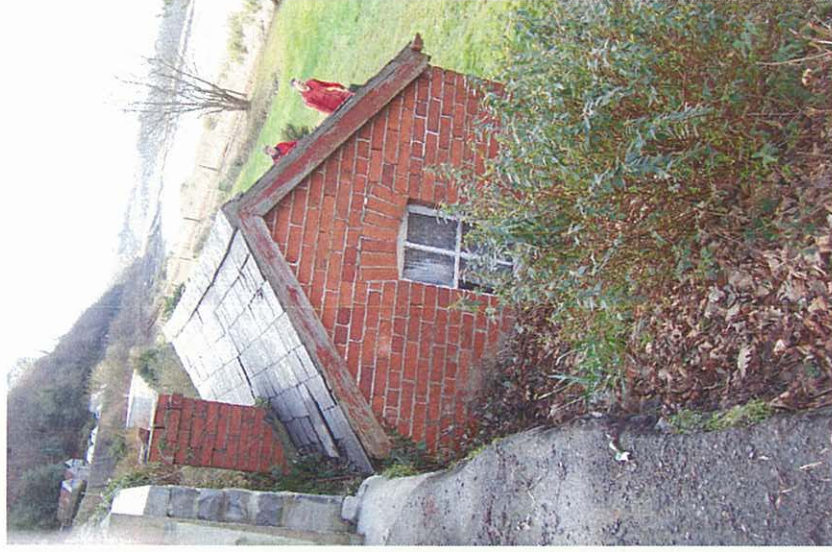
Photo. 10: Weighbridge shed (SN69529696).

Description: Weighbridge Office. Part of Glan-dovey station (PRN 19638) dating to 1863.

It is recommended that a photographic record of the external and internal features of the shed is made before its demolition. A watching brief to record any other features associated with the railway that may come to light during the road improvement scheme, or which would be threatened by the proposed works, should be considered. It was suggested that St Fagans be contacted to enquire whether they would be interested in the building. If this were the case then more detailed recording and deconstruction of the building would be necessary.

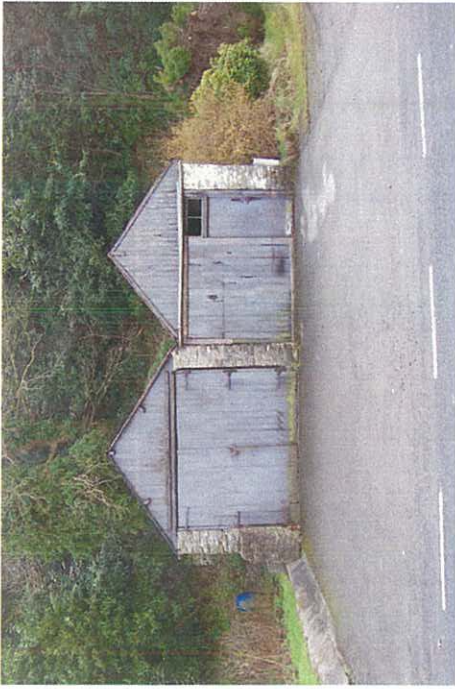
PRN 50460	Sheds	SN69419685	Possible	3
Two Sheds located to the west of Park Terrace, lie close to the possible route of the road scheme. Although a close inspection was not possible, the buildings appear to include some interesting features. The buildings are not represented on any of the usual historic maps. Because of their location it is possible that these buildings may be impacted upon by the scheme. See photo 12.				
PRN 50461	Weighbridge shed	SN69529696	Definite	1
It is understood that this building, which forms part of the Glan-dovey station complex, will need to be demolished as part of the proposed road scheme (see also PRN 19638). Other associated features may be encountered during groundworks in the area. See photo 10.				
PRN 50462	Raised track	SN69069666	Possible	3
This raised trackway appears to have provided access between the road and the quays (PRN 17929). The road scheme is unlikely to impact upon this feature, but the construction of a proposed pond immediately to the east, may impact upon the trackway. See also PRN 50463. See photos 23 and 17.

Photo. 12:Sheds (SN69419685).

Description: Two stone built sheds located to the west of Park Terrace. Not represented on historic maps, but possibly with structural features of some interest.

If these features are to be demolished during the road scheme, then a photographic record of the buildings should be made. More detailed recording of any significant features, fixtures or fittings may be required.

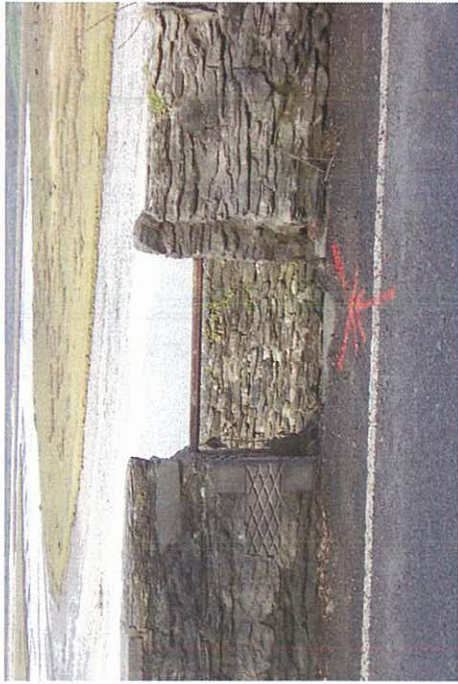
PRN 50463	Steps	SN69139674	Possible	3
These steps were probably constructed to give access to the railway at this point, or to give access to the river. It is assumed that the existing steps will be retained during the proposed scheme in which case the impact will be low. If they are to be rebuilt, repaired or replaced, however, the impact will be greater (see also PRNs 50466 and 50467).

Photo. 16: Gateway in west roadside wall leading to steps (SN69139674).

replacement is unavoidable, or where entirely new stretches of wall are to be constructed, they should be in keeping with the original walling, ideally constructed in the same manner from the same materials. Wherever possible, all features such as gateways, field access etc. should be retained, especially steps PRN 50463 and the gateways that are associated with it.

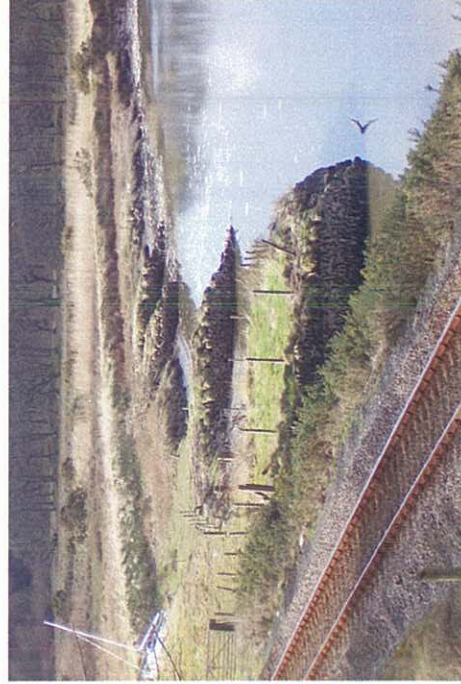
Photo. 18: Quays PRN 17929, with flood defences PRN18060 behind.

Record Number: 17929 **Grid Reference:** SN691967
Site Type: Quay/ferry/port **Period:** Post Med
Name:
Site Status:
Description: A group of stone built quays (possibly as many as six), located along the river bank at the southern end of Glandyfi. Also in the vicinity of Glandyfi are a ferry crossing point and a ford to the north of the settlement. PRN 50465 is a small structure possibly associated with the ferry crossing.

Record Number: 18060 **Grid Reference:** SN688963
Site Type: Flood defence **Period:** Unknown
Name:
Site Status: Earthwork embankments-flood water defences adjacent to Afon Melindwr and Afon Einion (part of) of unknown construction date.

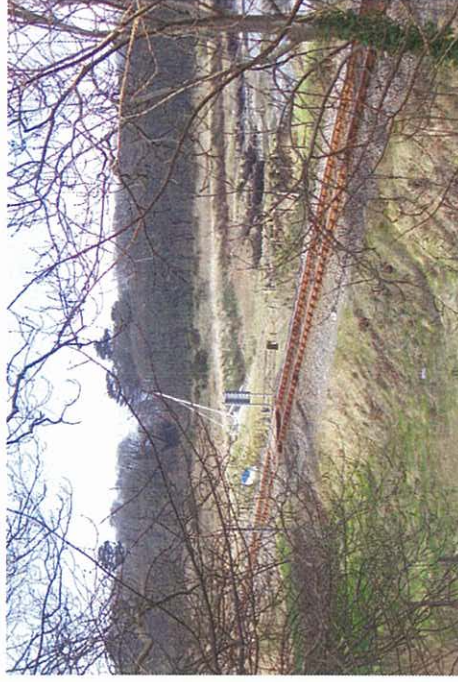
Photo. 17: View of flood defences (centre), railway embankment and raised trackway (left).

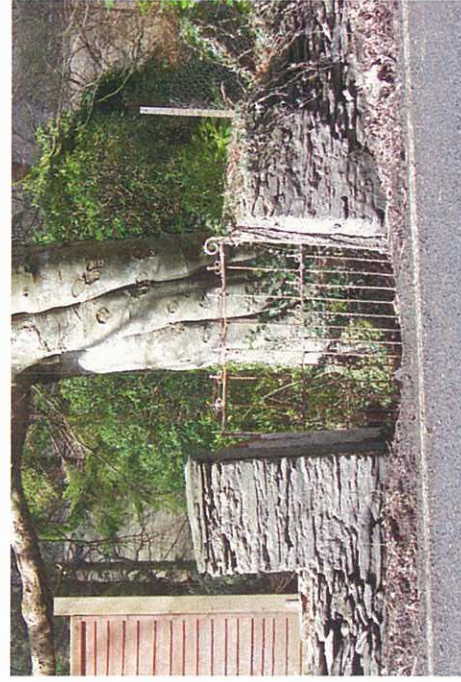
PRN 50467	Roadside walls east		Definite	1
The walls on the east side of the road are more extensive and complex than those on the west side (PRN 50466). This is because there are more roadside properties and access openings. Most of the walls are of dry stone construction in locally distinctive style. The condition of the walls, however, suggest that considerable stretches will need to be repaired or rebuilt. Considerable stretches may need to be removed completely. There will therefore be significant impact upon these features. See photos 2, 7, 14, 21 and 22.				
PRN50468	Ranger Lodge	SN68999653	Definite	2
It is understood that the road scheme will not impact directly upon buildings associated with this property. The eastern property boundary wall that runs along the edge of the road, however, lies within the path of the proposed scheme and will therefore be directly impacted upon. See photo. 19.

Photo. 19: Gateway in western roadside wall (SN69029654).

The roadside boundary wall of this property lies in the path of the proposed scheme. In the event of its removal, an appropriate mitigation strategy would be to rebuild the boundary in its new location to the same specification, using appropriate materials and including original fixtures and fittings, such as the gateway (photo 19).

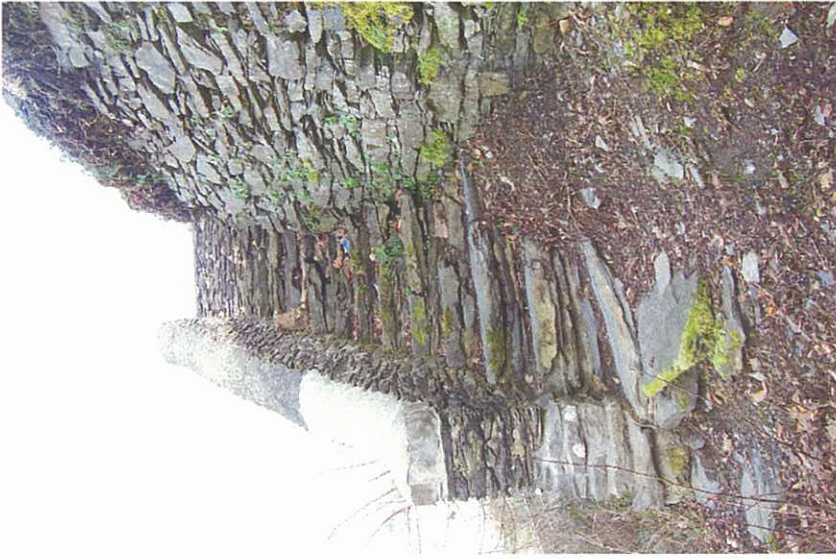
Photo. 20:Steps down roadside embankment.
(SN69139674)

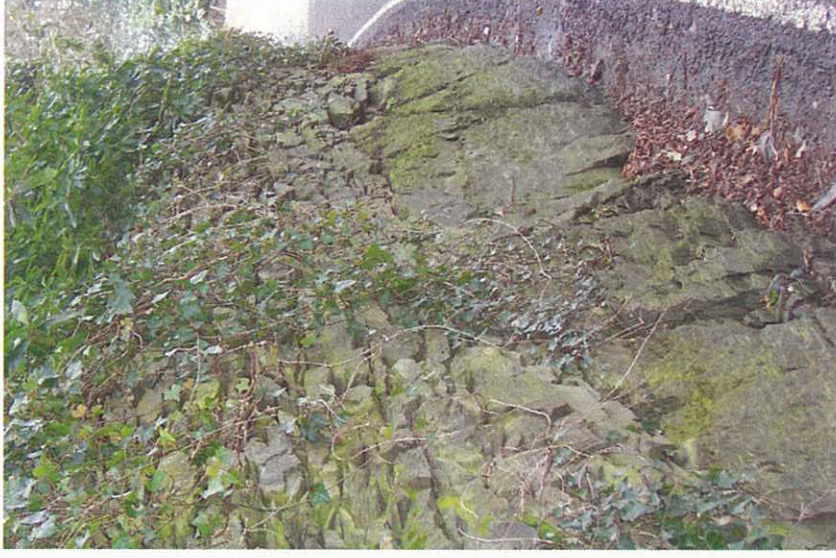
Photo. 22: Wall built upon bedrock.

Record Number:	50467	Grid Reference:	
Site Type:	Roadside walls	Period:	Post Med
Name:			
Site Status:			
Description:	The roadside walls running along the east side of the A487 within the settlement of Glandyfi assigned a PRN as part of desk top survey. The stretch opposite Glandyfi Castle is of original dry stone construction in a locally distinctive style. In places the wall is built directly upon the bedrock exposed by the road cutting.

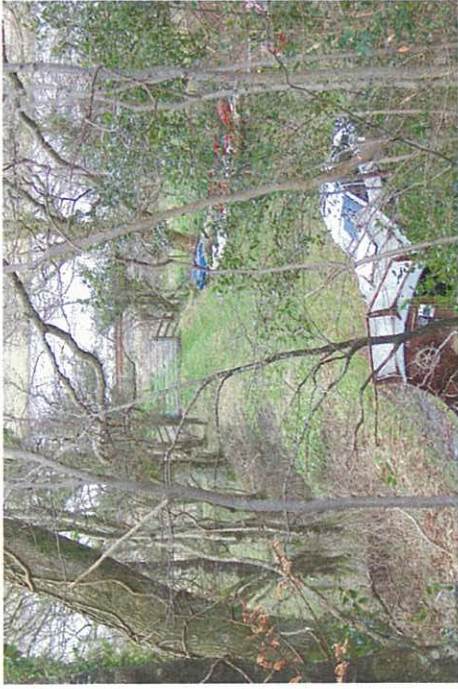
Photo. 23: Raised trackway leading to quays (SN69069666).

Record Number:	50462	Grid Reference:	SN69069666
Site Type:	Earthwork track	Period:	Post Med
Name:			
Site Status:			
Description:	This raised trackway appears to have provided access between the road and the quays (PRN 17929). The trackway appears to take a different route on the tithe map to that shown on later maps, presumably having been re-directed as additional quays were constructed.		
Record Number:	50463	Grid Reference:	SN69139674
Site Type:	Steps	Period:	Post Med
Name:			
Site Status:			
Description:	These steps were probably constructed to give access to the railway at this point, or to give access to the riverside quays.		
Record Number:	50464	Grid Reference:	SN69119667
Site Type:	Cottage site	Period:	Post Med
Name:			
Site Status:			
Description:	A cottage is indicated on the tithe map but not on later maps.		
Record Number:	50465	Grid Reference:	
Site Type:	Ferry shed	Period:	Post Med
Name:

There is a potential threat of damage to this feature from heavy machinery or over-zealous landscaping if a pond is to be constructed immediately to the east. Steps should be taken to minimise the potential for such damage, or to make good any unavoidable impact.
