**TIR GOFAL MANAGEMENT PLAN:
HERITAGE MANAGEMENT INFORMATION
(Call Out)**

**Prepared for:
Pengaer**

Tir Gofal Reference No: W/13/4715

**Report Number: 2005/9
Project Record Number: 50476**

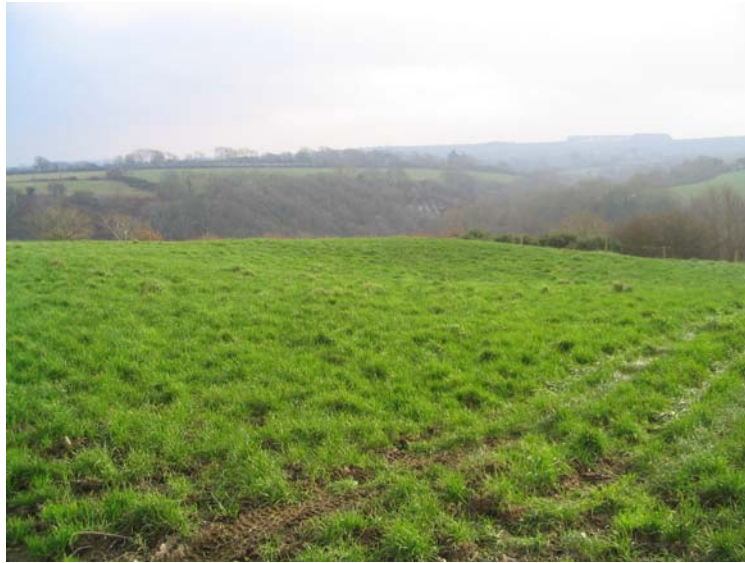
The site has been cultivated in the past and the banks are greatly diminished. However, there is a strongly likelihood that buried archaeological remains survive in this area. This area is now under permanent pasture and while this management regime is maintained the site lies in a stable condition. To the south and east the ground drops away steeply and these slopes are densely covered with gorse and bracken in the higher areas but lower down they become increasingly wooded.

Looking across the interior of the promontory fort PRN 1172 to the southeast, showing the fence line which it is proposed to renew

An old fence line is located where the ground drops away at the break of slope and provides a barrier between the grazed enclosure and the shrubby, wooded slopes below. It is proposed that this fence line is reinstated and improved to provide an adequate stock-proof barrier. This seems an appropriate measure to carry out in order to maintain the current grazing regime on the site of the promontory fort. It is hoped that the existing fence posts can be reused, but if it is necessary to renew any of the posts, or to insert additional fence posts, then posts should be struck into position rather than post holes excavated.

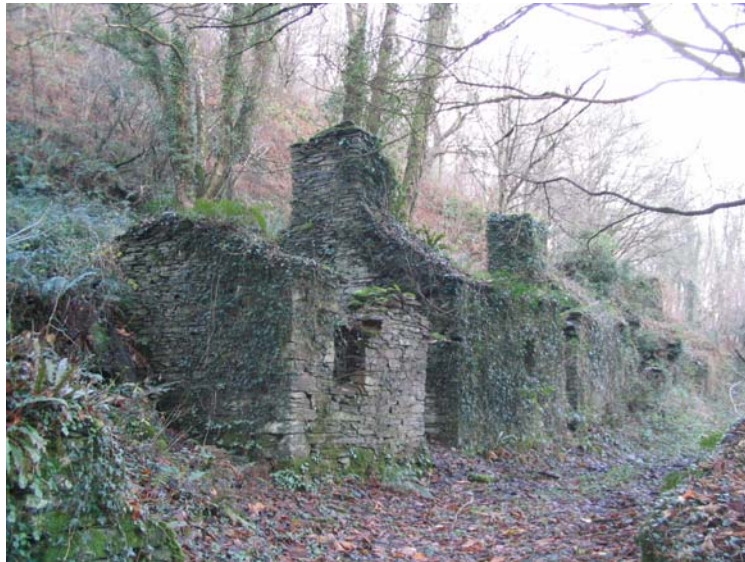
The row of quarry workers cottages seen from the southwest

The cottages are a continuous row of five single storey stone built units. It is unclear whether each of these units was a cottage; those at either end are smaller and lack a chimney or fireplace. Collapsed pigsties are also attached at either end of the row. The three central units are double fronted with a slightly off centre doorway with small windows flanking to either side. Large projecting stone chimney breasts stand at one end of each cottage and two of the cottages have evidence of blocked openings in the rear (northwest) wall.

The cottages are now in a derelict condition, none of them are roofed and although most of the walls still stand to roof height the wall tops are looking fragile, and the timber lintels over the window openings and fireplaces are beginning to fail. In addition the remains are becoming quite overgrown with ivy and saplings which are taking root within the masonry. Efforts have been made in the recent past to remove some mature trees which threaten to damage these structures through shedding boughs or root disturbance.

Discussions during the farm visit centred on preventing further damage or deterioration of these structures and the possibility was discussed of reinstating a roof on these cottages. Although these cottages were probably originally slate roofed the expense of reinstating slate would, in this case, be prohibitive. A corrugated iron roof would not seem out of place on cottages such as these, and this material may represent a practical alternative. The advantages of roofing these buildings are numerous; covering the structures and keeping them dry would prevent further damage by water ingress, seedlings would be prevented from re-establishing themselves in the

masonry, and a sound roof over the structures would allow the buildings to be used as a storage facility.

In the event that re-roofing these cottages is not undertaken, regular efforts should be made (where safe to do so) to cut back intrusive vegetation. Ivy stems and saplings should be cut off above the roots. No attempts should be made to remove roots unless a programme of consolidation can be carried out simultaneously. Also ivy should be allowed to die in place. It may be appropriate to spot treat the roots to prevent re-growth, however the approval of the Tir Gofal Project Officer should be sought in advance.
