TIR GOFAL MANAGEMENT PLAN: HERITAGE MANAGEMENT INFORMATION (HE2)

**Prepared for:
Penrallt**

**Tir Gofal Reference No
W/13/4718**

**ACA Report No. 2006/11
Project Record No. 50477
Prepared by
Philip Poucher**

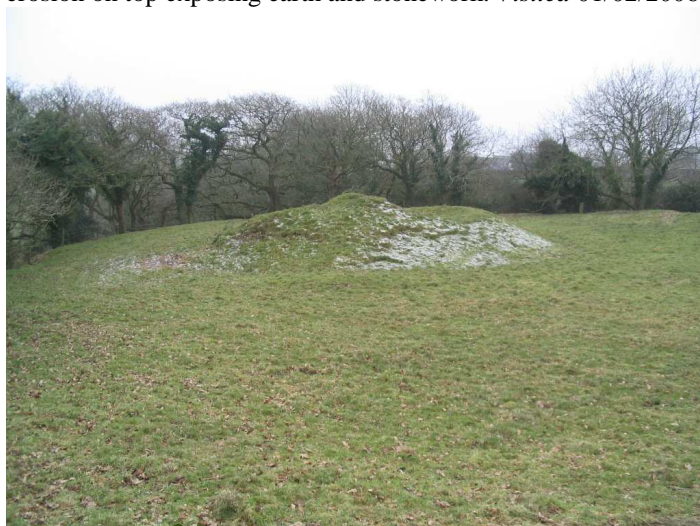
1	CASTELL-YR-ALLT (1171)	Medieval/ Motte	SN15784203	A	SAM	Generic
----------	-------------------------------	------------------------	-------------------	----------	------------	----------------

A motte lying within a bailey (PRN1170) which itself may be re-using an early hillfort. The motte is roughly circular, measuring c20m in diameter, and c4m high with a central depression of possible later disturbance. The motte consists of earth and stone, some stone having the appearance of tumbled masonry although no mortar is visible. The motte is mostly grass, recently cleared of scrub which has revealed a small area of erosion on top exposing earth and stonework. *Visited 01/02/2006 (PP)*

S facing shot of the motte.

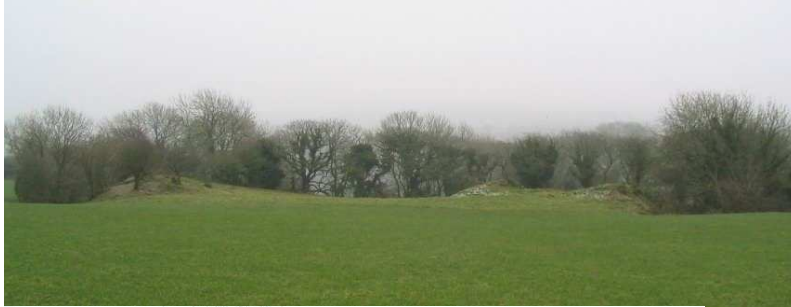
1	CASTELL PEN-YR-ALLT (1170)	Iron Age/ Hillfort; Castle	SN15784203	A	SAM Pe169	Specific
----------	-----------------------------------	-----------------------------------	-------------------	----------	------------------	-----------------

A motte and bailey castle possibly re-using an earlier hillfort, occupying an inland promontory. A naturally steep slope defends the southern side of the site. The eastern side is defended by an earth and stone bank with an external rock cut ditch more than 2m deep, making the bank 5m high externally. There are slight remains of a low bank defending the western side. more intact at the northern end. with an external rock cut

ditch. Within the northern end of the bank is a short section of stone walling, possibly the remains of a building, or a later field wall. The bank and ditch that presumably protected the north have long since been ploughed out although the line of the bank is just about visible. An earth and stone motte (PRN 1171) lies near the southern edge of the bailey. Nothing is known of the history of this site, but nearby St Illtyd's Church (PRN 5317) has Medieval origins and the two sites may have been associated. Trees and scrub grow on the steep valley slopes and within the external ditches, but scrub has recently been cleared from the banks and interior of the site. Areas of erosion are now visible on the motte and eastern bank. *Visited 01/02/2006 (PP)*

SE facing shot of the castle site.

- 1) The vegetation on the motte has been cleared;
- 2) Vegetation clearance has begun on the inner side of the north eastern bank.

- 1) Overgrown coppice on the outer side of the north eastern bank;
- 2) Overgrown gorse on the top of the north eastern bank; [NB. Now removed, PP 01/2/2006]
- 3) Sheep have eroded an area measuring 0.5m x 1m at the northern end of the north eastern bank;
- 4) Rubbish (silage wrap and other plastics) has been dumped in the south western rock cut ditch;
- 5) Feeders have previously been located within the scheduled area (2 circular areas with poor grass cover are evident on the northern side of the bailey). [NB. No longer evident, PP 01/02/2006]

- A) Cut, at ground level, the overgrown coppice on the outer side of the north eastern bank. Remove debris from site;
- B) Cut, at ground level, the overgrown gorse on the top of the north eastern bank. Remove debris from

- C) Fill and reseed the scrape, which sheep have at the northern end of the north eastern bank;
- D) Remove rubbish (silage wrap and other plastics) dumped in the south western rock cut ditch;
- E) Not to locate feeders within the scheduled area.
- F) Future ploughing operations should be kept 5m from the edge of the defensive bank.

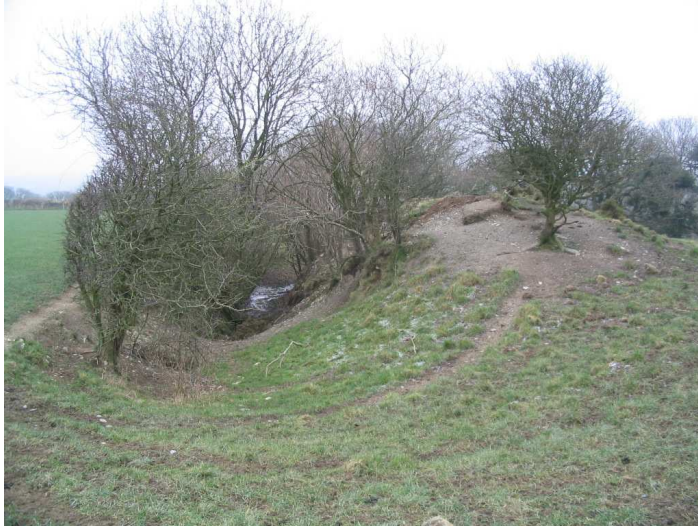
SE facing shot of the bank and external rock cut ditch protecting the western side of the castle.

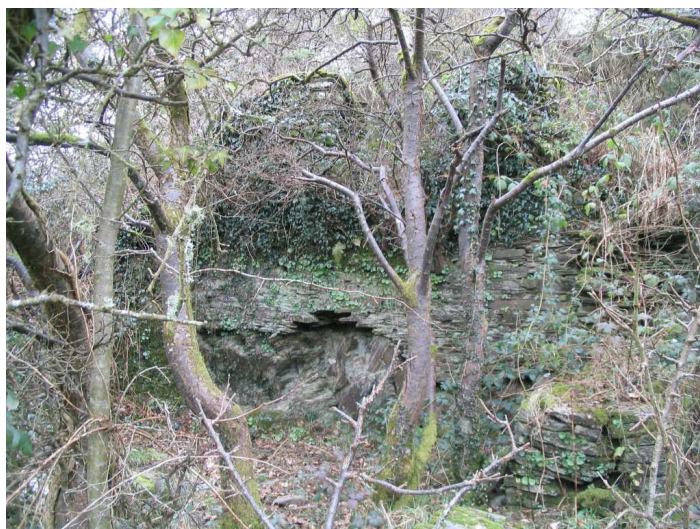
2	CASTELL <u>(55662)</u>	Post Med/ Dwelling	SN1630442163 B	Specific
----------	-------------------------------	-------------------------------	-----------------------	-----------------

A ruined stone built dwelling first marked on the old series Ordnance Survey map of 1819. The more detailed 1st (1889) edition Ordnance Survey map shows an L-shaped building within an enclosure located on the streamside. Much of the rear gable wall of the main dwelling remains, built of mortared slate with the outline of a window visible. The remaining walls have mostly tumbled and are difficult to trace amongst the trees and scrub that cover the site. Tumbled stone and earth banks marks out the rough line of the surrounding enclosure. *Visited 01/02/2006 (PP)*

ENE facing shot of the remains of the dwelling.

Much of the rear gable wall remains, other walls are mostly tumbled. Ivy covers the top of the gable wall and the site lies in an area of thick scrub and tree growth, all of which may threaten the stability of remaining masonry.

- Trees growing on or close to the upstanding masonry should be cut back to ensure branches and roots do not cause further damage. Dead material should be removed from the site.
- Scrub should be cut back from around the surviving masonry.
- Ivy should be cut back as it may be causing damage to the masonry.

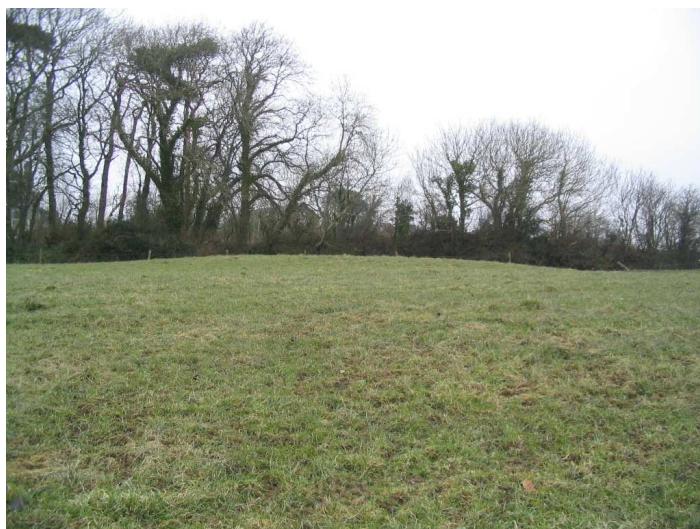
RHYD Y GARN WEN Bronze Age?/ SN15694286 U Generic
(5320) Round barrow?

A "Garn" place-name that may have indicated a round barrow or cairn existed here. A number of 'stones' are also marked in the surrounding landscape on the 1st edition Ordnance Survey map of 1889 which could indicate this was an area of Bronze Age funerary and ritual activity. Unfortunately many of these stones have since been removed and no definite trace of a round barrow has been recorded. However, a low roughly circular mound is visible in the field to the south of Rhyd-y-garn-wen, on land belonging to Penrallt Farm, close to the northern field boundary. The mound measured roughly 15m in diameter, and 0.3m high but without further investigation it is impossible to identify the true nature of this mound, the ground surface is naturally undulating in this area and the 1st edition Ordnance Survey map marks several ponds in this area that have now been ploughed out. *Visited* 01/02/2006 (PP)

N facing shot of the low mound near Rhyd-y-garn-wen. It is unclear if this represents the ploughed out remains of a barrow, a later feature, or a natural undulation.

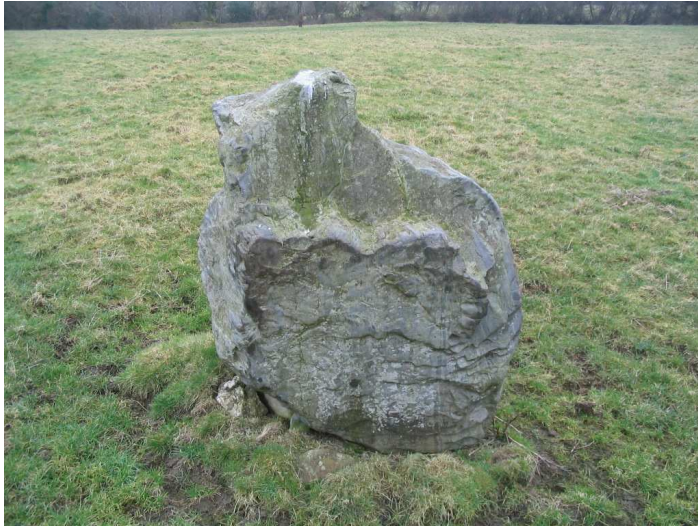
(55661) **Prehistoric?/ Standing stone** **SN1626842043** **B** **Generic**

A standing stone c1.4m high located in the centre of a field at the base of a small valley as it opens out into the Piliau valley. Standing stones are generally thought to be Bronze Age in date (c2000 - 500BC) and may have been sites for ritual/religious activity and/or landscape markers. Sites such as these may have been used over very long periods of time and, therefore, were probably put to many different uses. *Visited* 01/02/2006

S facing shot of the standing stone.

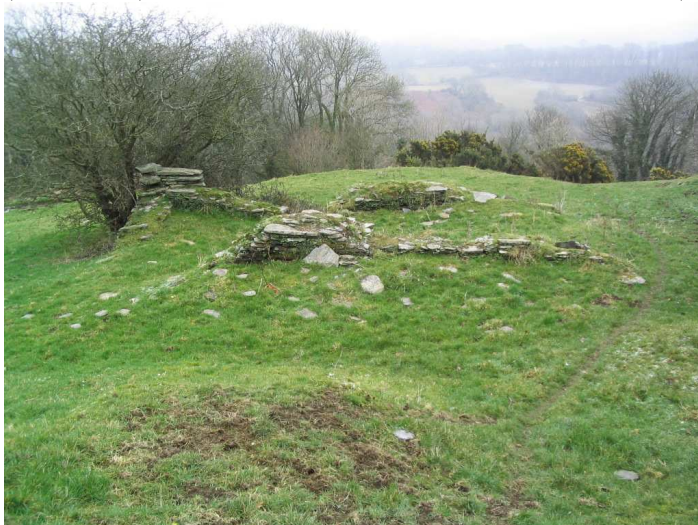
**PENYRALLT;
PENYRALLT-
LLANTOOD (55663)**

A deserted and ruinous farmstead complex. The complex is marked on the old series Ordnance Survey map of 1819 but Charles (1993) records the first reference to the name of the farmstead in 1673. Map evidence indicates that several of the farmstead buildings appear to have been abandoned in the late 19th/early 20th century, although the main dwelling and one other small building are still shown on the 1964 Ordnance Survey map. What appears to be the main farmhouse lies centrally, aligned N-S, measuring roughly 9m by 6m, with ruined slatestone-built walls standing at most 1.2m high. Little remains of the gable walls, but there is a doorway midway along the eastern wall. 19th century maps indicate one or two buildings on the east side of the farmhouse, little remains of these sites other than possible grass covered platforms. To the north of the farmhouse three or four farm buildings were built against what is now a stone field boundary. The stone wall would appear to be the remains of the rear walls of these buildings, standing 1.9m high at the eastern end, down to 1m high at the western end. Building platforms and low banks lie in front of the wall indicating the layout of these buildings. To the west of the farmhouse a small enclosure has been built into the field wall. The enclosure is 2.6m by 1.8m and may represent a former building. South of the farmhouse farm buildings stood against the field boundary. Trees in this area obscure the building platforms but the rear wall of these buildings now serves as the field wall. A trackway runs down the eastern side of the farmstead complex and into the valley below, and then on to Llantood. The 1st edition OS map marks a well (PRN 55664) a short distance to the north. *Visited 01/02/2006 (PP)*

E facing shot of the remains of the main farmhouse.

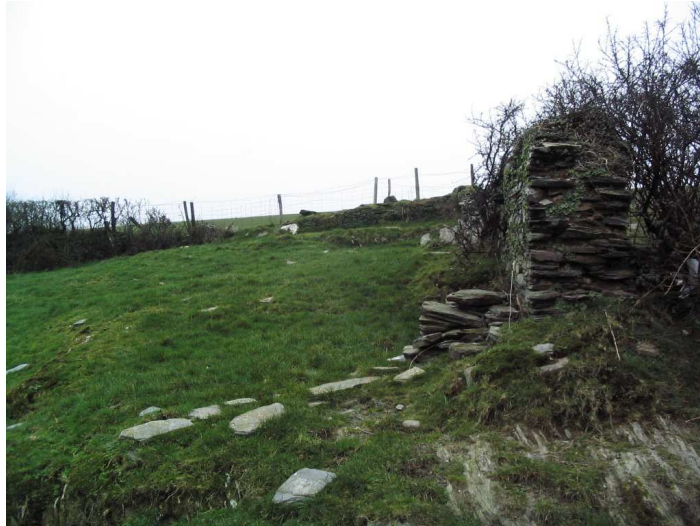
WSW facing shot along the field wall, formerly the rear wall of farm buildings north of the main farmhouse. The building platforms extend out to the left.

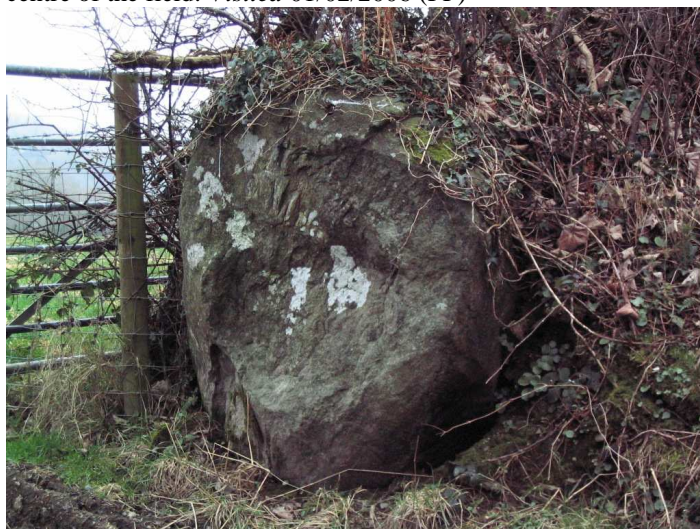
(55668) **Unknown/ Stone** **SN1655443596** **U** **Generic**

A stone marked in the centre of the field on the 1st edition Ordnance Survey map. Provenance unknown, no trace of the stone now remains in situ although a large stone now forms the eastern side of the field gateway to the south. This stone measures roughly 1.3m high and 1.3m wide with a gatepost hole drilled near the top of the stone. The size and location of the stone strongly suggests this is the stone that formerly stood in the centre of the field. *Visited* 01/02/2006 (PP)

E facing shot of the stone at the gateway into the field.

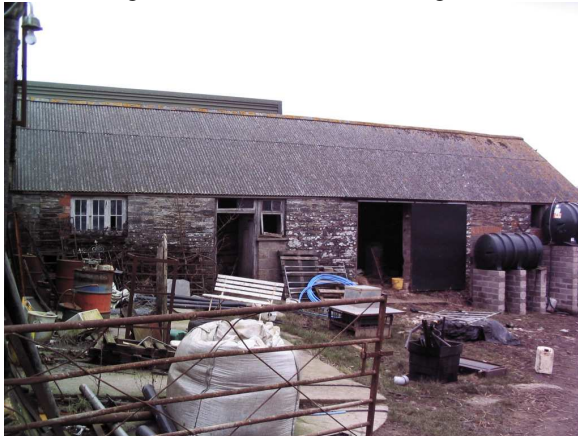
Name (& PRN)	Period/Site type	NGR	Status	SAM/listing	Management required
3	PENRALLT (<u>55665</u>)	Post Med;Modern/ Farmstead	SN1592742356	B		Specific

A working farmstead complex. The complex consists mainly of large modern farm buildings and a modern dwelling, but also contains two traditional buildings at the southern end. A building is first marked at this point on the old series Ordnance Survey map of 1819 and the tithe map of 1839 shows two buildings described simply as 'House', presumably consisting of a dwelling and accompanying barn, the main farmstead complex appears to have been further south (PRN 55663). The 'House' appears to have been abandoned and rebuilt in the 20th century, but the stone-built barn still forms part of the farmstead. A stone built pigsty with brick dressing and a slate roof lies to the south. This pigsty is not marked on the 2nd edition Ordnance Survey map of 1907 and so is presumably later but still appears to be early 20th century in date. The traditional barn is still in use, and in relatively good condition although modified. The pigsty has a deteriorating roof structure and is no longer in use. *Visited 01/02/2006 (PP)*

N facing. The traditional barn still in use within the farmstead complex.

This farmstead is essentially composed of modern buildings, although one stone built barn probably originally dating to the 19th century has been incorporated into the complex. A stone built pigsty stands nearby on the edge of the complex, out of use with a dilapidated and deteriorating roof structure. Map evidence and a traditional building style suggests this pigsty may be early 20th century in date, but post dates the 2nd edition Ordnance Survey map of 1907. The farmer has expressed a desire to demolish the building as it no longer serves a function in the farmstead complex, and re-use the stone in walling elsewhere on the farm. Ideally from an archaeological point of view it would be preferable to preserve

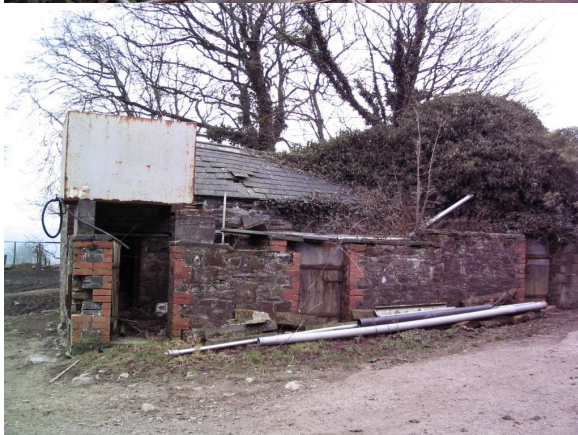
SSE facing shot of the former pigsty.

buildings built in a traditional vernacular style such as this and if no longer viable to use as a pigsty then an alternative use found unless a stronger justification for its demolition is evident.

- If an alternative use for this building is found then ivy should be trimmed back from the roof to relieve the pressure on the structure and the roof structure repaired using appropriate materials and techniques.
