TIR GOFAL MANAGEMENT PLAN: HERITAGE MANAGEMENT INFORMATION (HE2)

**Prepared for:
Waun-gron Uchaf**

W/13/4239

Report No. 2004/116

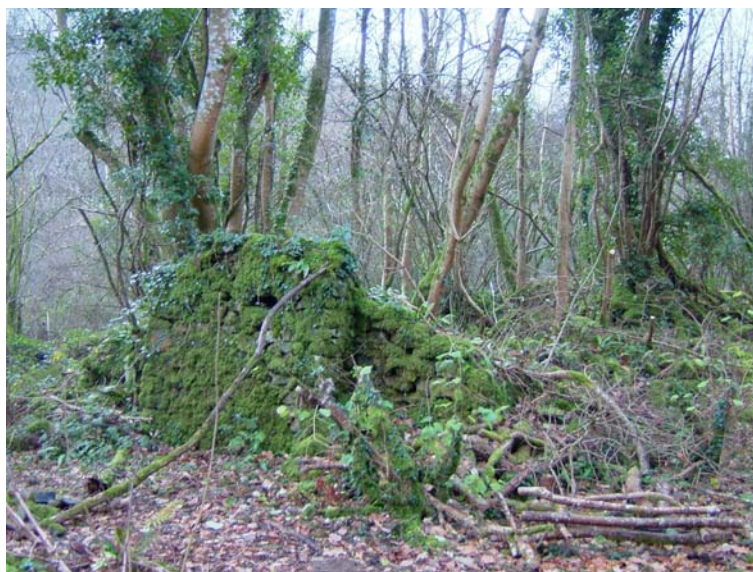
The site now lies in scrubby woodland, but its key elements can be made out - these are remarkably similar to those shown on the 1891 map. The buildings are ruinous and built of local stone. The house is c. 9m by 4m with a door in the south wall and massive chimney in the east gable standing up to 2m high. There is probably a smaller chimney in the west wall. The house is of one cell, but probably originally had timber dividing walls. There is a small outshot to the north side of the house, and possibly one to the south. An annexe (4m by 4m) with separate entrance is attached to the west wall of the house. This probably had an agricultural or craft function. The main outbuilding lies to the southwest of the house and consists of three cells, each with a separate entrance. It has been built in several phases. A small outbuilding to the north may have been a pigsty, but this is not certain, as it is overgrown. Immediately to the north of this two upright stones are the setting for a grindstone or similar. The farmstead is approached from a short track to the west flanked by collapsed dry-stone walls. Other boundaries to the small paddocks and garden plots of this holding are of similar construction, or are of more massive stone-faced banks.

Overall the remains of this farmstead are in good condition, but a few large trees that have taken root on the walls of the house and on other structures are causing problems.

The large chimney of the house of the deserted farmstead.

The aim is to reduce tree-root damage to the site of the old farmstead 53027. Scrub and small trees should be removed from the site of the old farmstead and spot treated to prevent re-growth. Larger trees rooted on and immediately adjacent to surviving structures should be felled and spot treated. Care must be taken during felling that trees are not dropped across walls and structures. Establish a follow-up programme of regular sapling clearance.

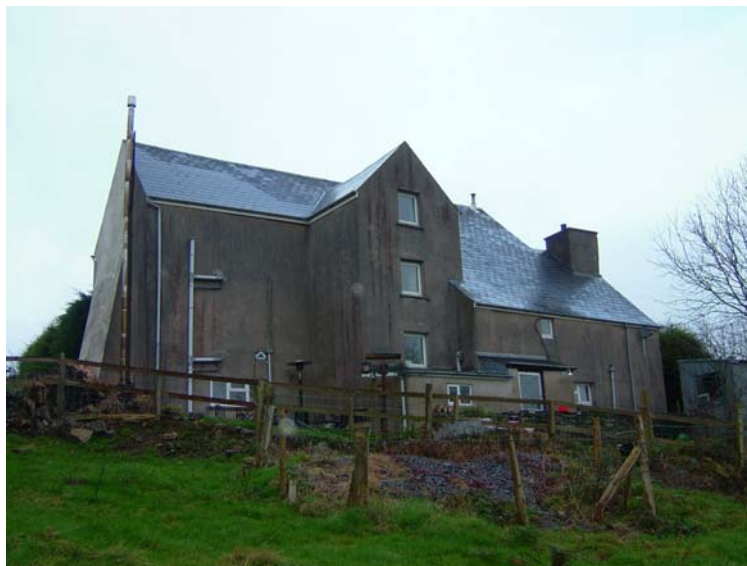
The house is considered to date to the 17th century by the RCAHMW. It is stone built under cement render. It is built on a slope with two storeys to the front of the house, and three to the rear. The front (north) elevation has a central front door and five symmetrically placed windows - the openings have been enlarged. The partly dismantled remains of a substantial chimney are apparent in the west gable wall. The rear of the house is three storey - with a three storey projecting turret. An outshot with a massive chimney is attached to the eastern end of the south side.

Rear of Waun-gron Uchaf house

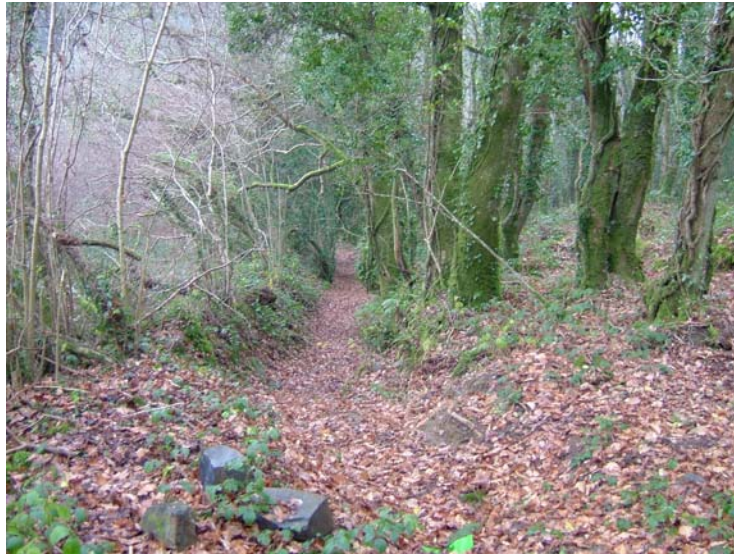
This track is shown on early 19th century maps. It connected Waun-gron Uchaf farmstead with lands to the south. It is not now used. It runs down the slope to the south of the house, where it is marked by a slight hollow-way along side a hedgebank, and then down the steeper slope in deciduous woodland. Here it is a distinct hollow-way 2m - 3m deep flanked by substantial banks. On flat ground close to the river stony banks flank it. It crosses the river by means of a ford, although a footbridge is marked on historic maps.

The trackway running down-slope in woodland.
