TIR GOFAL MANAGEMENT PLAN: HERITAGE MANAGEMENT INFORMATION (HE2)

**Prepared for:
Alltlywd Farm**

**Tir Gofal Reference No
W/11/4470**

**ACA Report No. 2006/22
Project Record No. 50516**

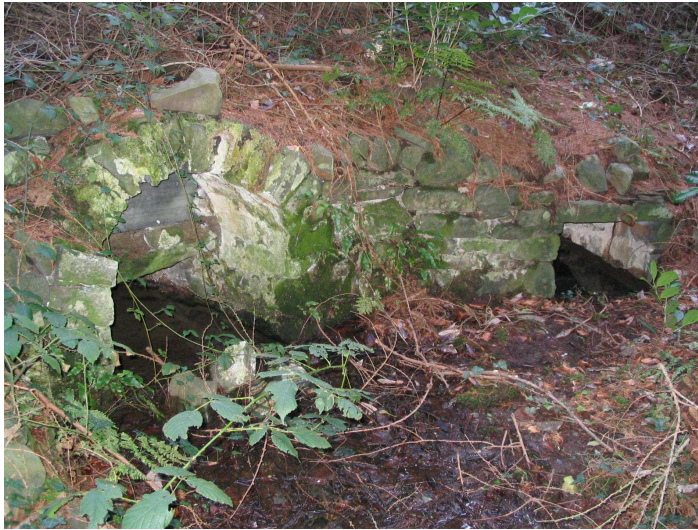
3	ALLT-LWYD <u>(55679)</u>	Post Med/ Well	SN5289068352	B	Specific
A stone built double well lying in the former orchard (PRN 50729) associated with Plas Alltlwyd/Gwyn (PRN 7032). The wells consist of a low mortared stone built face with one well at the eastern end with an arched opening and a 2 nd smaller well with a simpler square opening at the western end. Water still stands in

the wells although the base may have silted up and soil appears to have built up in front of the wells putting the access at ground level. The wells are not marked on any historic map sources but are likely to be associated with the 19th century country mansion house of Plas Alltlywd/Gwyn. A water pipe was apparently laid from the wells to the nearby WWII bunker (PRN 55677) during its time of operation. *Visited 20/02/2006 (PP)*

ESE facing shot of the well showing both the rounded opening and the smaller square opening.

The aim of the management for this site should be continued preservation and maintenance of this interesting garden/orchard feature. The site now lies in woodland with one tree growing on top of the well structure putting pressure on and causing damage to the site, as well as the potential for further damage should the tree collapse. Water still stands within the wells and flows out in front but silt has also built up in both these areas.

- The farmer has already expressed a desire to remove the tree growing over the well, care should be taken to avoid damage to the remains of the well when this is undertaken.
- The farmer has also expressed a desire to remove some of the build up of silt from in front of the well. The true structure of the well is not known but it appears likely the original ground surface may have been slightly lower than at present. Care should be taken whilst removing

any later build up to ensure the masonry of the well is not damaged, any features currently hidden in the build up are not disturbed and the clearance does not go below the original ground level.

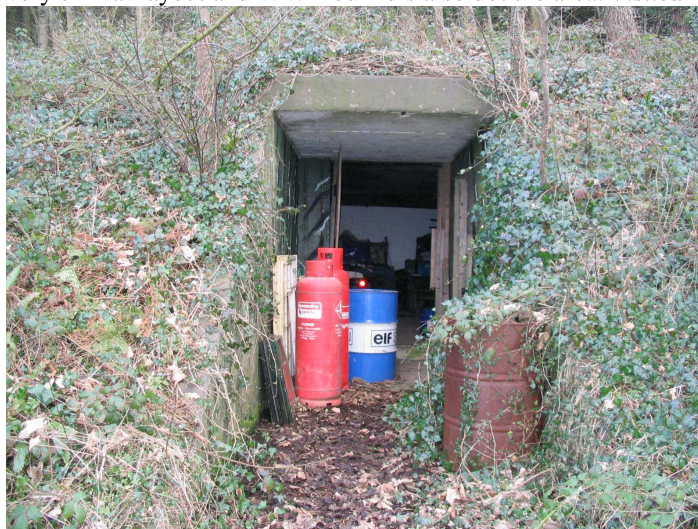
SSE facing shot of the main entrance to the main operations bunker.

The development of radar shortly before WWII was a major technological breakthrough which makes well preserved remains of wartime radar complexes such as this important to preserve and maintain. Although the radar mast itself has gone the main operations bunker and Nissan hut accommodation block are still remarkably well preserved. Both buildings are now used for storage, climbing vegetation has established itself on the Nissan hut which may be causing damage on what was essentially only meant to be temporary wartime structure. The tumbled remains of an associated building are also just about still visible but greatly obscured by a covering of scrub and trees.

- Climbing vegetation should be trimmed back from the Nissan hut. The vegetation should only be removed where this is possible to do without causing damage or threatening the integrity of the underlying structure.
- Scrub should be cleared from around the ruined associated building to improve its visibility and establish any further threats to the site that may be caused by surrounding trees.

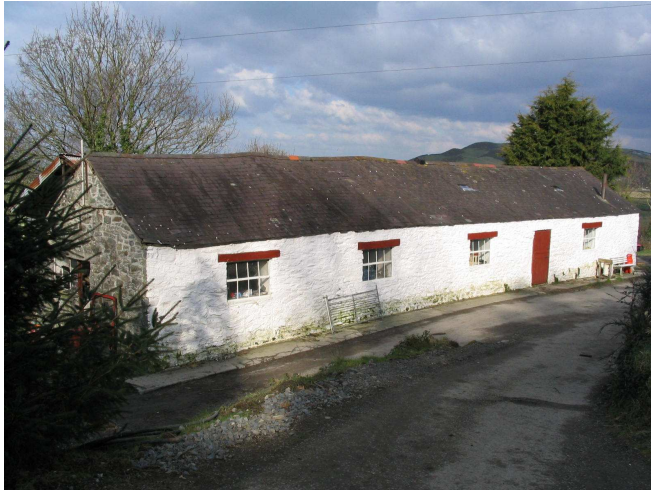
The farmstead complex is still occupied, with many areas in domestic use or used as storage/workshop buildings. The buildings are generally in a good and stable condition, although a bulge was noted in the rear wall of the L-shaped range. *Visited 20/02/2006 (PP)*

N facing shot of the L-shaped farm building range.

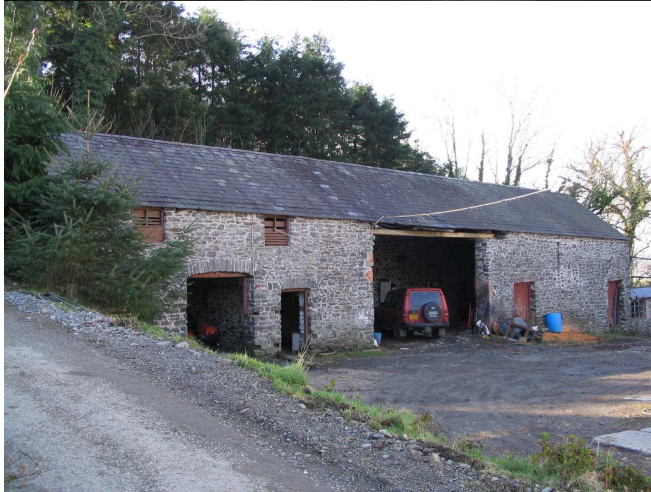
W facing shot of the large barn at the western end of Alltlwyd farmstead.

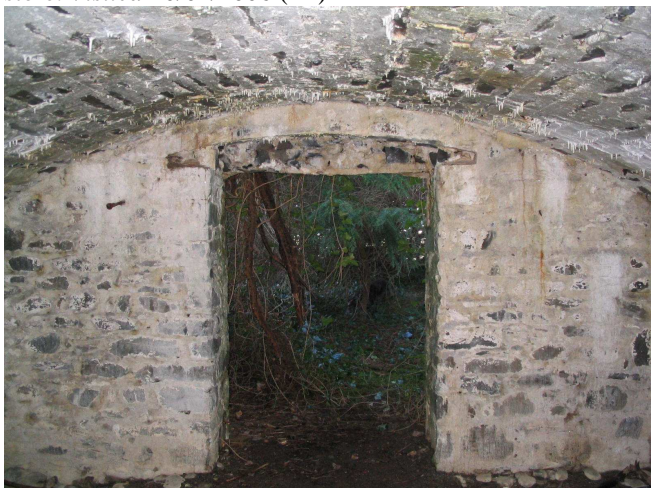
An unusual subterranean building lying within the former orchard (PRN 50729) associated with Plas Alltlwyd/Gwyn (PRN 7032). The building is built into the hillside, the entrance leads into the single room at a level from the north. Built of mortared rubble, measuring 4.9m long and 4.7m wide with a curved ceiling, 2.3m high at its highest point. The floor appears to be of earth with numerous smooth sea-washed white pebbles strewn over the floor. The walls are featureless apart from a single iron pin driven into the wall next to the door. The walls are 0.6m thick at the doorway, the door has now gone. The building is not marked on any historic map source but it seems likely it was associated with the 19th century country mansion house of Plas Alltlwyd/Gwyn. It may have been associated with the orchard in which it lay, possibly used as a fruit store. *Visited 20/02/2006 (PP)*

NNW facing shot looking out of the entranceway.

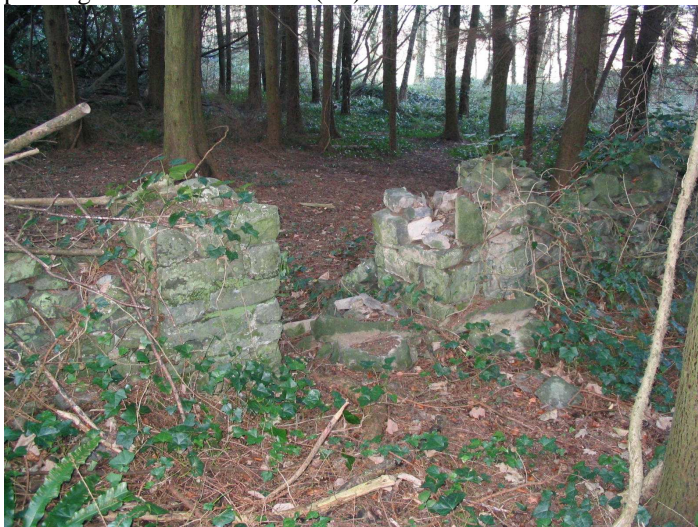
WNW facing shot of the entranceway to the former orchard, looking into what would have been the orchard behind.
