TIR GOFAL MANAGEMENT PLAN: HERITAGE MANAGEMENT INFORMATION HE2

Prepared for:
Pengau
W/12/4437

Report No. **2004/92**
Project No. **50530**

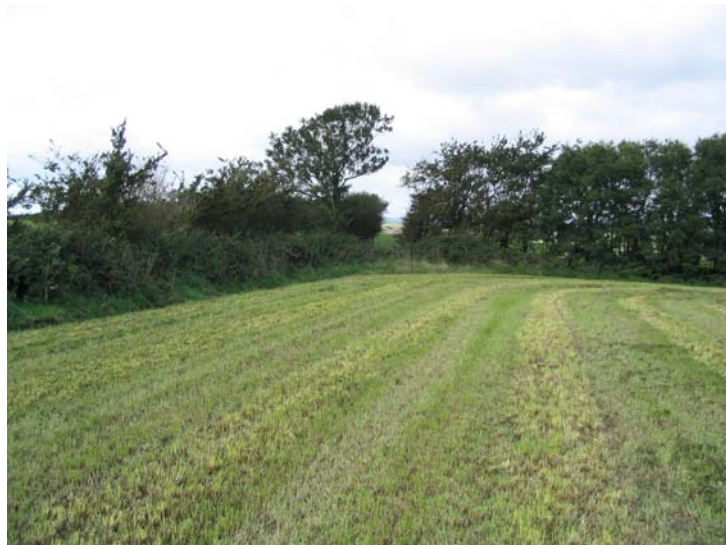
Name (& PRN)	Period/Site type	NGR	Status	SAM/listing	Management required
BREACH (<u>22845</u>)	Post Medieval cottage	SN36850795	B		Generic
A cottage shown on the Ordnance Survey Old Series map (1831) and parish tithe map (1840) but absent from later maps, presumably abandoned. The site is obscured from view by impenetrable scrub. It is not known what survives of the cottage today.					
TRALLWYN (<u>22846</u>)	Post Medieval cottage	SN36900860	B		Generic
Trallwyn cottage appears on the Ordnance Survey Old Series map (1831), and is also shown on the parish tithe map (1840). It is shown in outline on the 1st edition Ordnance Survey map (1890) and was presumably abandoned by that time. The site was under improved pasture at the time of the archaeological farm visit. No surface traces of the cottage survive today

The site of Trallwyn cottage.

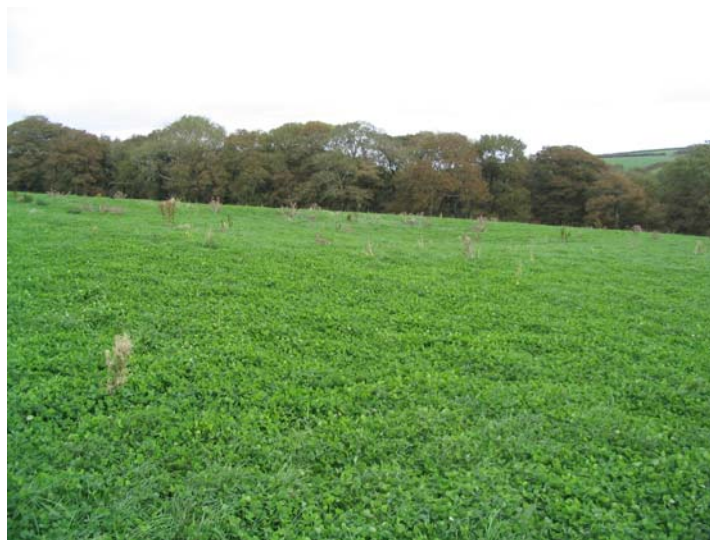
(51284) **Post Medieval** **SN37440803** **C** **Generic**
quarry

Marked on the 1st and 2nd edition Ordnance Survey maps (1890, 1906). The quarry consists of a shallow sub-oval depression (c.20m diameter by 1m deep). The edges are denuded by ploughing.

View of the quarry from the south.

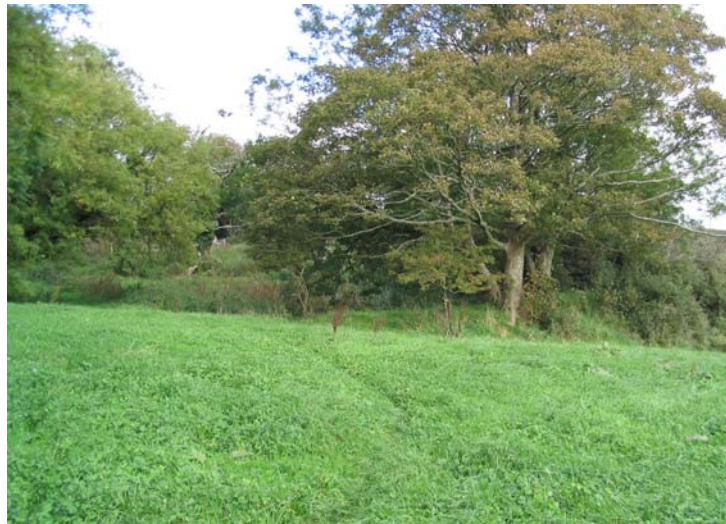
PENGAU (52041)

This pond to the east of Pengau mansion (PRN 20938), which first appears on the Ordnance Surveyors Drawings (1811-12) is now all but dried up. Built in to a shallow slope, it is retained by a curved earth dam wall c. 30m diameter. The pond is overgrown with scrubby vegetation and mature trees on the dam wall.

The pond is now heavily overgrown.

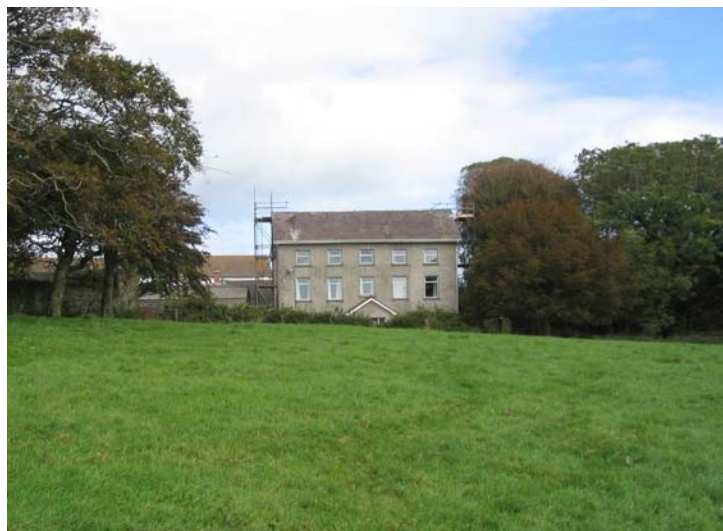
Name (& PRN)	Period/Site type	NGR	Status	SAM/listing	Management required
PENGAY;PENGAY (20938)	Post Medieval mansion	SN37450850	B		Generic
<p>An early Georgian mansion with impressive views across the Taf, Towy, Gwendraeth estuary to the shores of Devon beyond. Pengau is described by Francis Jones as "a commodius 18th century house of three storeys, with a range of five windows on each floor" (1987, 148). The house has remained substantially unaltered since at least the early nineteenth century (the plan is similar to that shown on the O.S. Original Surveyors Drawings 1811-12), but has not escaped modernisation. A cement render obscures original detail including a date-stone with the inscription "M.M. 1725." Modern windows have also been inserted.</p> <p>Associated with the mansion is an impressive complex of farm buildings (PRN 51280), a walled garden (PRN 52040) and several ponds (PRN 52041, 52042, 52043). Among the occupiers of Pengau was the notable - Bevan esq who was credited with pioneering the Norfolk and other improved systems of agriculture in the early nineteenth century (Lewis 1833).</p>

The early Georgian mansion at Pengau.

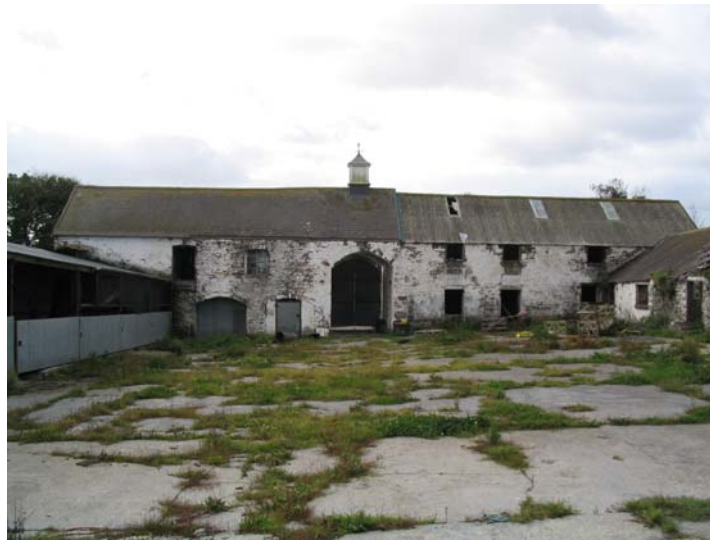
PENGAY; PENGAY (51280)	Post Medieval farmstead	SN37370851	B	Generic
---	--	-------------------	----------	----------------

To the north of Pengau mansion (PRN 20938), across the road is a large courtyard surrounded by some fine farm buildings. The buildings have suffered from neglect in recent years but retain their historic character.

They are stone built, with slate roofs and show considerable expense in their design. In the centre of the long south range, a lofted double cartshed and stables, is an arched gateway with bell tower above. The bell fell in recent years but has been kept. A casting gives the date 1760. Opposite is an impressive barn and lofted cartshed with double threshing floors and high arched doorways, originally with slate canopies. Both buildings feature king post roof trusses. Long low buildings flank either side of the courtyard but are only partially intact. Insufficient detail survives to interpret function but they probably served as accommodation for livestock; either cow sheds or stables.

The buildings are now derelict and falling into disrepair.

Buildings on the south side of the courtyard at Pengau.

1. Those traditional buildings in a weatherproof and a structurally sound condition must be maintained in a weatherproof condition.
2. Those traditional buildings or parts of traditional buildings that have not been previously modified must be maintained using traditional materials and methods of construction.

3. Characteristics and features which reflect history and function of the traditional buildings identified in this agreement must not be removed.
4. Wherever practicable, repair original features rather than replace them. (Capital Works Option)

5. Repairs should be unobtrusive and make use of appropriate traditional materials and methods of construction. (Capital Works Option)
6. When repair is not possible, replacement features must be modelled on the originals, using the same materials and methods of construction. (Capital Works Option)

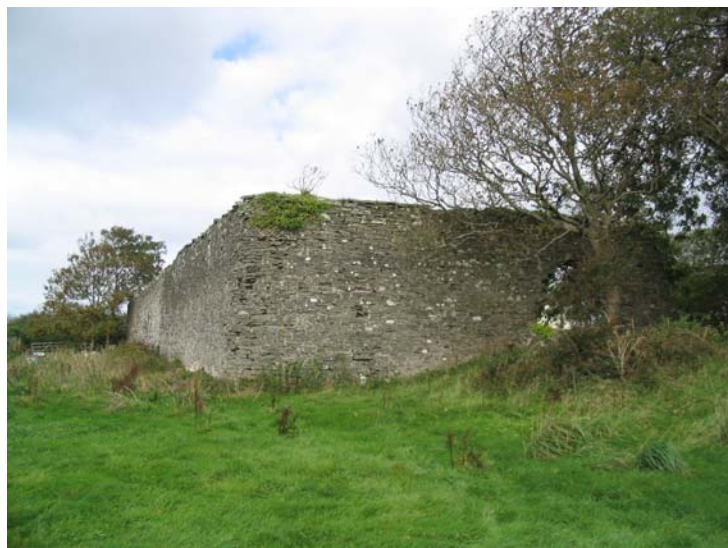
An impressive walled garden to the south-west of Pengau mansion (PRN 20938). The garden is roughly rectangular, aligned northeast-southwest enclosing an area of about half an acre. The perimeter walls average about 3m but reach over 5m on the south- east side. Outside the garden to the east are the grown out remains of a shelter belt, whilst a trackway skirts around the north and west sides. Doorways are in north-east and north-west walls.

The garden first appears on the Ordnance Survey Original Surveyors drawings (1811) but it is tempting to suggest that it may be contemporary with the house or soon after. In 1890 (1st edition Ordnance Survey map) it is shown formally laid out with regular beds to the north and an orchard to the south. A narrow building shown abutting the south wall no longer survives. The garden fell out of use long ago and was put down to pasture. No visible traces of the orchard or beds survive. The perimeter wall is intact and stable, but masked by ivy in areas and breached by a substantial hole (3m diameter) in the south-east corner. The edges of the hole are exposed and unstable. Displaced masonry is scattered about the ground surface below where it has fallen. Some young trees are established in the wall tops.

The south-east corner of the garden wall stands to over 5m.

The aim is to slow down decay of the garden walls and enhance visibility.

1. Cut back ivy growth on the walls leaving the roots in situ. This will reduce weight on the walls by excessive vegetation growth.
2. Young trees growing on/ within the walls to be cut off at the roots and spot treated to prevent re-growth. This will prevent displacement of masonry by uprooting or collapse.
3. Mature trees growing near to the walls to be monitored. Unstable specimens to be cut off at the roots before being allowed to fall naturally. This will prevent damage by trees/ branches collapsing on to the walls.

1. Ivy to be cut off at the roots, spot treated to prevent re-growth and allowed to die back. Roots to be carefully removed taking care not to displace masonry. Follow up with a programme of masonry consolidation and re-pointing using a traditional lime mortar mix.
2. Consolidate unstable masonry around the hole in the south-east corner of the wall using a traditional lime mortar mix.
