TIR GOFAL MANAGEMENT PLAN: HERITAGE MANAGEMENT INFORMATION (HE2)

Parkland associated with the gentry farm of Y Fron.

**Prepared for:
Y Fron Farm
Tir Gofal Reference No W/12/4465
ACA Report No. 2004/105
Project Record No. 50536**

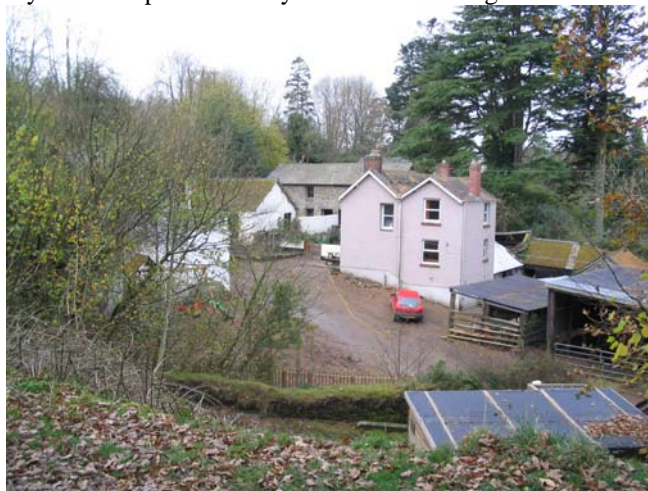
Y Fron Farmstead from the east

Y Fron farmstead is in separate ownership from the adjacent mansion, and consists of a farmhouse which appears in part to formerly have been a farm building, a barn (PRN 53151), a stable/cart shed (PRN 53149), a combination farm building (PRN 53150), a number of outbuildings (PRN 53152) and a former stable/cart shed and later cow sheds (PRN 53153). The farmstead makes for an interesting complex of buildings, not all built at the same time which demonstrates different phases of investment in the farm. The majority of the farm buildings appear to be in a reasonable state of repair, the main areas of concern lie with the cow shed (PRN 52153) where the roof is in danger of failing, please see specific management recommendations for this building.

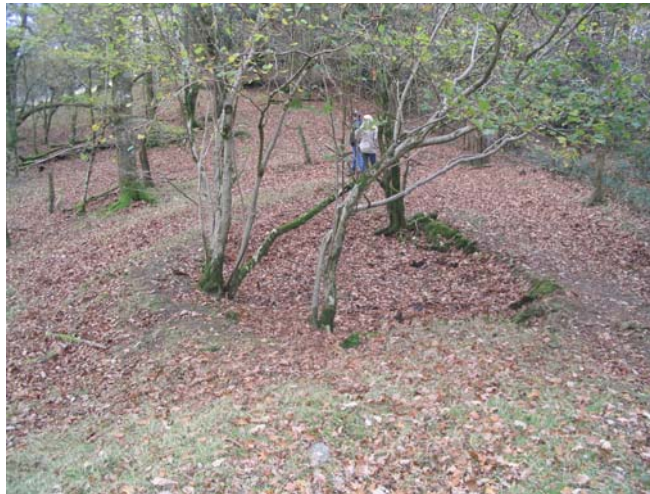
(53147) **Post Medieval pit SN7806533007 C Generic**

A small D-shaped depression, approximately 4.5 metres at its widest and no more than 0.5 metres deep. The pit lies within woodland at present. It is unknown what its origins are, perhaps a quarry pit or possible charcoal burner's platform

A small D-shaped pit within woodland on the ridge behind Y Fron Farm

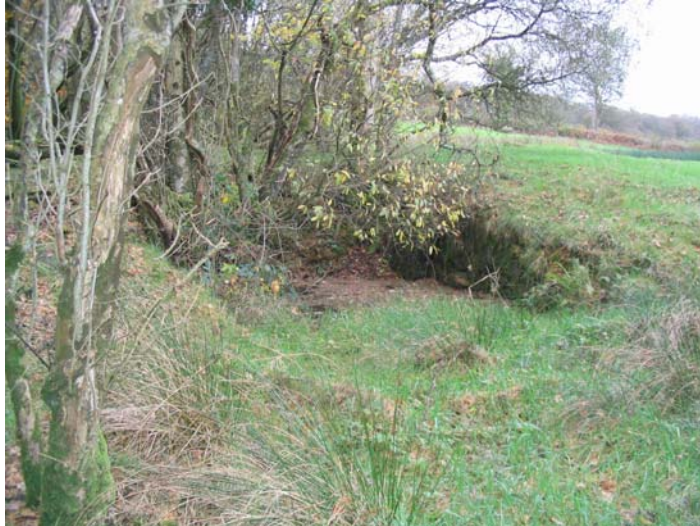
(53148)

A small run in adit or level lies adjacent to the boundary with Allt Rhydings where a mining complex has been recorded (PRN 20570). It has parallel vertical sides and a possible tip to the northwest side where the level runs out and standing water in its base. Some young trees are now growing within it.

A small adit or level lies to the west of the mining complex within Allt Rhydings

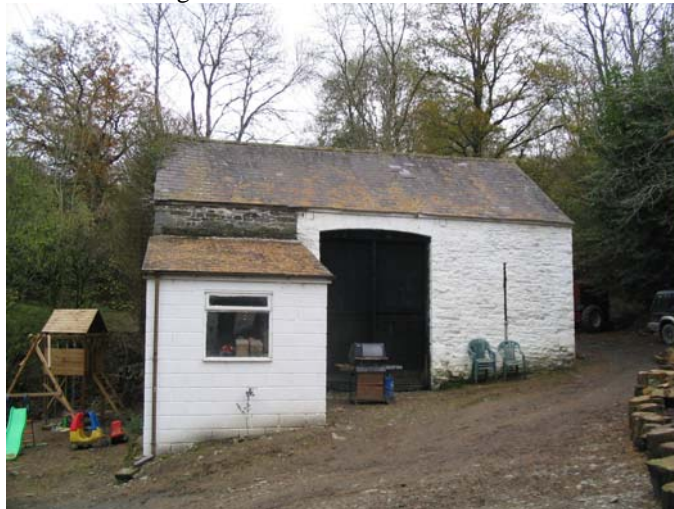
Name (& PRN)	Period/Site type	NGR	Status SAM/listing	Management required
1	FRON (<u>53151</u>)	Post Medieval barn	SN7788033238	B	Specific

A large barn which survives unaltered and intact. It has a central opposing doorways flanked by ventilation slits. Internally it is open to the roof, but has a low wooden partition at the north end, a small entrance (a hog hole?) in the east side. A breeze block lean-to has been added to the west side, but other than that there appears little modern intervention. The building retains its original double doors in a good state of repair. The roof is slated on the west side and corrugated iron on the east. The 1st edition OS map indicates the location of a horse engine, a power supply for crop processing, on the east side of the barn, although the location is now obscured by a metal open sided hay barn.

The slates are reasonably intact although there are couple which have recently become loose and displaced. Ivy is also established on the northern gable end.

A fine largely intact barn at Y Fron Farmstead

The slates should be replaced and roof made sound and weatherproof, before any damage from water ingress ensues. Also the ivy should be cut at roof level, and spot treated to prevent regrowth if necessary

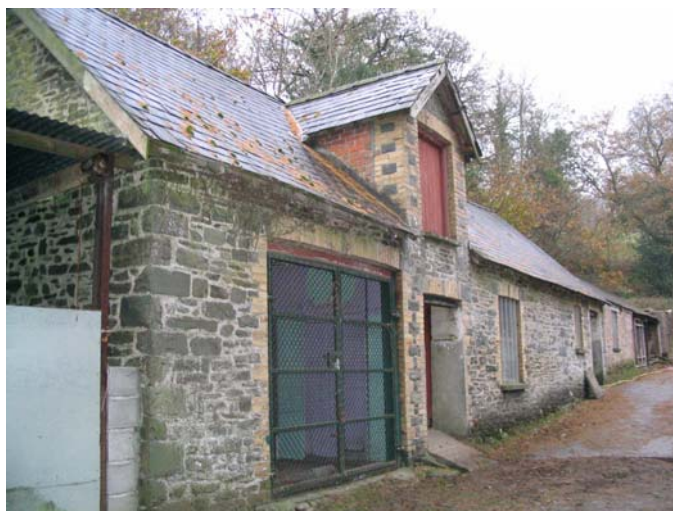
2 **FRON (53153)** **Post Medieval cow shed** **SN7788633278 B** **Specific**

A stone and brick built range of cow sheds lie to the northeast of the farmstead. These appear to be later additions to the farmstead, although they are recorded on the 1st edition OS map of 1886. They consist of two distinct phases, although further modifications are also traceable; at the north end, a former stable/cart shed, used latterly as a cow shed, constructed in stone with yellow brick dressings and roof dormer opening, and to the southeast is a mostly brick built cow shed. The style of building of these two elements is different from the other buildings in the farmstead, and the widespread use of brick suggests a later date from the other farm buildings. The buildings have retained slate roofing, but the former stable/cart shed has corrugated iron on the east side. Notably the southern section of the building has the 'Tor Brat' style of slating, where the slates have a gap between them in each course. These buildings appear to be in the most perilous condition of all in the farmstead, a truss is missing from the roof of the cow shed and consequently the roof is bowing.

A former cart shed and stable with an attached cow shed lie to the northeast of the farmstead

The owners have expressed a desire to see these buildings repaired. This would be a worthwhile undertaking since the roofs need attention to prevent further damage and potentially collapse. As with all conservation and repair of historic buildings, elements of the roof should be repaired rather than replaced wherever possible and the distinctive slating style should be replicated on the cow shed roof.

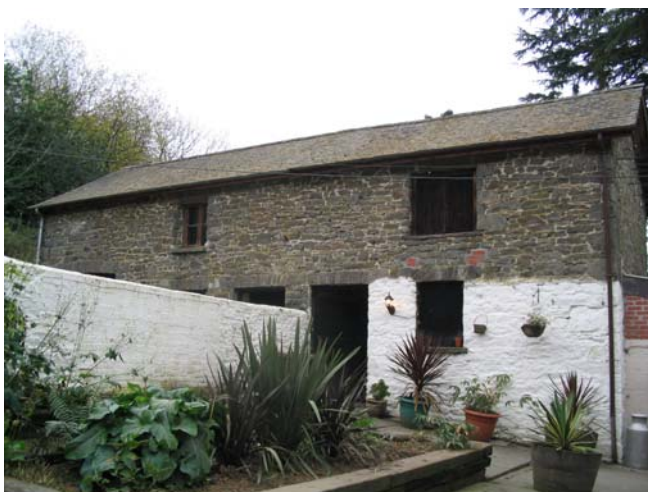
FRON (53149) **Post Medieval stable; cart shed** **SN7784633240 B** **Generic**

A single range incorporating a stable at the north end and a cart shed at the south end (southern end is owned by the adjacent property Y Fron House). The stable is well constructed in stone work, but with fine stone voussoirs over the openings. It is also fortunate that the original wooden shutters and doors survive at the stable end. The stable is lofted and some of the stall work survives on the ground floor.

A finely constructed stable and cart shed are now in divided ownership between Y Fron Farm and Y Fron Mansion

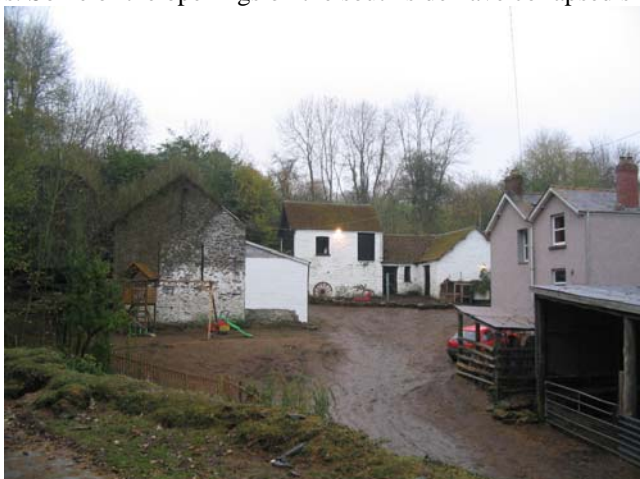
FRON (53150)

A range of buildings including a cart shed and granary and cow shed. This building may be the earliest surviving building in the farmstead, and is certainly unusual with evidence of different phases of development. The west end is one storey, unusually it is L-shaped in plan and appears to have been animal accommodation. To the east is a 2 storey cart shed which appears to be a later addition. Fortunately many of the original fixtures and fittings survive in this building, including plank doors and shutters. Another point of interest is the survival of patches of yellow ochre limewash on the south of the building. The building is in a fair condition by and large, although the roof has become very mossy it is intact and covered by asbestos tiles. Some of the openings on the south side have collapsed sills.

In the centre of the photograph is the unusual L-shaped combination farm building at Y Fron, possibly the earliest building in the complex

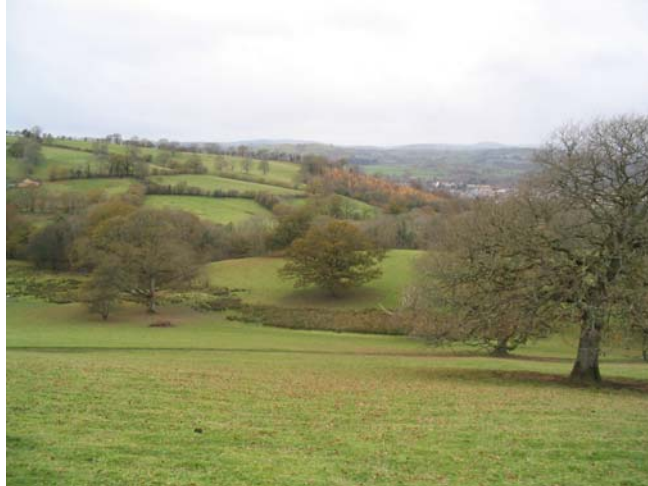
3	<u>(51367)</u>	Post Medieval park	SN77793341	B	Specific
---	----------------	--------------------	------------	---	----------

The 1st edition Ordnance Survey map of 1886 shows trees within this area that are reminiscent of planting as part of a designed parkland landscape, all within the main view from the mansion house. The parkland landscape is still in evidence today (2004), many of the oaks shown on the 1st edition map survive in the parkland, particularly those which lie in the fields immediately to the north and northwest of the house. There has been some loss of the specimen trees which lay in the furthest northern extent of the parkland. Some coniferous specimens survive to the east of the site of the hay barn (PRN 51366).

The parkland landscape at Y Fron is one of the most striking aspects of the farm holding.

It is suggested that some tree planting is undertaken in order to replace those specimen trees which have been lost, or those which are dying. The tree species should follow the existing profile of trees represented in the park which is predominantly oak. The replacement trees should be carefully located in positions as close as possible to those represented on the 1st edition OS map, a copy of which is enclosed.
