# **ST MARY'S CHURCH, TENBY, PEMBROKESHIRE**

**ARCHAEOLOGICAL WATCHING BRIEF,  
FEBRUARY 2004**

Report No. 2004/47

REPORT NO. 2004/47  
PROJECT RECORD NO. 50649

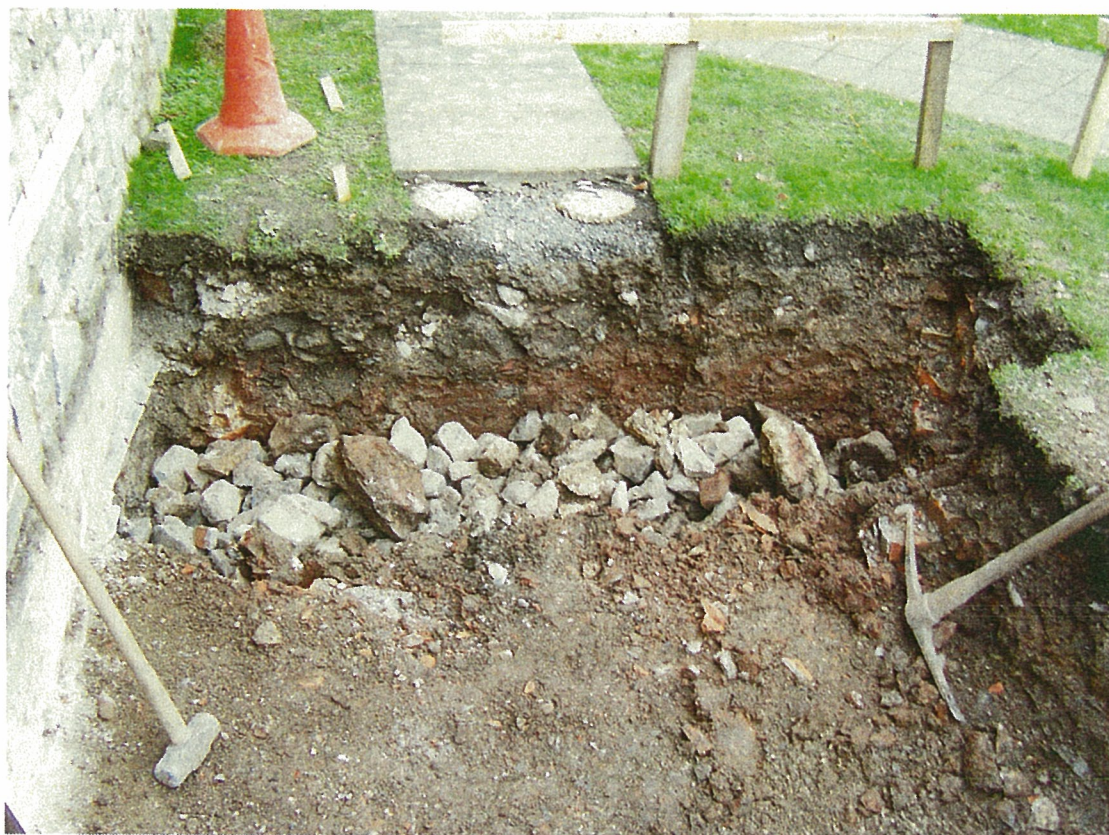
On arrival at the site, a trench measuring 2.30m east-west and 3.50m north-south had already been excavated to a depth of 0.80m. Along the northern edge a deeper trench had been dug and backfilled with rubble (and could not therefore be investigated). This area appeared to have been disturbed previously as traces of red brick ?wall-footings were observed in the upper trench edges.

**Photo 1:** *Looking north, showing the north section, the backfilled trench, and red brick ?footings.*

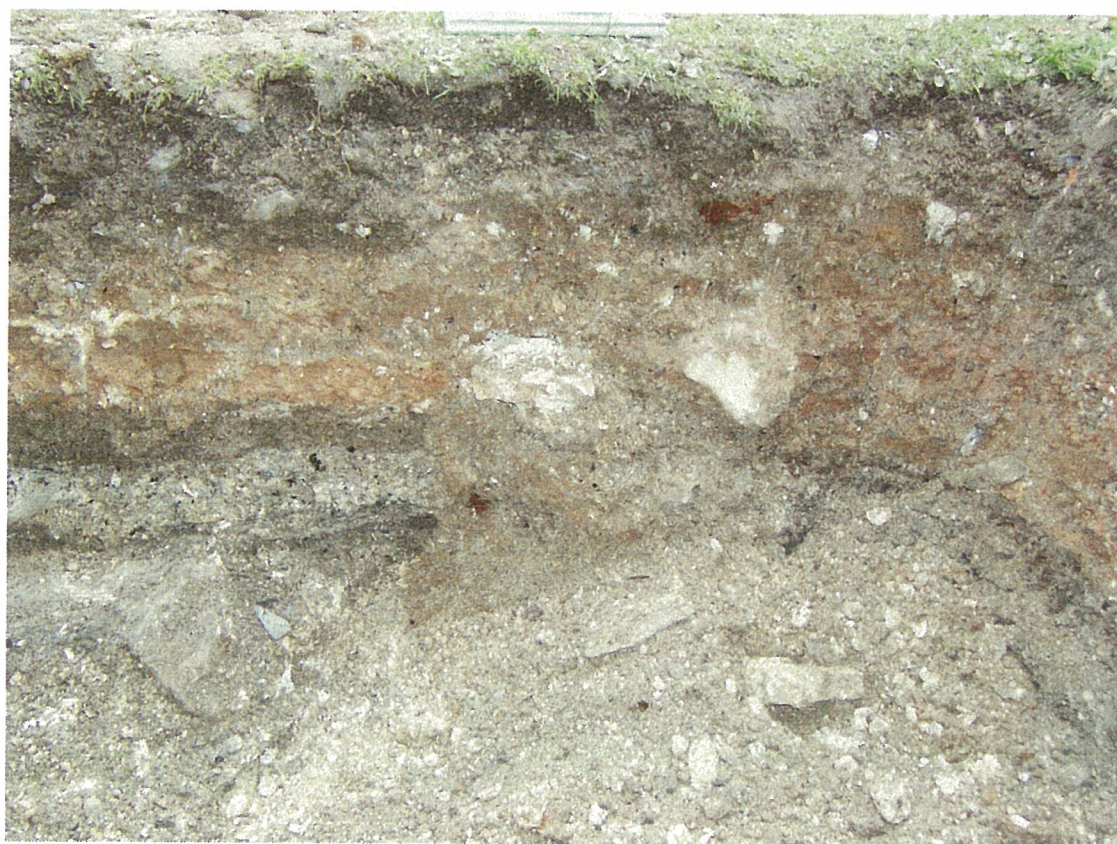
The eastern trench section indicated that a relatively complicated sequence of deposits had been truncated by the digging of the trench. Below 0.20m of topsoil was a layer of reddish brown clay with mortar and stone inclusions. This appeared to seal – and, in the south-east corner, possibly to cut – a series of laminated deposits overlying the mortared rubble foundations. Directly above these rubble foundations was what appeared to be a trampled surface. It could not be ascertained what this surface represented or was related to. The deposits overlying the trampled surface are presumed to be occupation, construction, or demolition deposits. Various finds had been put to one side by the workmen. These included animal bone, some probable human bone, post medieval ceramics and a copper-alloy token.

**Photo 2:** *Detail (looking east) showing sequence of laminated deposits above stone footings (left) and possible pit cut (right).*

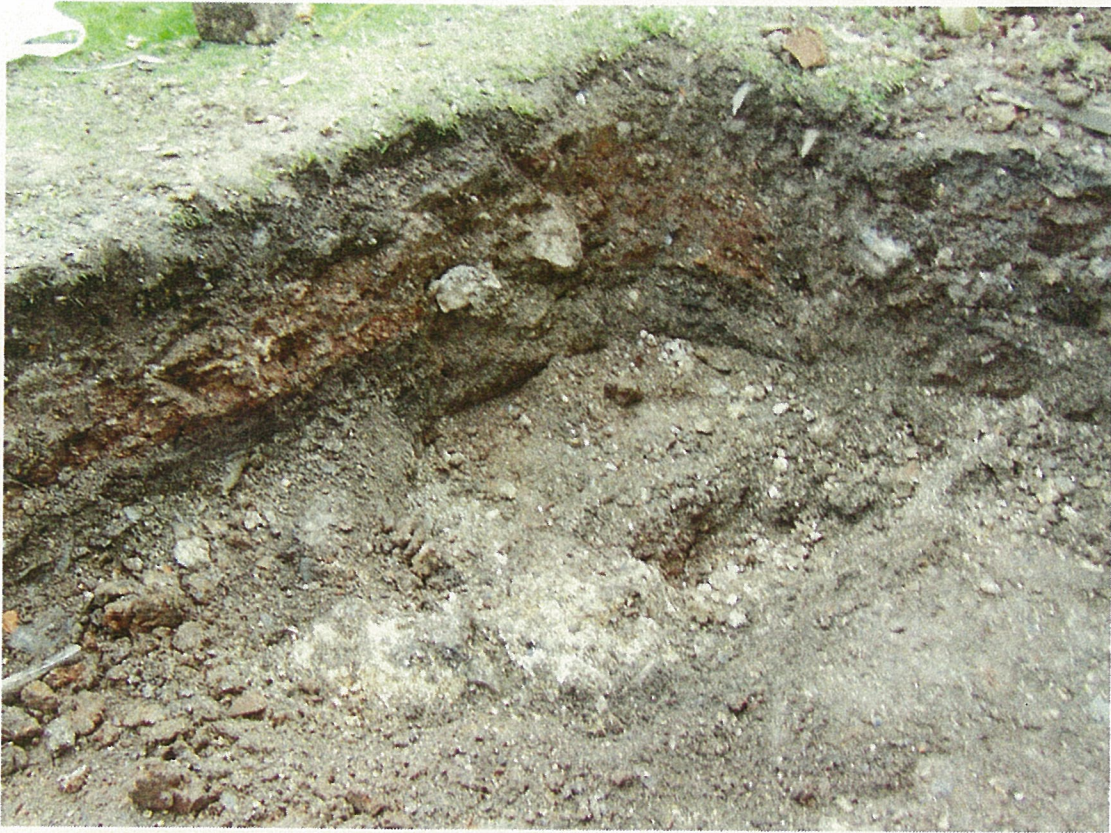
In the southeast corner, mortared rubble wall footings were observed in the bottom of the trench. These did not appear to have been truncated by the current works. The footings appeared to be approximately 1.60m long, aligned in a north-south direction. The west edge of these footings appeared to be intact, while the east side appeared to have been truncated by a probable pit. Slate fragments, and ceramic sherds (possibly 18<sup>th</sup> - 19<sup>th</sup> century?) were observed within the fill of this pit. The northern edge of the mortared rubble footings may also have been a true edge, but this was not ascertained with any certainty.

**Photo 3:** *South east corner of the trench showing partly exposed mortared footings in base of trench.*
