ABERPORTH AIRFIELD, BLAENANNERCH, CEREDIGION

AN ARCHAEOLOGICAL DESK-BASED SURVEY

REPORT NO. 2004/63
PROJECT RECORD NO. 50862

Aberporth Airfield,
Blaenannerch, Ceredigion
An archaeological desk-top survey

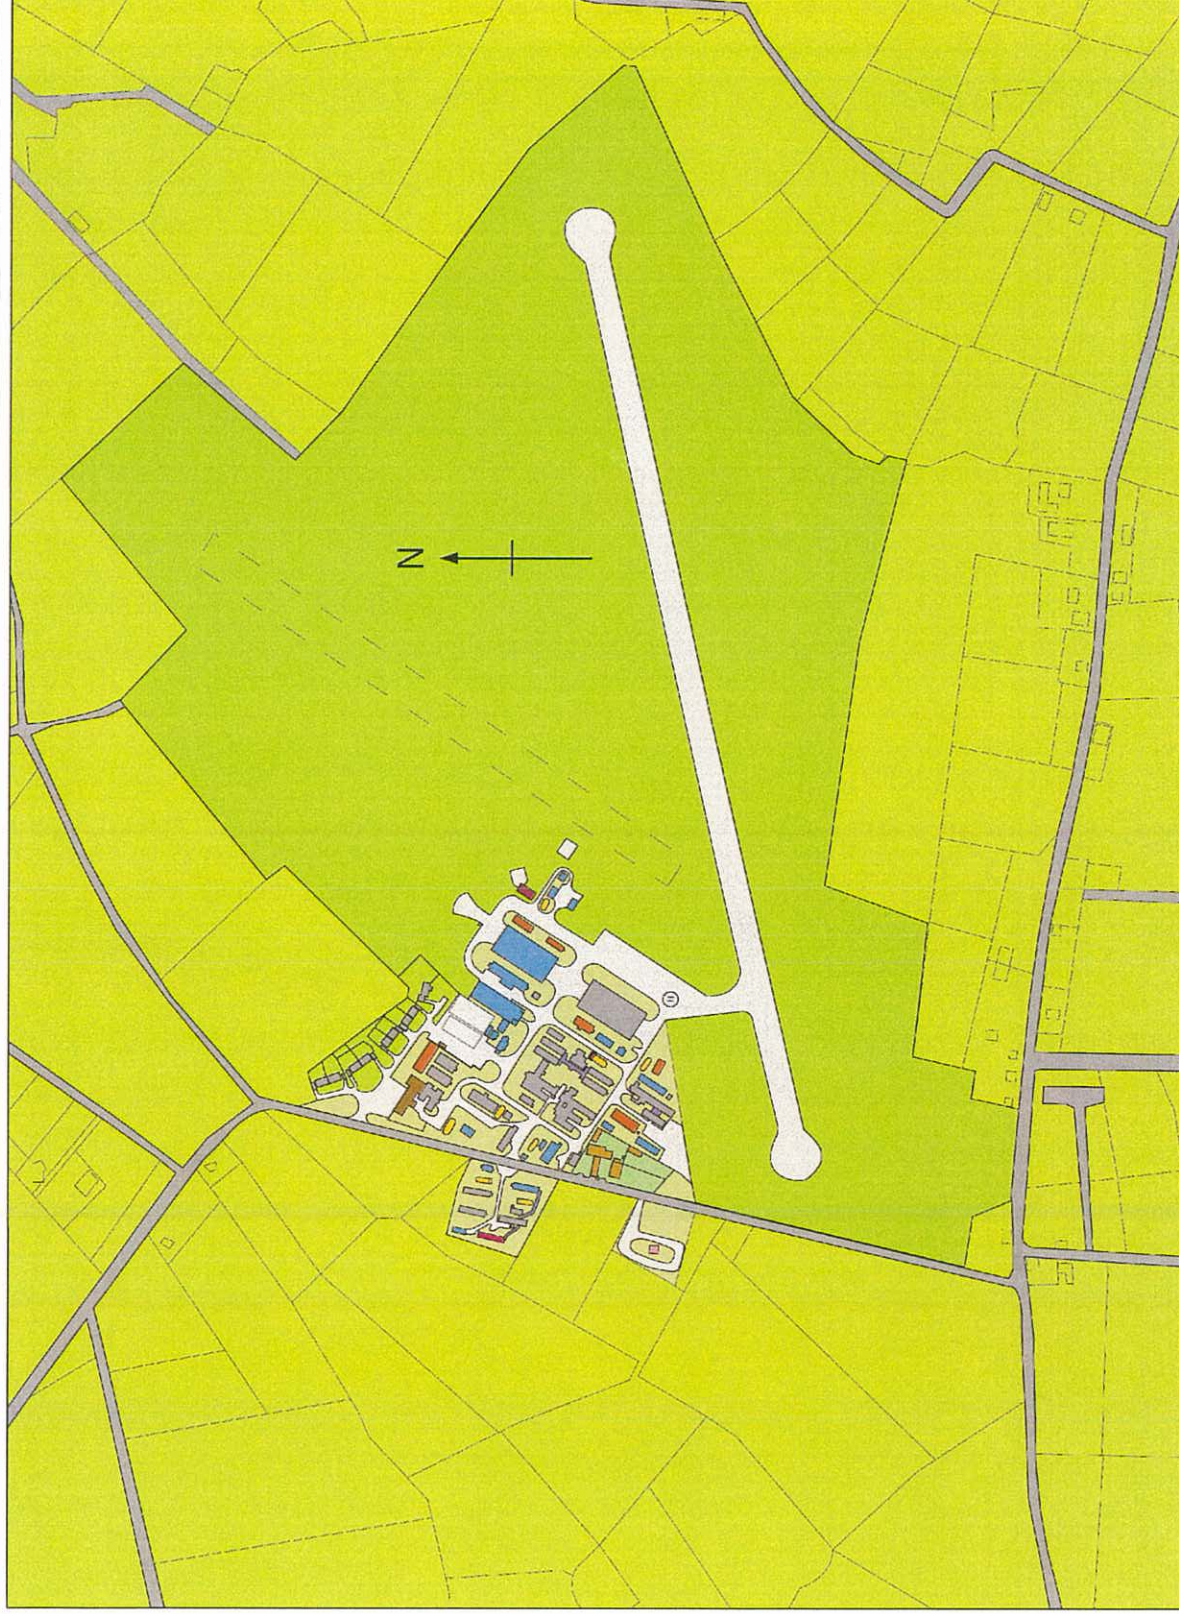
Figure 2: Plan of Aberporth Airfield circa 1977 before demolition of buildings

The perimeter of the airfield as represented on the 1977 OS map, is little altered from the 1948 map, except for the encroachment of agricultural fields on the north and south edges of the airfield, which have effectively isolated pillboxes PRNs 50931 and 50933 from the rest of the site.

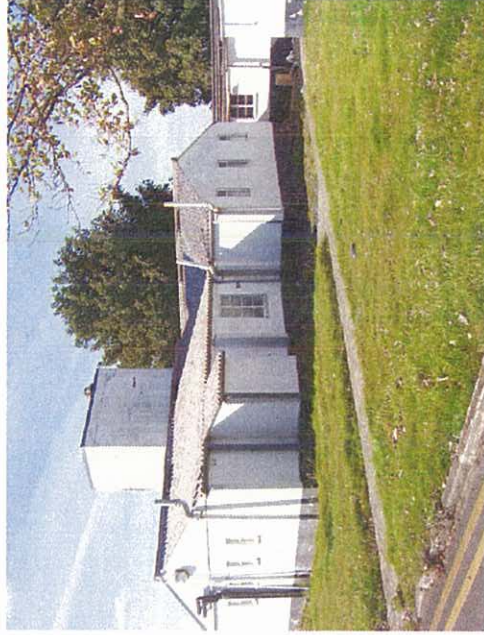
Description: Previously identified as Building 16. Airmen's Ablution building A single storey building of brick construction with concrete rendered sides, a pitched roof with asbestos cement corrugated sheets, steel roof trusses and steel frame windows. With water tower and flat roofed boiler room. The footprint of this building is represented differently on the 1948 edition OS map and may have been replaced or extended. Internally, red tiled floor throughout. White glazed tiles to height of doorways. Containing toilets, sinks, showers and possibly clothes washing facilities (wooden draining boards).

Photo 1: PRN 50878 from north-east

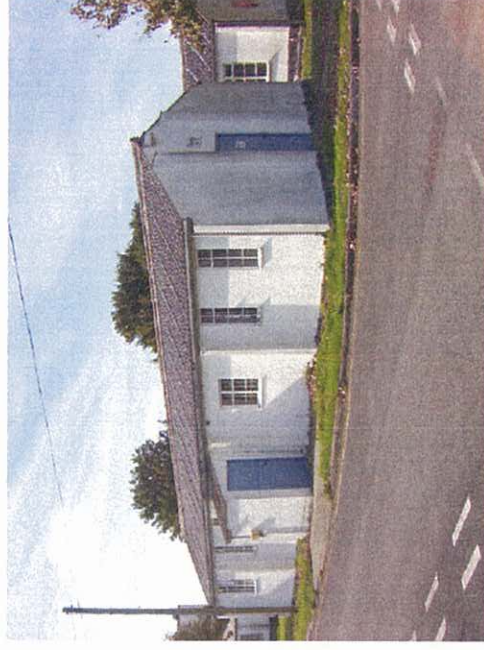
Site Name: Aberporth Airfield
PRN: 50879
NGR: SN24700249500
Site Type: Building
Period: 1940s
Source: OS/ Field visit
Description: Previously identified as Building 17. Sports Store/Radio Club. A single storey building of brick construction with concrete rendered sides, a pitched roof with asbestos cement corrugated sheets, steel roof trusses and steel frame windows. Original function uncertain but more recently a sports store, and for the Aberporth Amateur Radio Club.

Photo 2: PRN 50879 from north-east

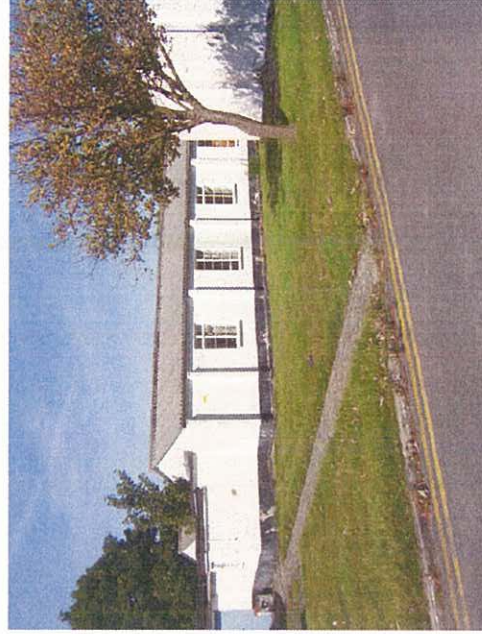
Site Name: Aberporth Airfield
PRN: 50880
NGR: SN2469049510
Site Type: Barracks
Period: 1940s
Source: OS/ Field visit
Description: Previously identified as Building 18. Airmen's Quarters 'Dickson/Edison'. A single storey building of brick construction with concrete rendered sides, a pitched roof with asbestos cement corrugated sheets, steel roof trusses and steel frame windows. PRNs 50880 and 50888 are connected to PRNs 50887 and 50881 by a flat roofed corridor, possibly of later construction, since it is not represented on the 1948 map. The footprint of this building is incorporated into a larger block on the 1948 edition OS map, including PRNs 50879 and 50878.

Photo 3: PRN 50880 from south-east

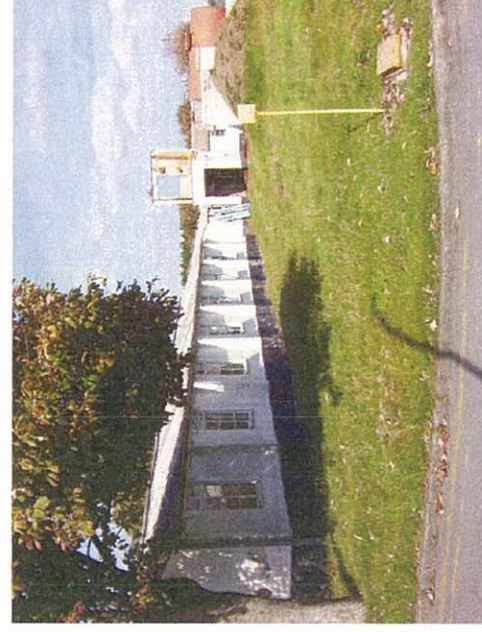
Site Name: Aberporth Airfield
PRN: 50881
NGR: SN2466049460
Site Type: Barracks
Period: 1940s
Source: OS/ Field visit
Description: Previously identified as Building 19. Airmen's Quarters 'Tedder/Whittle'. A single storey building of brick construction with concrete rendered sides, a pitched roof with asbestos cement corrugated sheets, steel roof trusses and steel frame windows. On the 1948 edition OS map this building is represented as a detached block incorporating B25. Buildings PRNs 50880 and 50888 are connected to PRNs 50887 and 50881 by a flat roofed corridor, possibly of later construction, since it is not represented on the 1948 map.

Photo 4: PRN 50881 from south

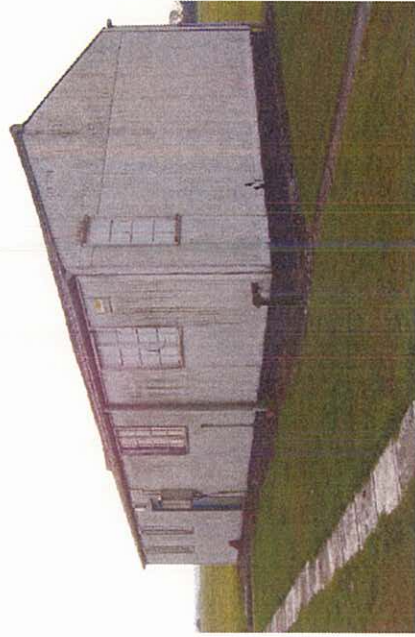
Site Name: Aberporth Airfield
PRN: 50885
NGR: SN2467349410
Site Type: Building
Period: 1940s
Source: OS/ Field visit
Description: Previously identified as Building 23. NAFFI Staff Quarters. A single storey building of brick construction with concrete rendered sides, a pitched roof with asbestos cement corrugated sheets, steel roof trusses and steel frame windows. The north end of the building is a red brick built extension. This building is not represented on the 1948 edition OS map.

Photo 5: PRN 50885 from north-west

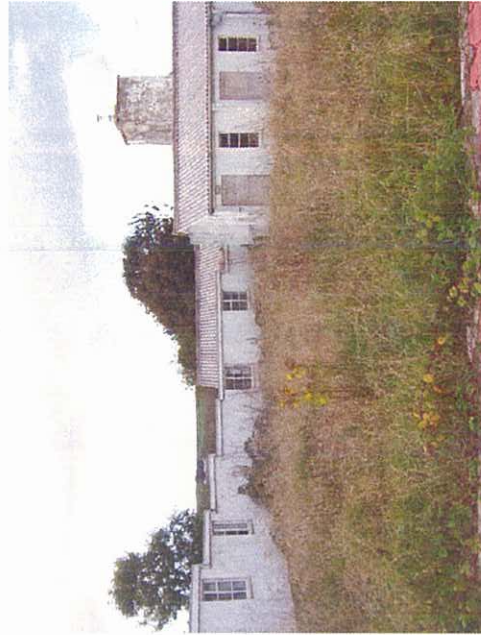
Site Name: Aberporth Airfield
PRN: 50914
NGR: SN2453049530
Site Type: Ablutions block
Period: 1940s
Source: OS/ Field visit
Description: Previously identified as Building 52. Airmen's Ablution 'Drake' A single storey building of brick construction with concrete rendered sides, a pitched roof with asbestos cement corrugated sheets, steel roof trusses and steel frame windows. There is a water tower at the centre of the building. A building represented in this location on the 1948 edition OS map has a different footprint and may have been replaced. The existing building is connected to PRN 50914 and 50910 by corridors which are not represented on the 1948 map. Adjacent PRN50914 is a fuel tank. Internally the building contains numerous wash basins, shower and toilet cubicles.

Photo 23: PRN 50914 etc. from east

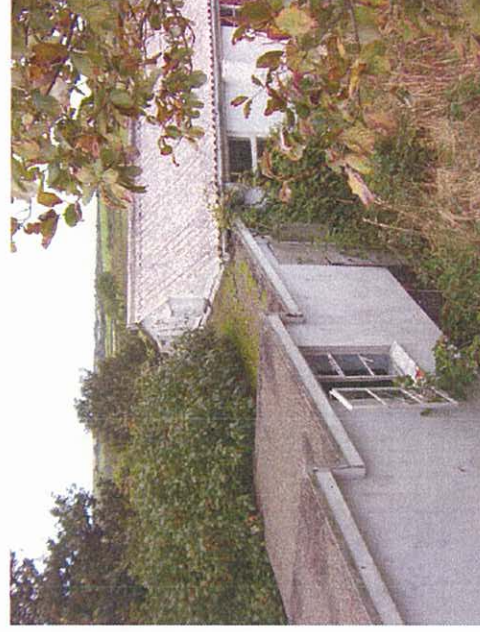
In compound PRN 30592, the only apparent modification is a flat roofed corridor linking together PRNs 50915, 50914 and 50910. In the main compound (PRN 30594), a similar flat roofed corridor appears to have been constructed, linking PRNs 50887, 50881, 50888 and 50880. The purpose of these modifications is not known.

Photo 24: PRN 50915 and corridor from south-east

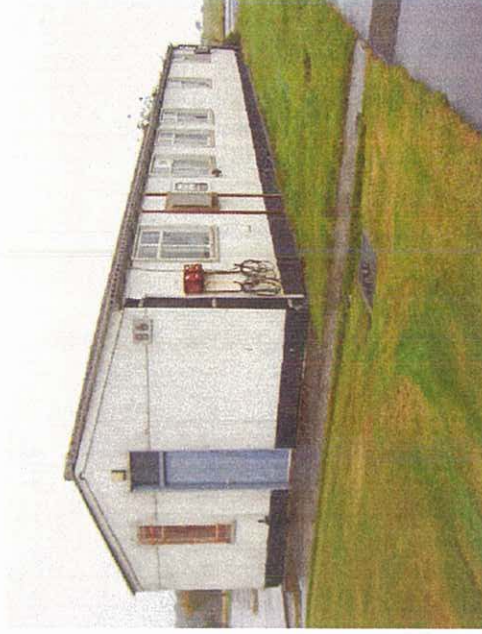
Site Name: Aberporth Airfield
PRN: 50868
NGR: SN2479049540
Site Type: Building
Period: 1940s
Source: OS/ Field visit
Description: Previously identified as Building 6. MT Offices/RAE Fire Brigade Quarters. A single storey building with a pitched roof of asbestos cement corrugated sheets and timber roof trusses. Sides faced with asbestos cement corrugated sheets. Timber frame windows. Brick and timber internal partitions. This building is not represented on the 1948 edition OS map except as part of B2. Not visited.

Photo 25: PRN 50868 from south

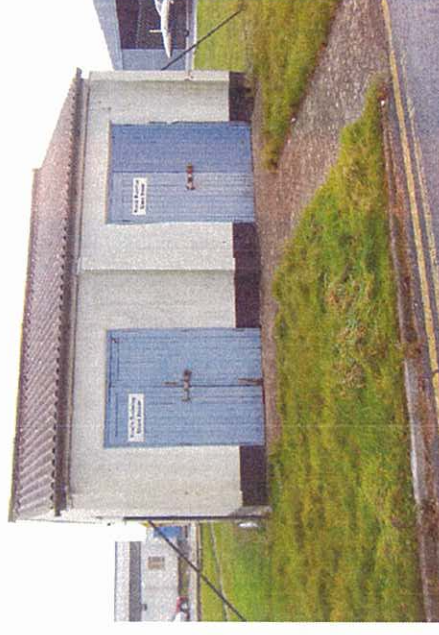
Site Name: Aberporth Airfield
PRN: 50871
NGR: SN2473049520
Site Type: Building
Period: 1940s
Source: OS/ Field visit
Description: Previously identified as Building 9. Paint and Dope Store/Youth Training Store Room. A single storey building of brick construction with concrete rendered sides, a pitched roof with asbestos cement corrugated sheets, steel roof trusses and steel frame windows. Walls constructed of concrete rendered red brick. This building is represented on the 1948 edition OS map. Not visited.

Photo 26: PRN 50871 from north-west
