CARMARTHEN RESURFACING WORK TRIAL TRENCH 2004

RHIF YR ADRODDIAD / REPORT NO. 2004/76
RHIF Y PROSIECT / PROJECT RECORD NO. 51530

CARMARTHEN RESURFACING WORK TRIAL TRENCH 2004
PRN 51530

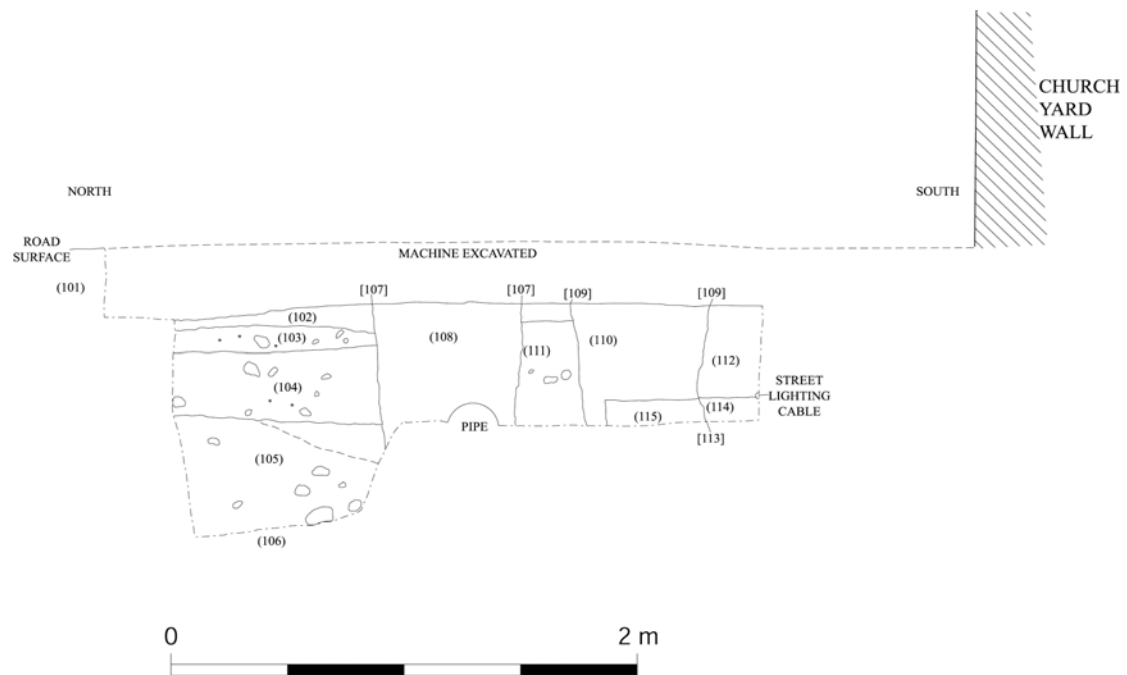
Figure 2: Trial Trench Section

The earliest layer (106)(Figure 2) was pale brownish yellow compact silty clay and probably was redeposited natural. Above this there was a layer (105)(Figure 2 and Photo 1) or similar layers or lenses of dirty sandy gravel, including a patch of soil that was possibly re-deposited turf. Above this was a very clean and compact orange brown slightly sandy silt clay (104) with charcoal flecks in the upper part, which may be the result of root or worm action. Very similar to this layer (104) and possibly the same, was another layer (115) separated by later features. Although all of these layers seem to be very natural in appearance, given the heights of known artificial deposits in the vicinity, observed within St Peter's Church (excavated by the author) and a gas pipe trench (Heather James pers. comm.), they are probably mainly composed of redeposited natural sub-soils. The most likely interpretation is that these are make-up layers for a Roman road, the Roman road surface having either been robbed or truncated by later activity.

The layer (103) above these "Roman road make-up layers" was mid brown clay silt with sub angular stones - possibly make-up for more modern or even the present road surface. Above this (103) there was a mid grey layer (102) with 80% sharp angular stones, which is a sub-base for the current road.

Nearly all of the southern part of the trench encountered modern cuts for services (Figure 2 and Photo 2)(107; 109 and 113) and their fills (108; 110; 111; 112 and 114). Pipes were observed in 108 and 114, and an electricity cable, possibly for street lighting, just in the southern edge of our trench.

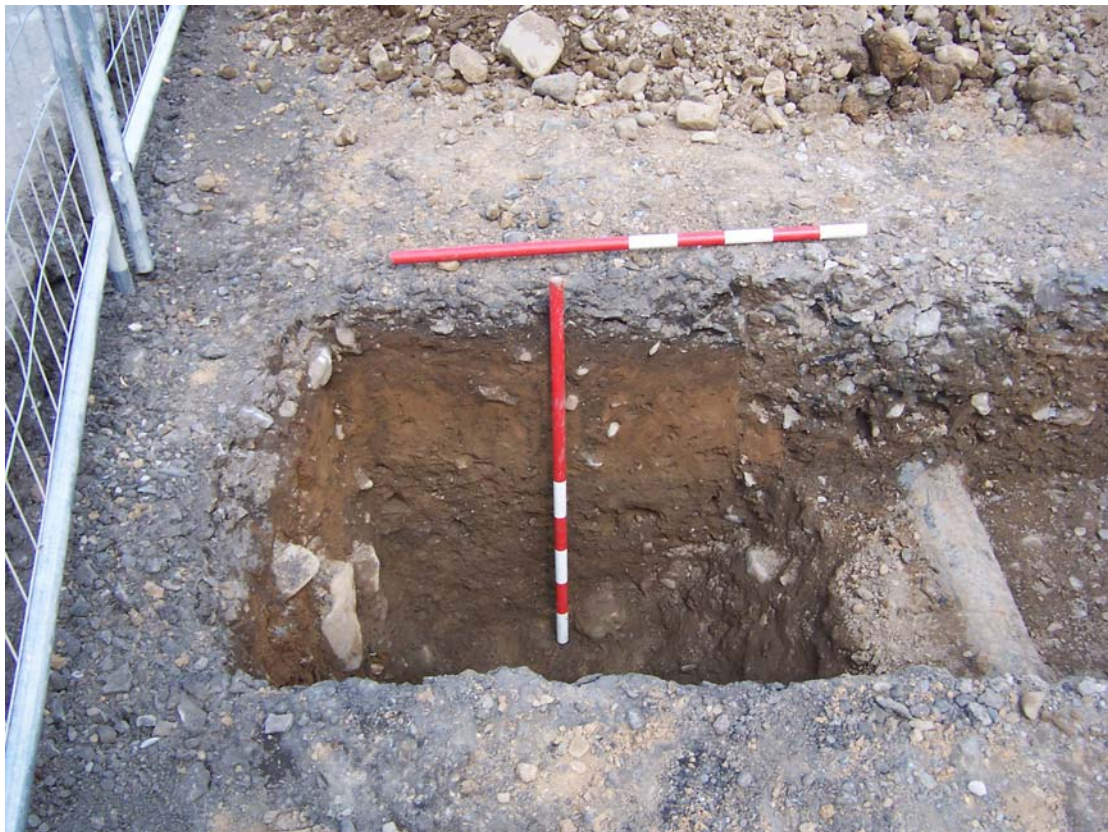
**Photo 1: North end of trial trench with probable Roman road make-up. View E.
Scales 1m**

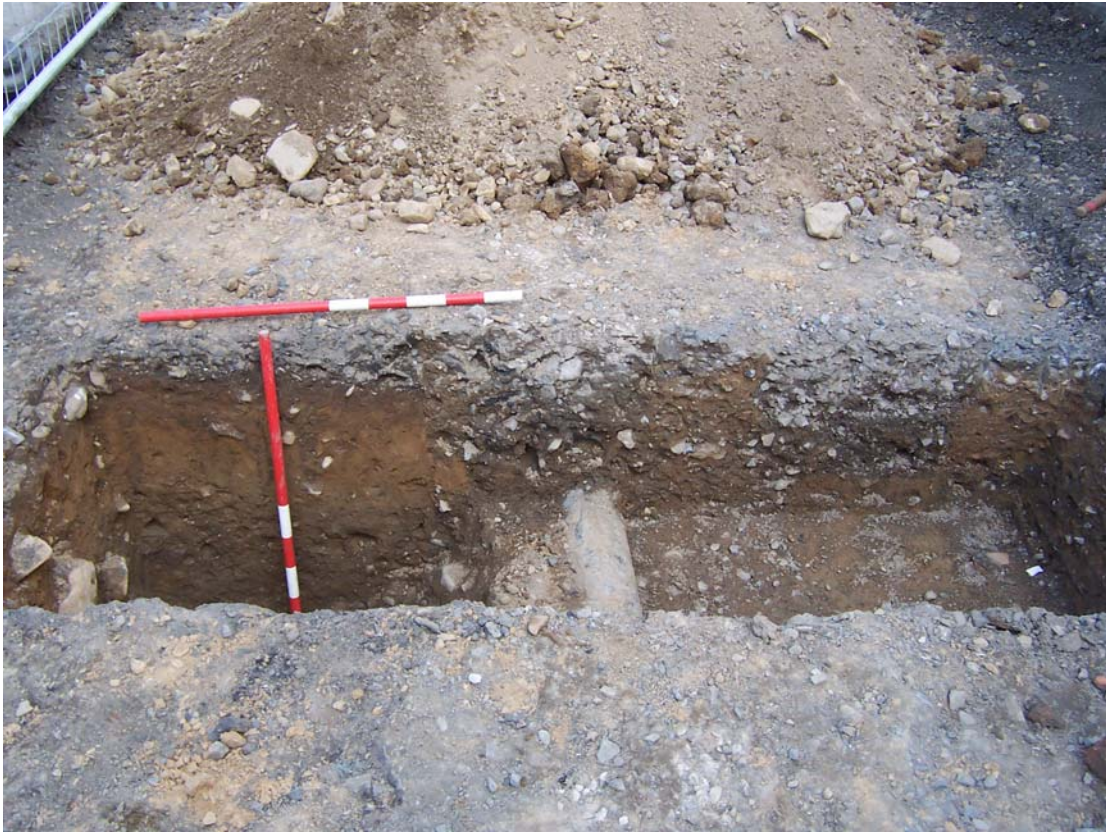
Photo 2: Trial trench with service trench cuts on right side. View E. Scales 1m

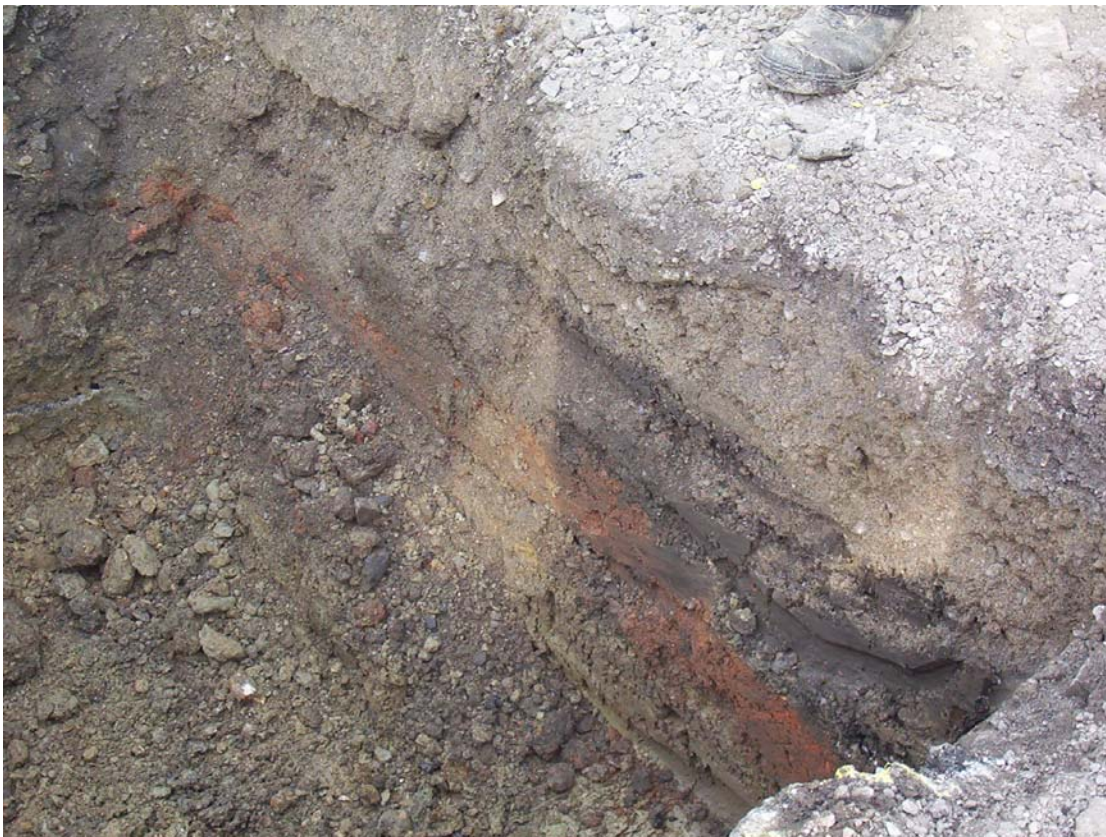
Photo 3: Tree hole, possible road indicated by red layer. © Fraser Gardiner

A call was received on 29th July that a hole excavated for tree planting had encountered the possible remains of a Roman road. Unfortunately the hole had already been lined with concrete before our arrival. The photograph kindly supplied by Fraser Gardener shows a red layer (Photo 3) some 180mm thick and about 600mm below the pavement surface. This layer maybe the remains of a Roman road, but appears to be more like a heat-affected layer, possibly the remains of a workshop. However, without inspection conclusions are speculative.

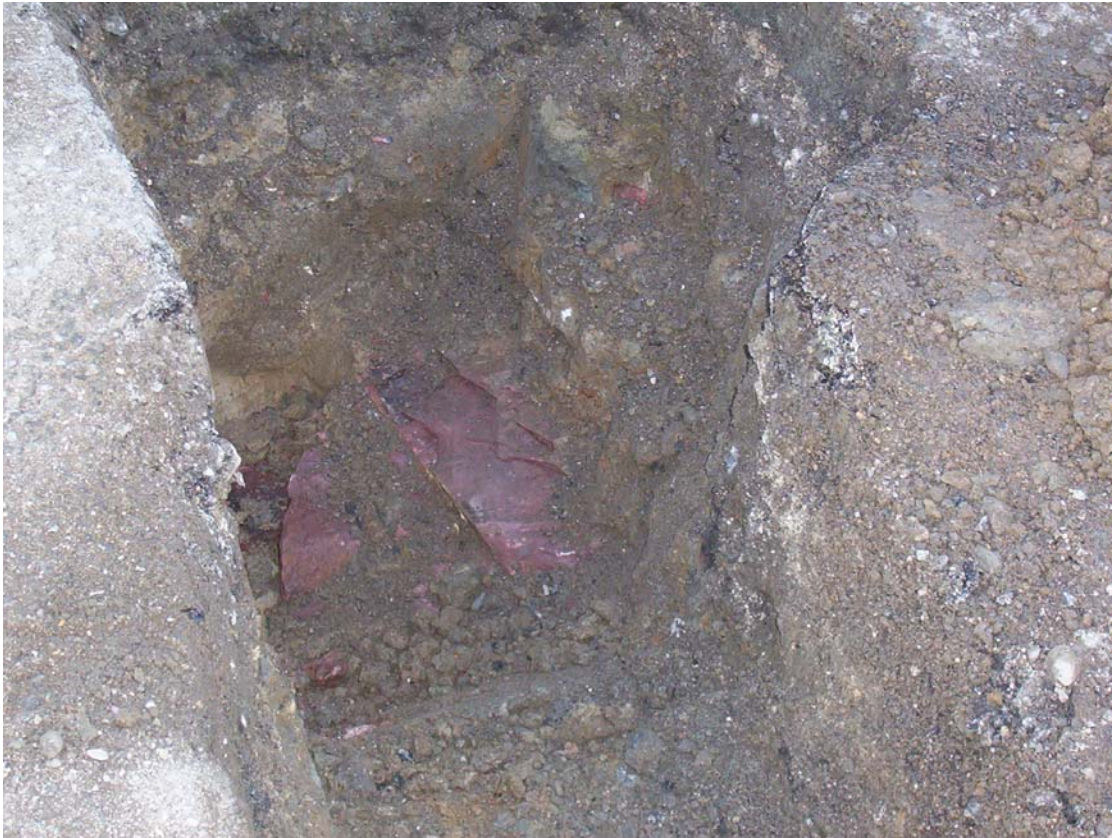
Photo 3: Sump hole, possible medieval wall footing. © Fraser Gardiner

A hole was excavated for a sump and reportedly encountered a wall, or wall footings, of red sandstone, found about 0.6m below the surface. This structure is likely to be of medieval date and not Roman (Photo 4). This was not visited during the archaeological work
