ROMAN MILITARY ROADS, FORTS AND VIGI IN SOUTHWEST WALES SCHEDULING RECOMMENDATIONS 2005

RHIF YR ADRODDIAD / REPORT NO. 2004/115
RHIF Y PROSIECT / PROJECT RECORD NO. 51964

Ionawr 2005
January 2005

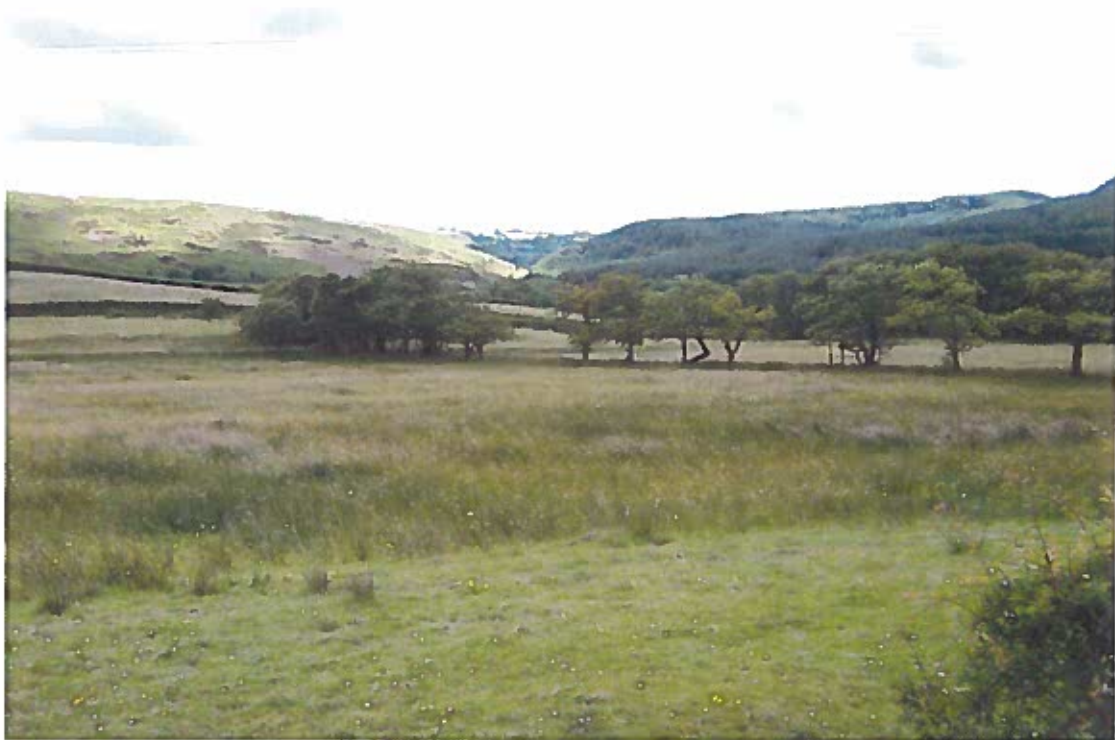
Photo 1: The line of the road is visible traversing the fields behind the hedge trees viewed from road looking southwest

This segment of the road has been suggested for scheduling due to the exceptional extent to which the agger survives as an uninterrupted upstanding feature crossing several fields along the valley floor. Two other road segments and quarries (PRNs 51966, 33994 and 51964) located on the crest and slope of the hill to the west are also suggested for inclusion as they represent the engineering techniques employed where the road traverses hillier terrain. At SN72923834 the road alters course slightly. This was probably an important sighting point for the westward continuation of the road. Elsewhere, lesser course changes can be discerned. Parts of the route are currently under forestry, other parts are suffering slight erosion by livestock.

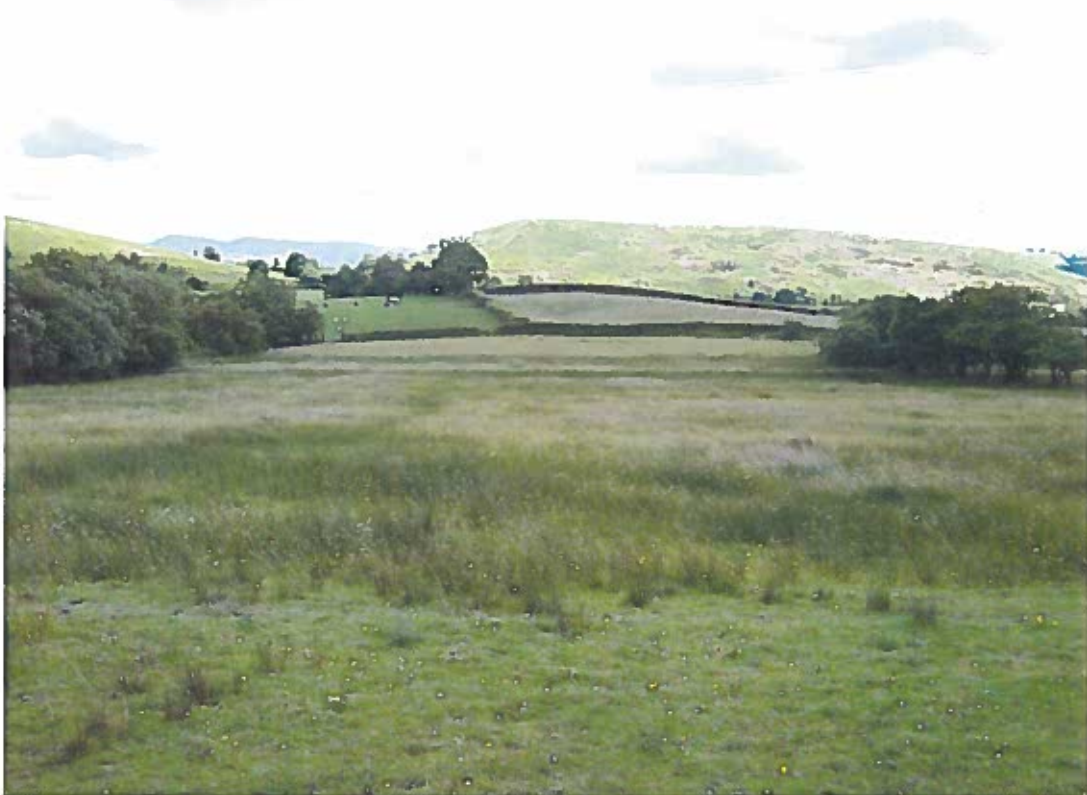
Photo 2: The road line crosses the field left to right in the mid-ground. Viewed from road looking south

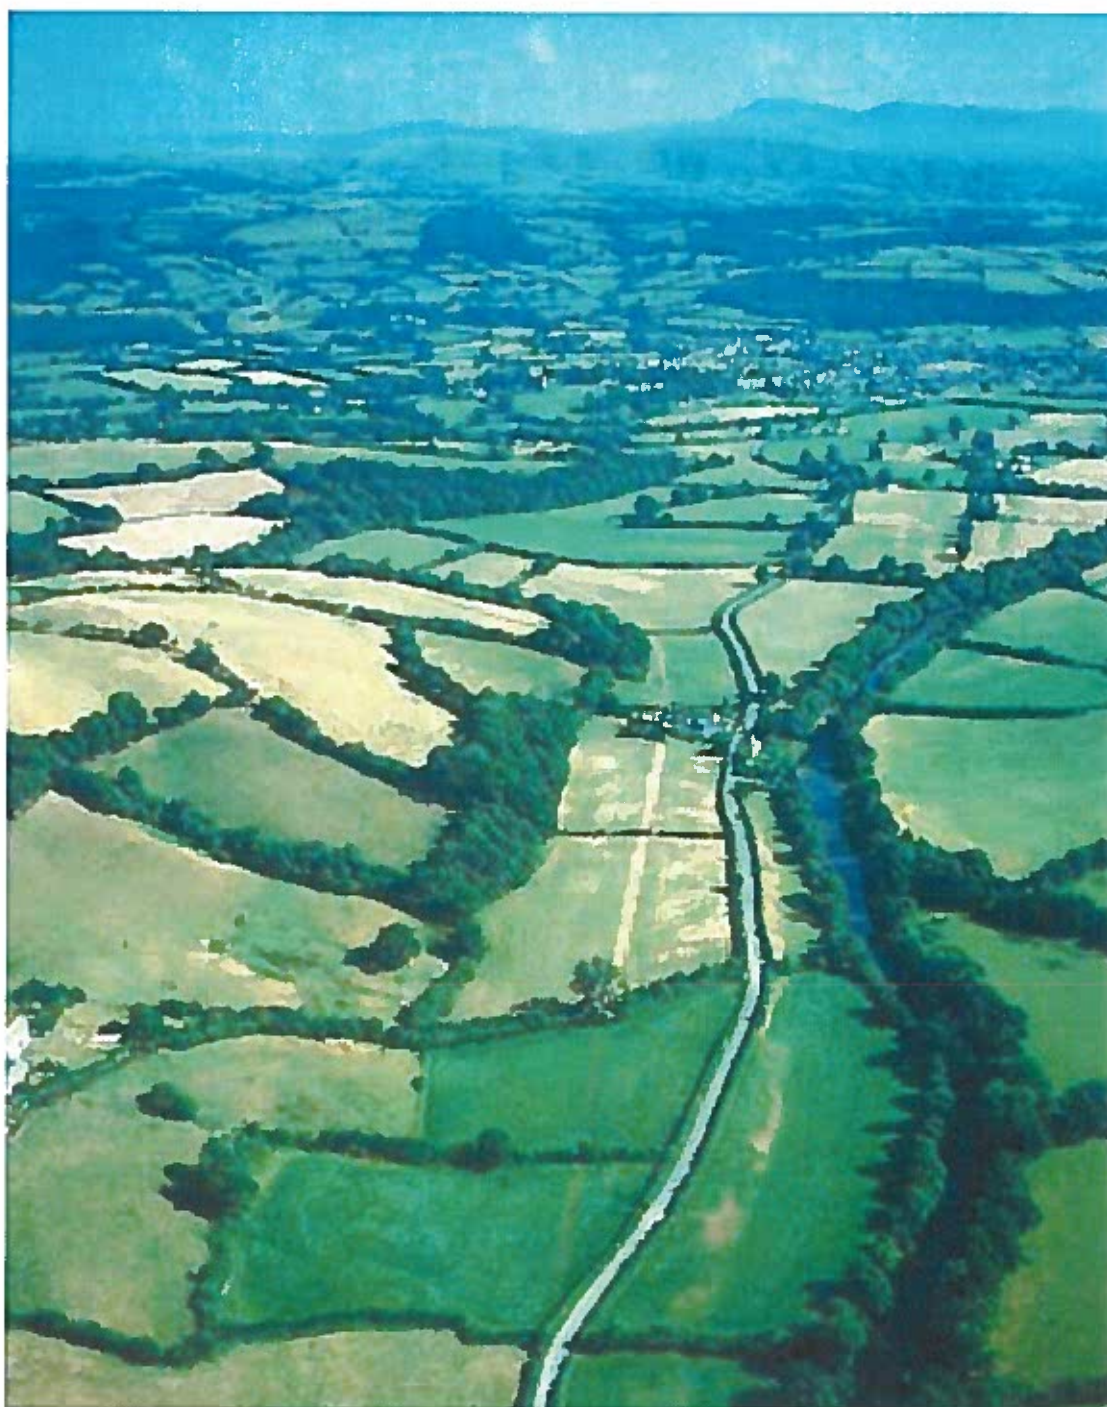
Photo 3: An aerial photograph of the road from Llandovery to Pumsaint, facing to the southeast. The segment in the centre of the frame survives as an extant agger. Beyond the farm the road curves round to the left.

This stretch of the Roman road is recommended for scheduling because of the exceptional survival of the agger in the three fields to the north of Dolauhirion farm. In addition, the curved cropmark to the southeast is suggested for inclusion as it illustrates how the course of the road was dictated by earlier courses of the river to the west and other topographic features. Earthwork cutting PRN33984 is also suggested for inclusion as an example of a hillside cutting and due to its excellent state of preservation, public access and visibility.

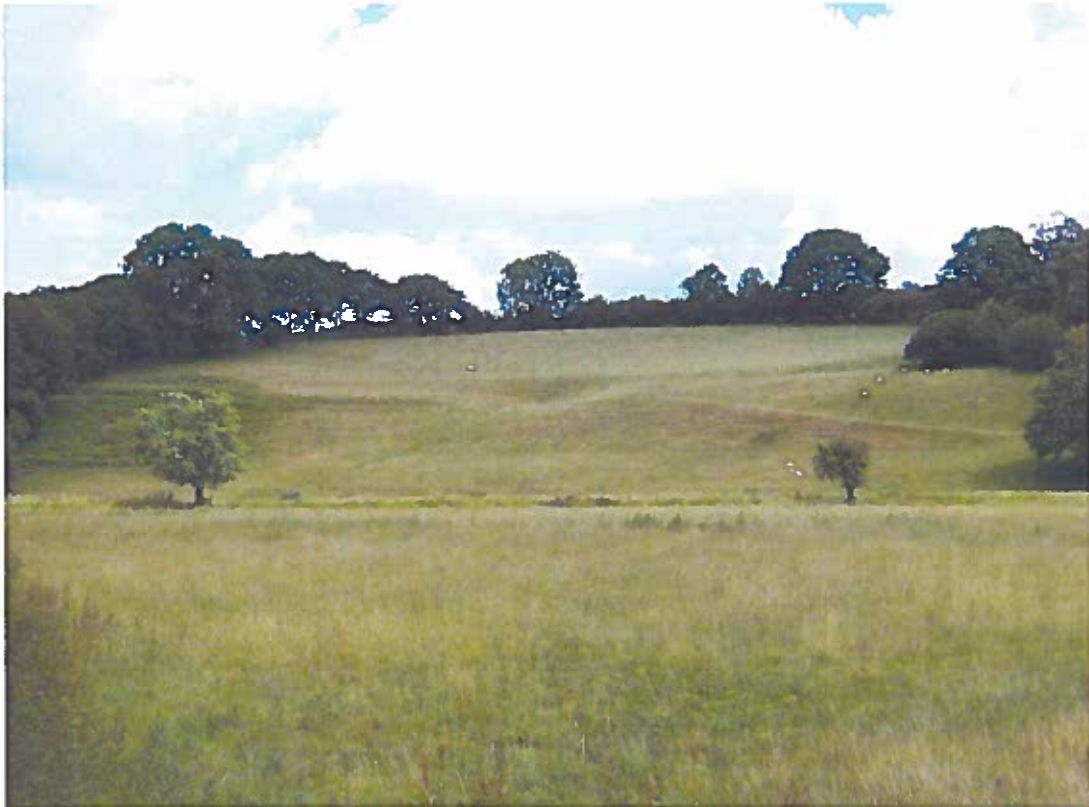
Photo 4: The Roman road RR62c (PRN33984) survives as a cutting in the hill slope at SN76663547 (facing northeast).

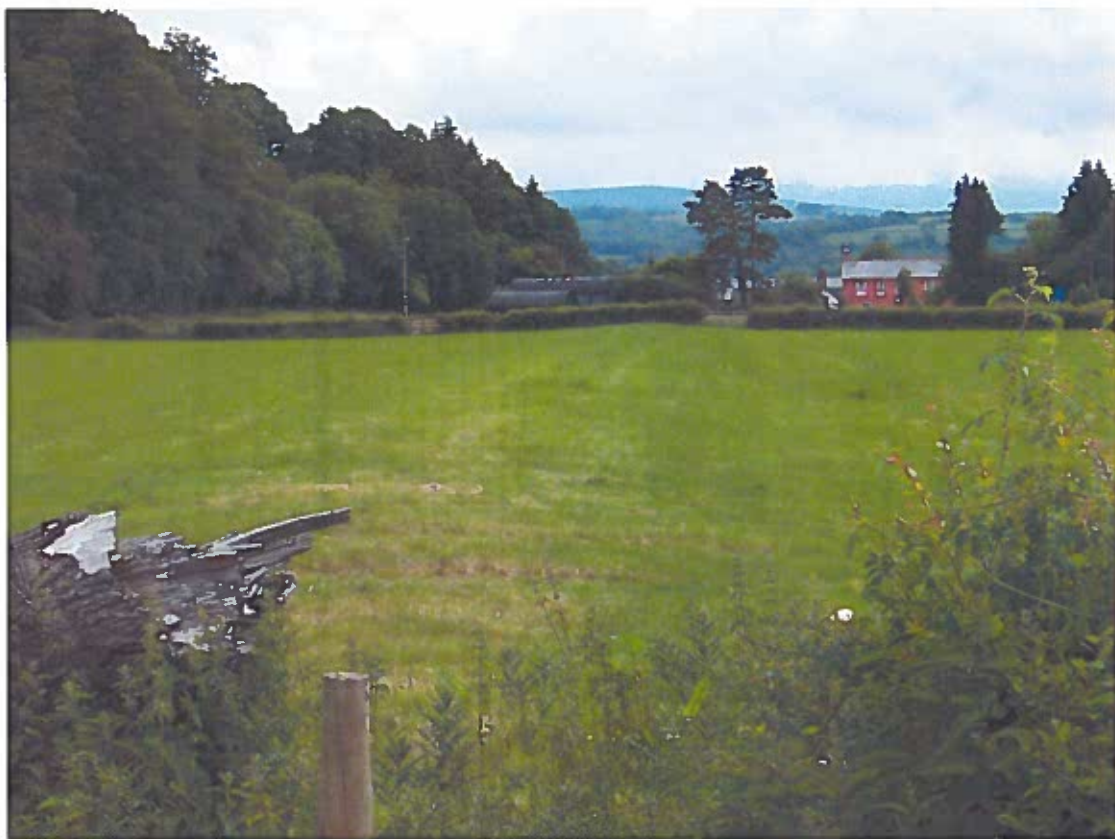
Photo 5: The line of the road can be seen as a raised hump running towards the farm.

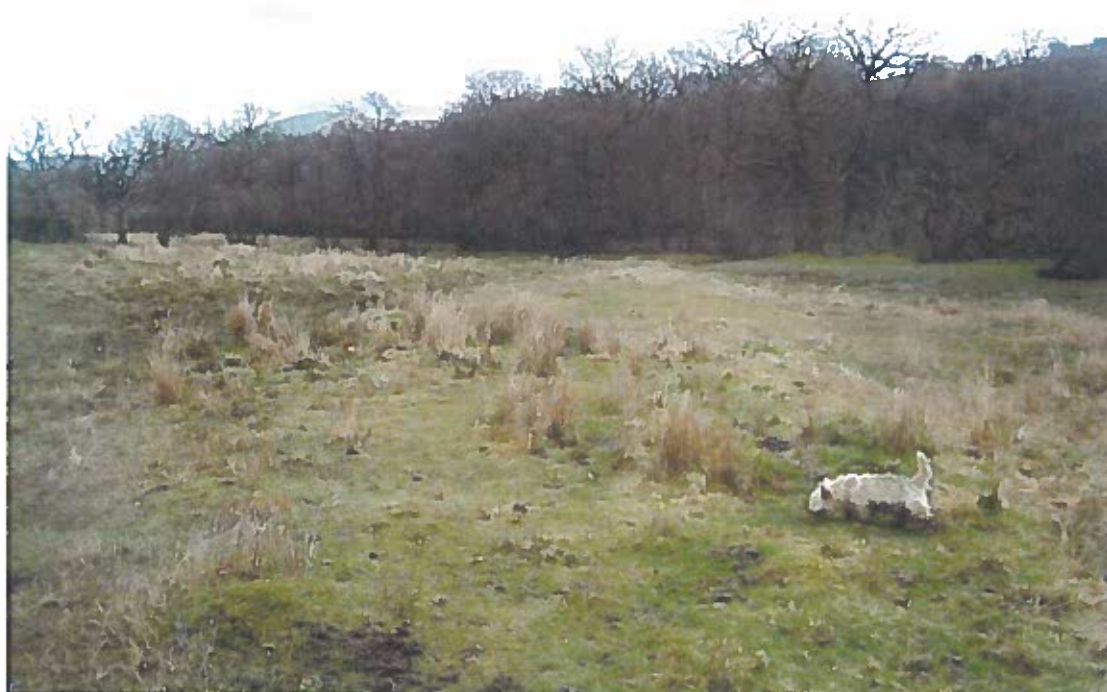
Photo 6: The raised agger is visible in the centre of the shot (left of dog). View facing east.

This segment of Roman road is recommended for scheduling due to the exceptional preservation of the agger between SN74673842 and SN73903842. Here the land is marshy, accounting for the good preservation but also offering good potential for waterlogged preservation of environmental data and any drainage structures that may have formed part of the road construction. Elsewhere along this stretch, ploughing has reduced the clarity of the road, although its line can still be traced as a low linear rise. The land is currently in a Tir Gofal agreement.

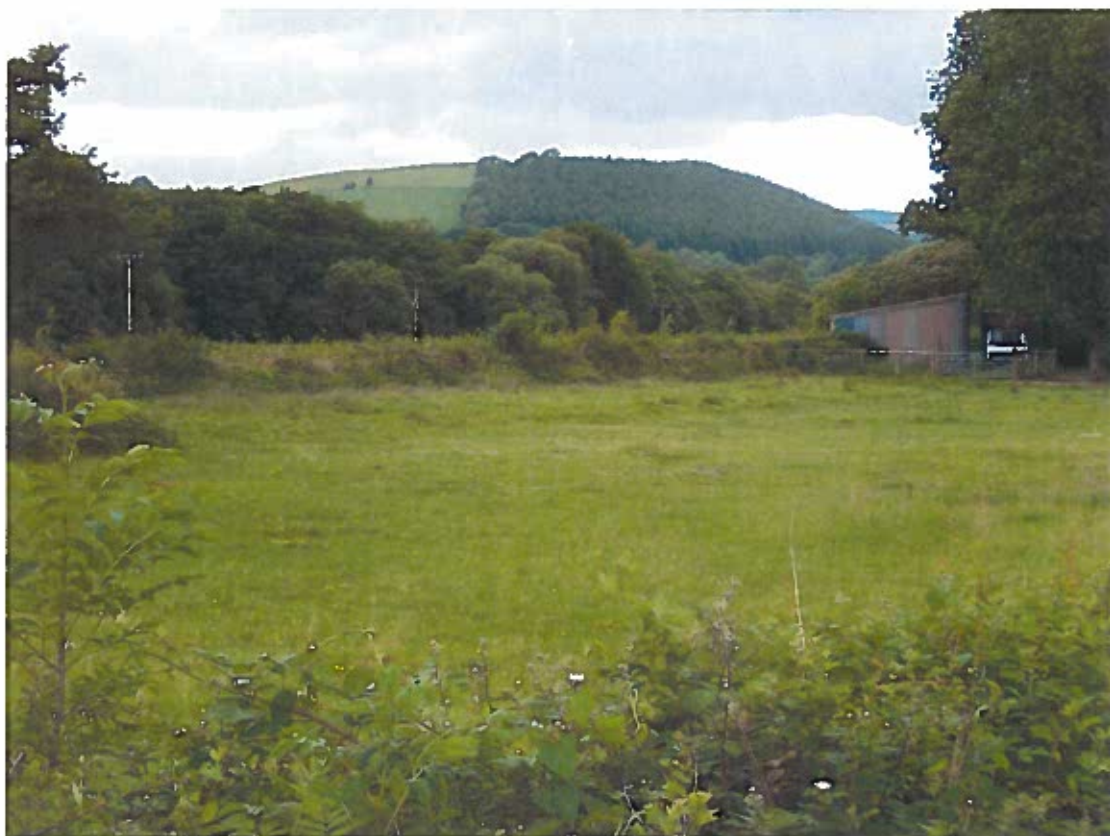
Photo 7: Well preserved agger at Dolau Bran. The stables are built on the road

This segment of Roman road is proposed for scheduling due to the good survival of extant agger surviving at Dolau Bran (SN79533793) at the southern end of the extensive cropmark. In the central portion, the road is less easy to trace and may be being actively eroded by the river. The site of two marching camps is located close to where the road changes course to climb and follow the crest of a pronounced ridge towards the northeast. Here clear earthwork remains of the road and associated quarries are visible in pasture at Rhydins Farm, further northeast the ground is rougher and covered in bracken. This may obscure well-preserved segments of agger (see photo 8).

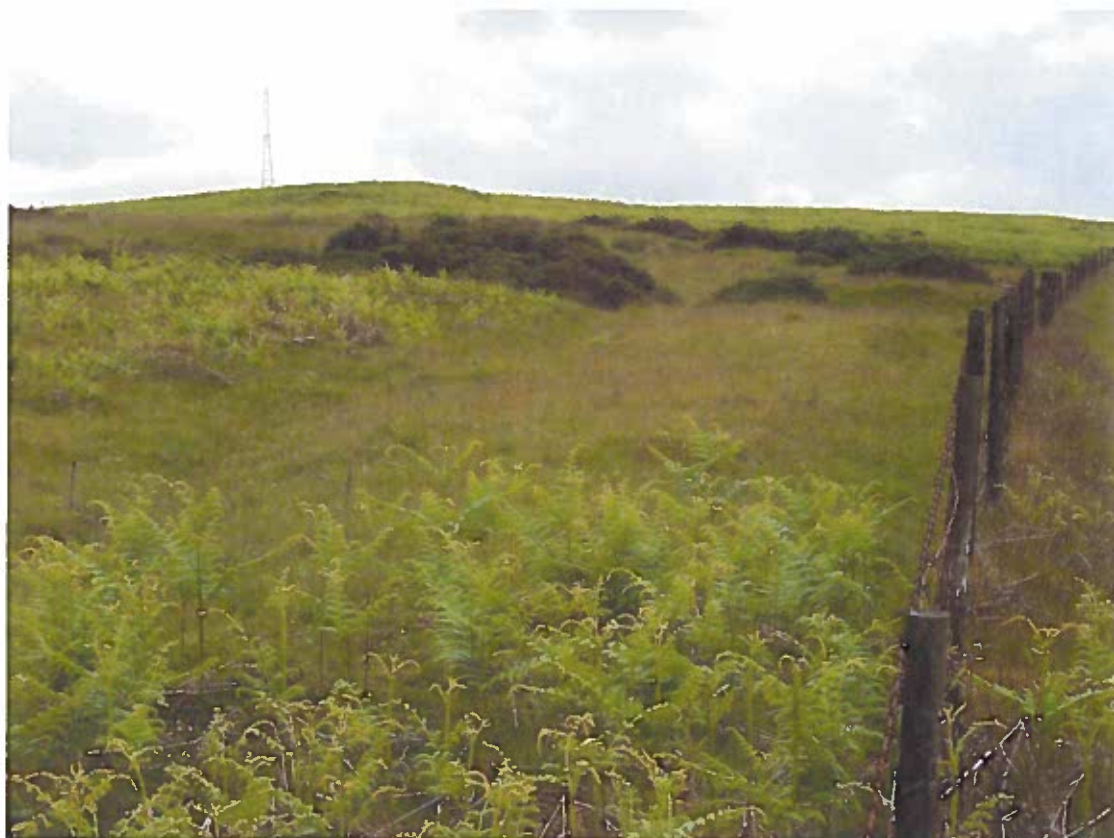
Photo 8: Probable agger at SN83274094 looking southwest.

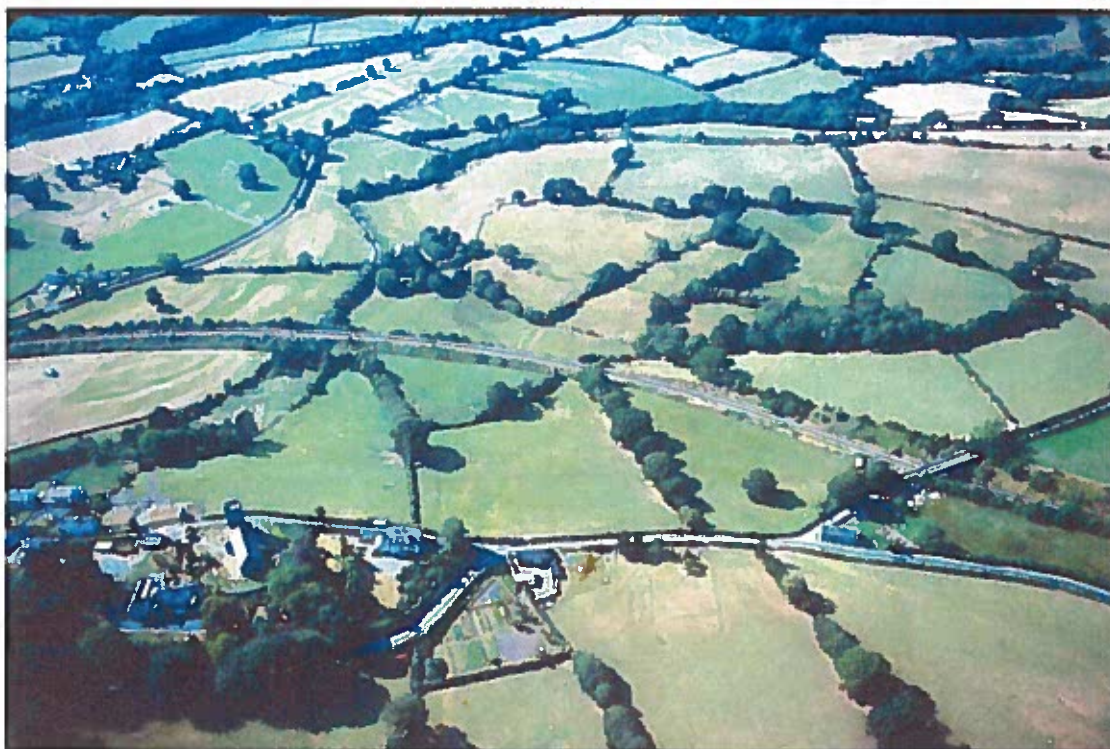
The Roman fort at Llandovery (Alabum?) was possibly established in the AD50s, based on ceramic and stratigraphic evidence. The fort is located on high ground immediately to the north of Roman road RR623 (PRN 3419). Parts of the northeast and northwest sides of the fort survive as earthwork banks in pasture, but much of the rest of the fort has been built upon. It appears to measure approximately 170m by 120m. A modern minor road runs through the fort, probably on the line of a Roman street. Following recent geophysical survey, there is evidence of a possible second fort, annexe or reduced fort on the same site. There is also evidence of a *vicus* (PRN 8505) running along the north side of the A483 from aerial photographs DS.27.10.2004.

Photo 9: An aerial photograph of Llandovery fort (left) and probable *vicus* area (centre) shot facing north. The fields to the north of the road were included in the recent geophysical survey. Note the cropmarks visible in the field south of the road (centre). This area was not included in the recent survey.

In the light of the geophysical results showing stratified structural features along the north side of the A483 as far as Llanfair Farm (figure 7), it is recommended that the existing scheduled area is enlarged to encompass the area in which buried remains have been detected. In addition it is recommended that part of the fields to the south of the road are scheduled. Access to this land was not given for the recent geophysical survey, but aerial photographs (photo 9) clearly show parchmarks indicating structural features running along the southern edge of the road for an uncertain distance eastwards. Further survey would be required to ascertain the eastern limit of the *vicus*.

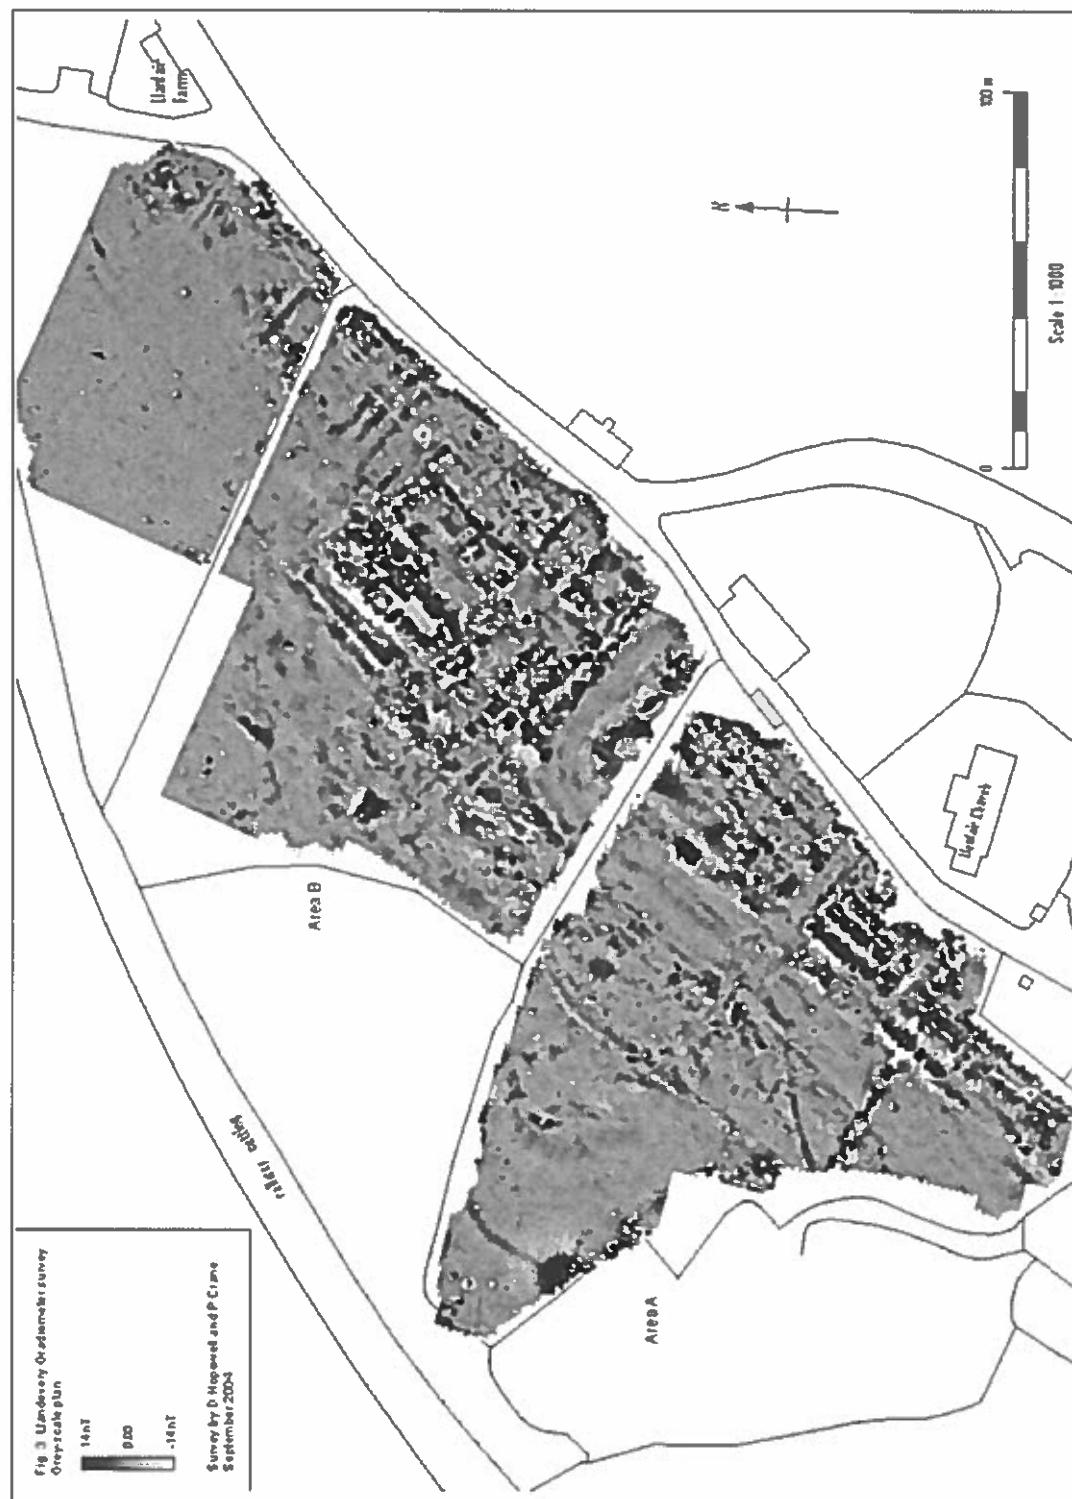
Figure 7: Geophysical survey of Llandovery fort
