# **LLANBADARN BODY REPAIR CENTRE, LLANBADARN FAWR, CEREDIGION**

## **ARCHAEOLOGICAL WATCHING BRIEF, 2004**

Project Record No. 52113  
Report No. 2004/87

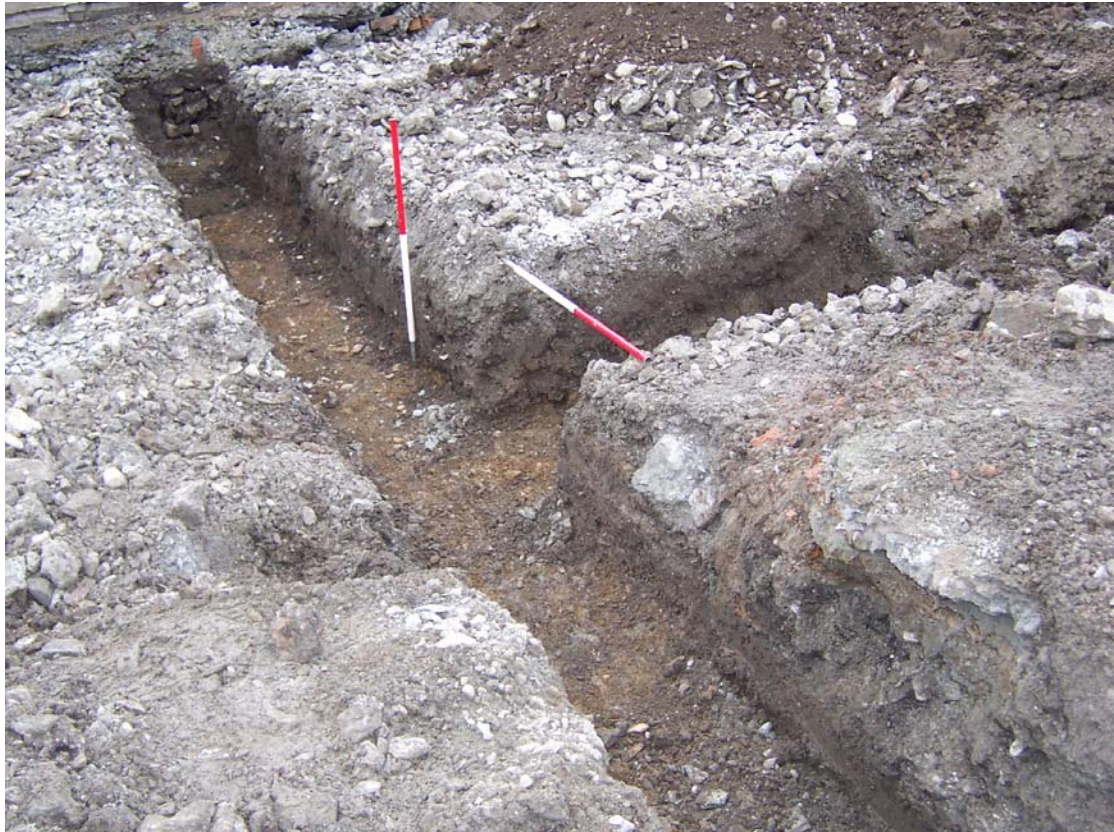
*Photo 1 – Trench 5 from northeast*

The only feature of note that was observed occupied the southeast facing section of Trench 5 (Photo 1). A stone foundation course was observed, supporting an east-west brick wall, 0.4m wide, running for 6.80m from the southwestern end of the trench at a level 0.3m above the trench bottom. This wall, which was also observed during the 2001 evaluation (Evans 2001, 5) reflects the alignment of a building shown on the 1937 O.S map (see plan of site). This building is not shown on any earlier editions and appears to have been erected between 1905 and 1937. Its use is unknown. Apart from this no other archaeological features were located in the trenches.

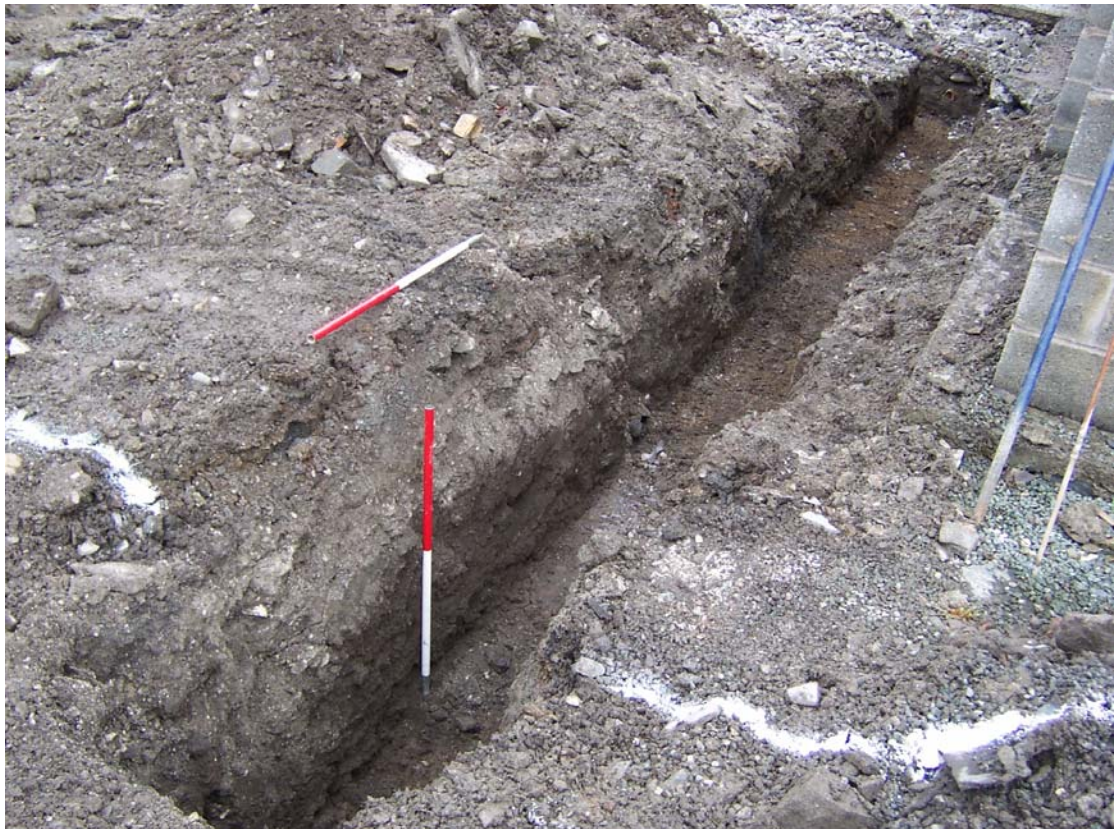
*Photo 2 – Trench 1 from west*

Much of the area consisted of made-up ground overlying a dark brown loam deposit (ie. garden soil) which in turn overlay a compact layer of dark brown silty clay at the level of the bottom of the trench. Cut into the garden soil deposit were numerous drainage pipes, with a brown salt glaze dating from the 19th century, and 20th century plastic pipes.
