**TIR GOFAL MANAGEMENT PLAN:
HERITAGE MANAGEMENT INFORMATION
(Call Out)**

**Prepared for:
Trefach
Tir Gofal Reference No: W/13/5203**

**Project Record Number: 52219
Report Number: 2009/81**

Call Out Visit

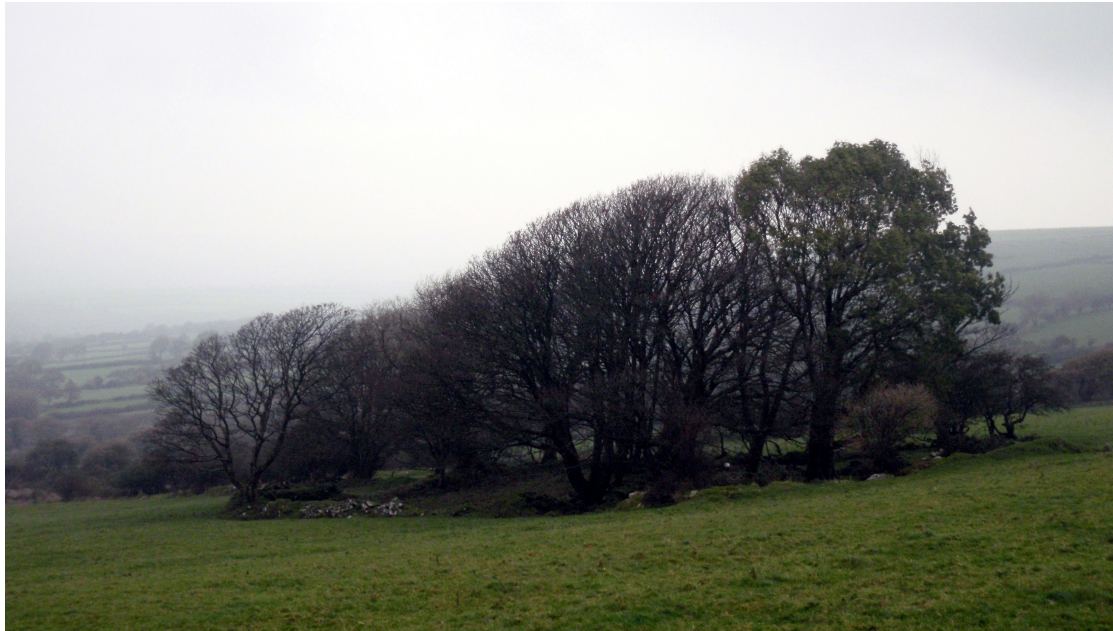
Looking northeast across the site of the now ruined farmstead Fagwyr Llwyd

Although the farmstead is now a ruin the layout of the Fagwyr Llwyd complex is still traceable on the ground. It comprises the farmhouse with at least three farm buildings, of unknown function, to the east and south and two stone-walled enclosures to both north and east. A trackway originally accessed the farmstead to the south.

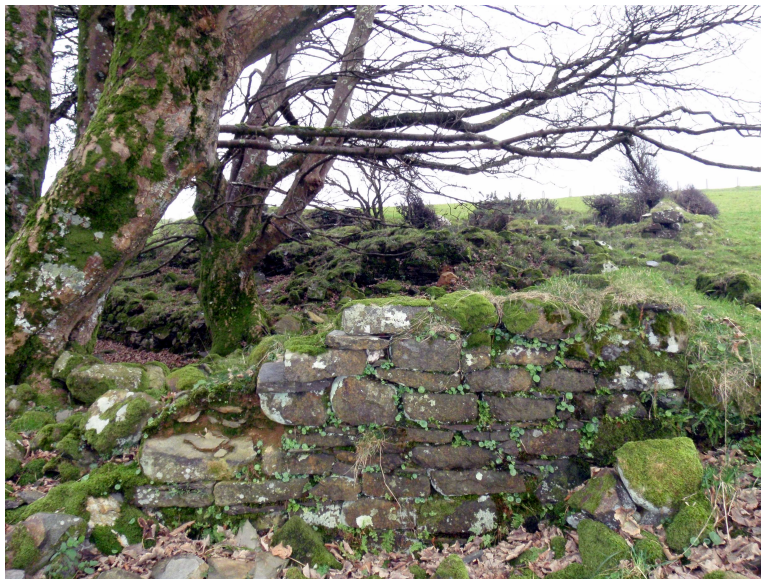
Looking south, remains of the north-facing farmhouse wall

The rectangular main house lies on the western side of the farmstead, aligned north-south, and measures approximately 11 by 5 metres. The end walls are of partially

dressed stone and stand to a maximum 1.5 metres high, while the sidewalls are now generally low rubble spreads. No internal features survive apart from the remains of a fireplace in the southeastern corner. Rubble associated with the nearby farm buildings indicate that they were roofed in slate and it seems probable that the house would have been similarly roofed.

There are some limited stretches of stone wall that stand a few courses high, particularly the north and south ends of the farmhouse and the walls of the adjacent farm building. These would benefit from some consolidation work to help prevent further deterioration of the structures.

- Consolidate any areas of loose masonry using a traditional lime mortar mix, trying to follow the original mix and appearance as far as possible.
- Re-pointing is necessary where mortar has weathered back to a depth equivalent to the joint width or is very loose.
- Consider capping the wall tops in order to prevent water from washing out lime mortar bonds and accelerating collapse.

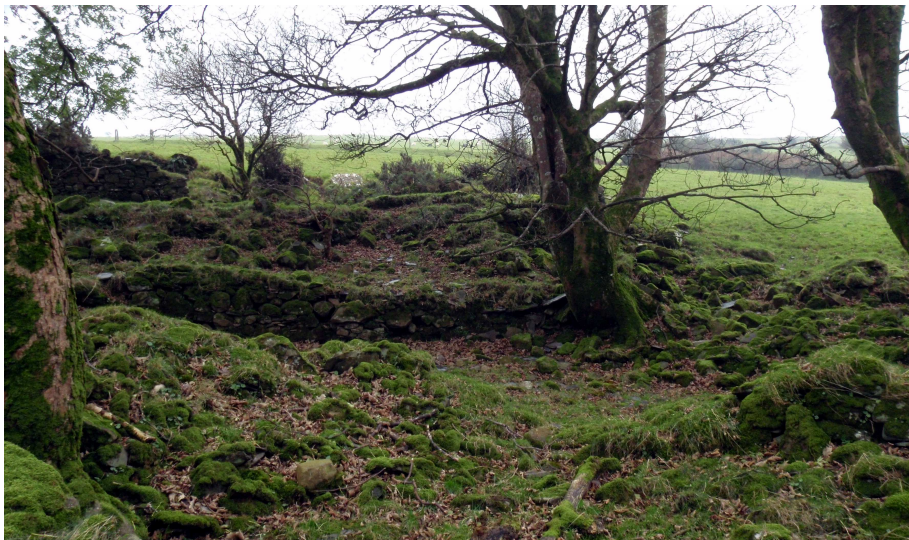
The parallel farm building is of rubble stone construction and measures approximately 9 by 5 metres. There is an internal division and the building is presumed to have had an agricultural function, possibly a cow shed, although too little remains to know for sure. It backs onto an extensive stone walled enclosure, on the southeastern corner of the farmstead, which itself is subdivided into three strips.

Looking east, from within farmhouse, across adjacent farm building

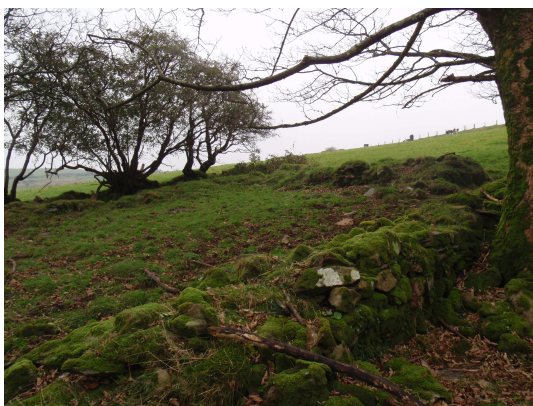
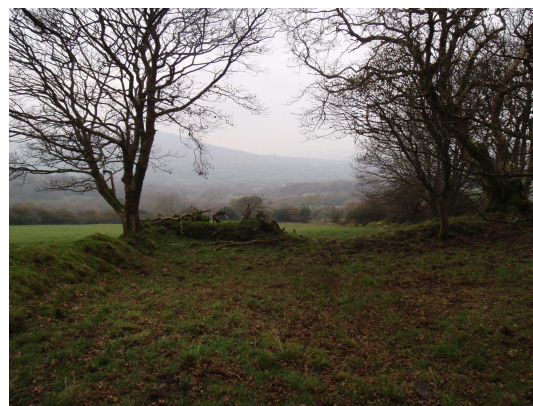
A further stone walled enclosure, or yard, lies on the north side of the complex, extending some 27 metres east-west, with a possible gateway within the northern boundary leading out to the fields beyond.

(Left) looking southeast, the eastern enclosure and (right) looking north, the northern enclosure with possible gateway.
