TIR GOFAL MANAGEMENT PLAN: HERITAGE MANAGEMENT INFORMATION (HE2)

**Prepared for:
Llwynceiliog**

**Tir Gofal Reference No SE/10/4430
ACA Report No. 2005/31
Project Record No. 52220**

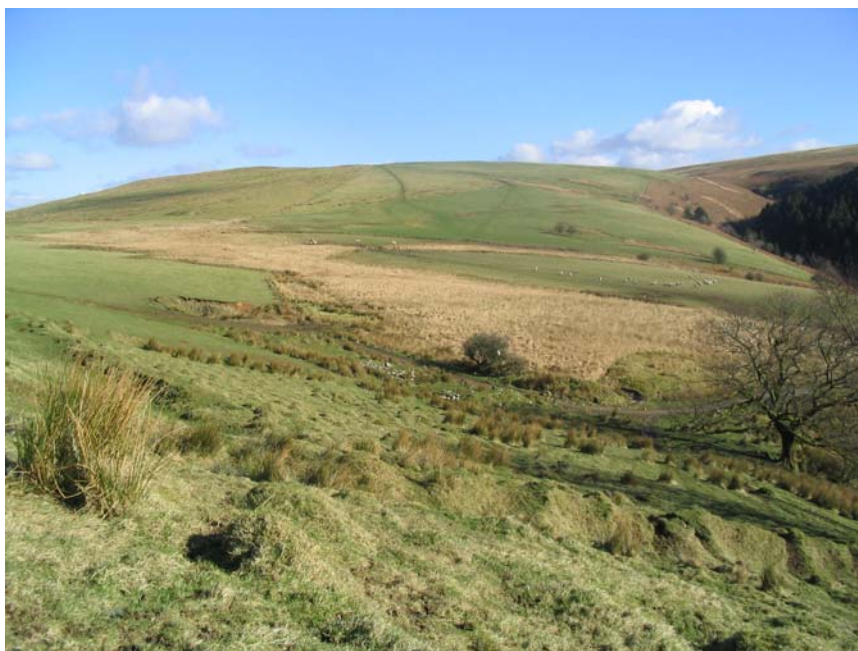
Looking east across Banc Llwynceiliog. By the tree in the middle distance are the remains of the farm Trefly (PRN 24468) and on the hillslope beyond are the 'Gwenlais/Anell leats' (PRN 8883).

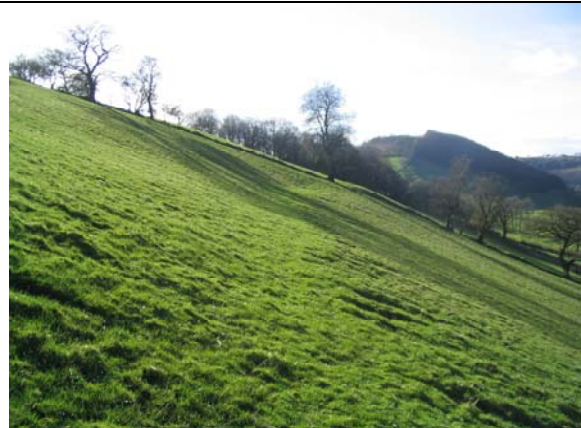
Part of leat to the west of Llwynceiliog farm, where it is visible as a levelling off of the hillslope.	A very well preserved section of leat survives in the fields immediately to the southeast of Llwynceiliog.

<p>The course of the leat becomes difficult to trace in rough ground and marsh in the valley below Banc Llwynceiliog</p>	<p>Those fields to the east of the farmstead have little remaining traces of the leat, except the profile is usually preserved in the field boundaries which cross-section it.</p>

Parts of the leat which runs through Llwynceiliog are scheduled, however even where the scheduling does not extend there are likely to archaeological remains which survive below ground. It is therefore important that the entire length of the leat remains undisturbed from any damaging activities, including cultivation or reseedling or other ground disturbing practices. Any works which may affect the leat at any point along its course should be discussed with Cambria Archaeology as first point of contact who will then consult with Cadw where the scheduled area is concerned.

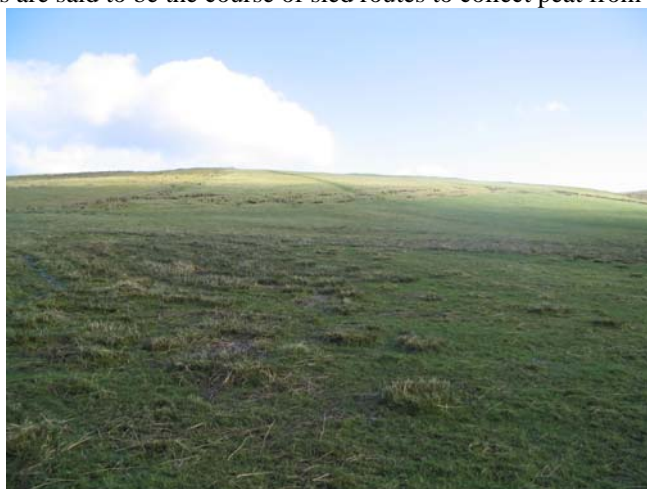
The 'Gwenlais / Annell leats' can be seen coursing across the contours of the bank

It is recommended that no further sheep feeding should take place at this location or at any other within close proximity of the Scheduled site. Any further sheep feeding should be relocated down the slope in order to prevent as little traffic over the site as possible. If there are any potentially damaging operations taking place in this area then please consult with Cambria Archaeology in advance.

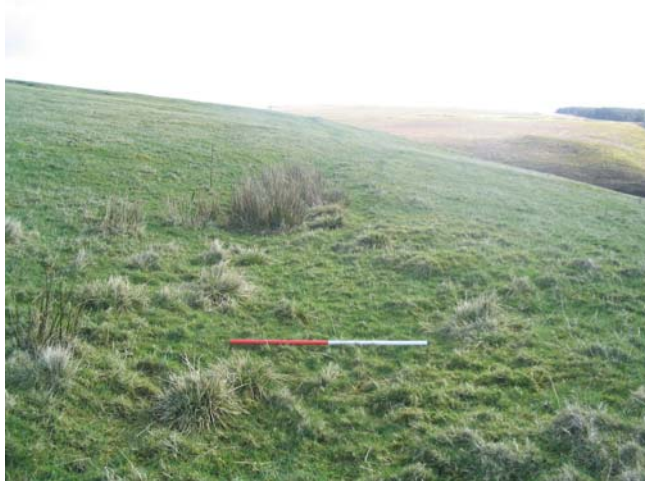
The upper reaches of the leats survive as a terracing in the hillslope.

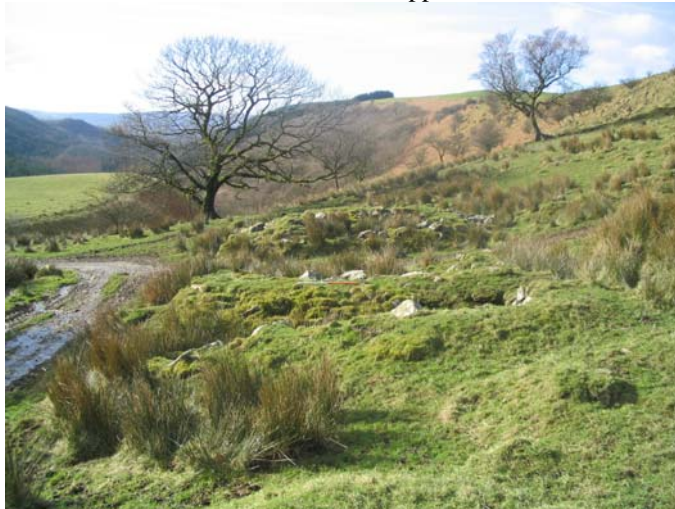
A farmstead marked on the Old Series 1831 (sh 41). Also shown on the 1st edition Ordnance Survey map 1888. It appears to be disused at this time. A National Trust survey of 1998 describes this farmstead as a ruined 3-room structure with walls standing up to 1.2 metres high and 1m wide (NT 80424). Seen on the farm visit in 2005 and it appears much as described by the National Trust. Damage has occurred from two tracks; one track cuts right through the building going directly up the slope and a further track skirts around the south of the building. Both of these appear to be in regular use. The location of these tracks is

unfortunate, but now they are in place they do not appear to be causing further damage. Recent quarrying activity has taken place to the east of the site, this does not appear to have affected the site.

The outline of a small 3 room building and further enclosure walls remain of a farm called Trefly

Traffic using these routes should endeavour to stick the trackways and not cause damage or erosion to the fragile remains of the building of Trefly. Any further realignment or work on the tracks which may affect either the building remains, or the associated enclosure banks should be carried out in consultation with Cambria Archaeology.

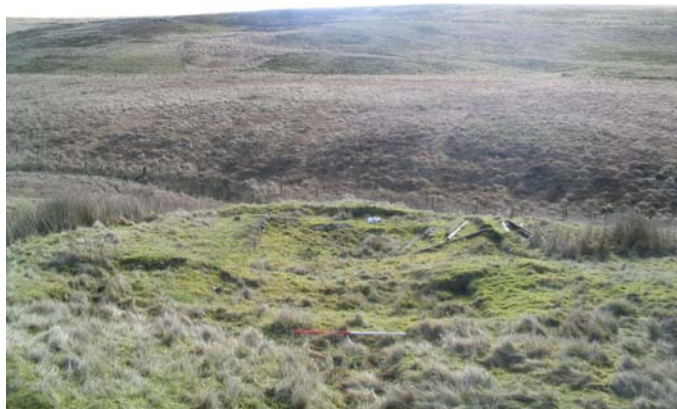
Excavated long hut site which stands on a spur overlooking a stream to the south. A long hut is a simple rectangular building which may or maynot be a domestic dwelling. It seems likely however, that this may be a 'hafodtai' a seasonal dwelling used when stock were taken to the uplands to graze in the summer. When seen in 1998, it was noted that those parts of the site that remained deturfed following the 1969 archaeological excavation, exposed coursed drystone walling, which appeared as low earth wall bases where the turf remained in place. This site is a scheduled ancient monument CM212. Recent reports from the Cadw Field Monument Warden suggest that this site is in a stable condition. When visited in 2005 the excavated stone walls and surfaces were gradually becoming grown over with moss and grass. The stonework appears stable. Some old fencing posts lie on and near the site, these are now embedding in the turf and removing them would probably cause damage, and it appears better to let them rot in place.

The excavated remains of a small upland dwelling, lying at the edge of Mynydd Mallaen

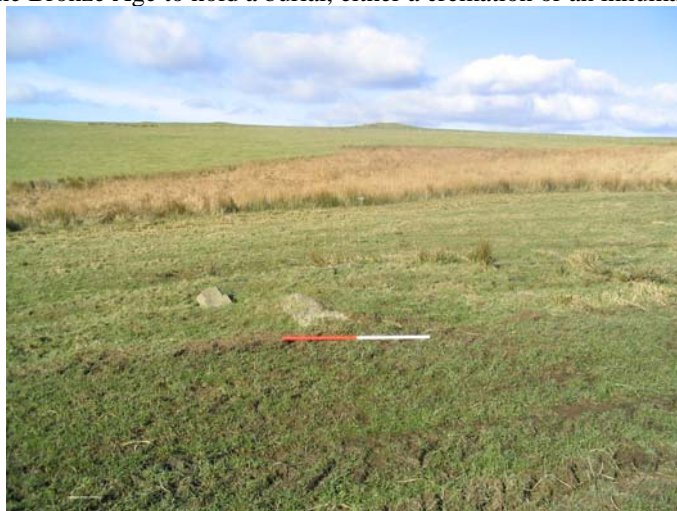
A possible cairn approximately 240 metres to the south - southeast of the round barrows PRNs 1962 & 1963. Five stones project from the turf in an otherwise stone free area. Earth and turf covered mound 0.30m high at maximum and approximately 4 metres diameter. One stone recently dislodged by tractor tracking up to a feeder 50 metres to the northeast. It seems likely that this may be the remains of a round barrow or cairn, constructed in the Bronze Age to hold a burial, either a cremation or an inhumation.

This may be the remains of a round barrow, which forms a group with those that can be seen on the horizon.

The site of this possible cairn or round barrow should be protected from further damage from vehicles tracking up and down the slope. The site of the barrow could be avoided by vehicles keeping further to the southeast of the site.

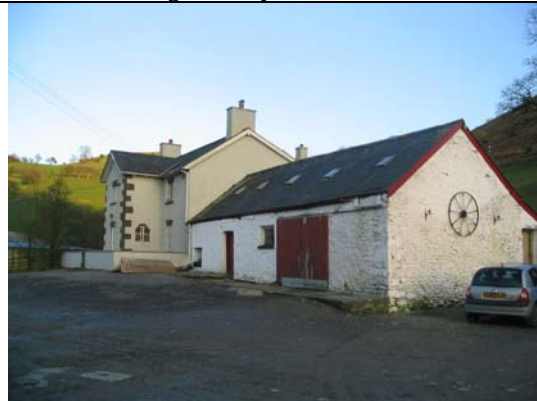
The farmstead consists of an impressive farmhouse, in the Dolaucothi estate tradition with a projecting two-storey porch. To the southwest and adjoining the farmhouse is a former cow shed. On the opposite side of the yard is a stone barn and lofted cart shed with yellow brick dressings. The farm buildings are all in good condition, having recently benefited from restoration through the ESA scheme.

Llwynceiliog Farmhouse and adjoining cow shed

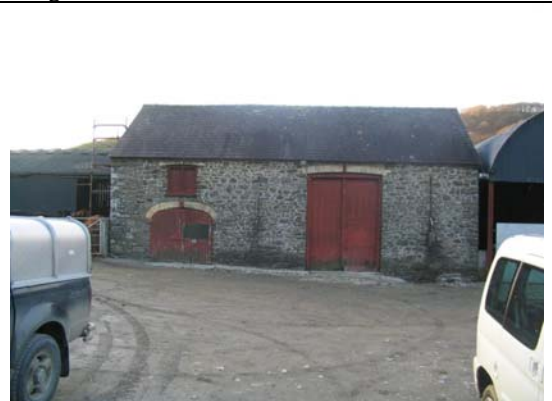
The barn at Llwynceiliog is currently being restored

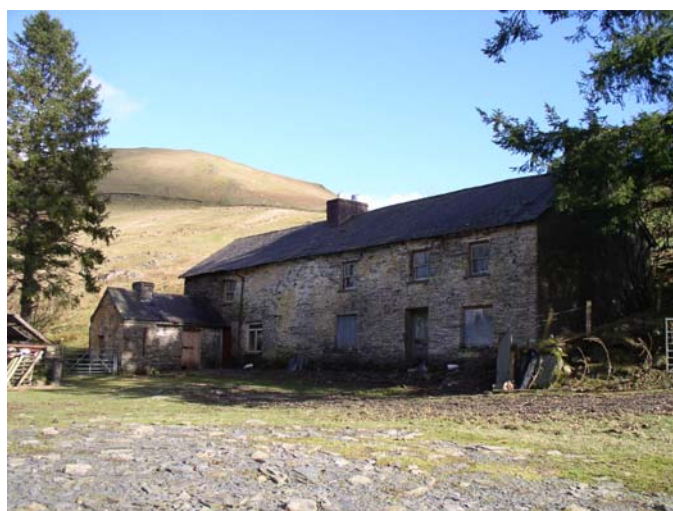
The farmhouse, although standing empty and unlivd in since the 1950's, is in a reasonable condition at present and the owner has endeavoured to keep the structure weatherproof. However, it is reaching a stage where a considerable injection of funds is required to ensure its long-term survival and for this to happen, a long-term use needs to be identified.

The farmhouse at Nantystalwyn

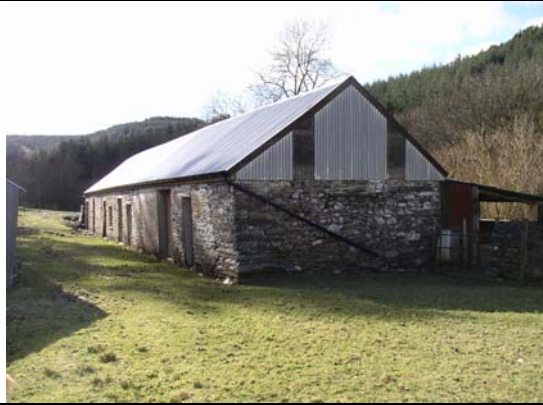
There are two parallel ranges of buildings which survive at Nantystalwyn, a third, a barn, has been demolished. The long range furthest away from the house is in good condition, having recently been re-roofed with zinc and extensively re-pointed. The range nearest the house is in a poor condition, some sections of the corrugated iron roofing sheets have been lost and the structure appears unstable in places. Although this building has undergone various alterations and additions in the past, there is still a large proportion of historic fabric surviving within it. Ideally this should be salvaged and repaired in order to create a functional, useful building again.

This sheep shed at Nantystalwyn has recently been reroofed and renewed doors partly funded by an ESA grant.

Ideally the range of farm buildings at Nantystalwyn should be repaired. In their current state they will rapidly deteriorate and will be lost in a few years. They still retain much of their historic fabric which not only holds important clues about their previous form and function, and about how the farm functioned as a whole, but also add 'group value' to the farmstead and their collapse would be a loss to this historically important farmstead.

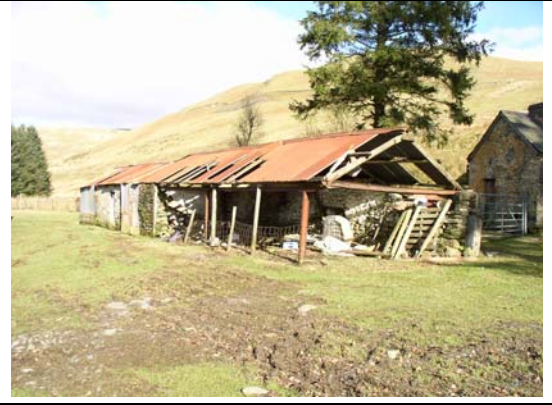
This farm building, which seems to have performed a number of functions at different times, is in a poor state of repair.
