## **TIR GOFAL MANAGEMENT PLAN: HERITAGE MANAGEMENT INFORMATION (HE2)**

**Prepared for:  
Ty Mawr  
Tir Gofal Reference No  
W/11/4749**

**ACA Report No. 2005/34  
Project Record No. 52231  
Prepared by: Helen Milne**

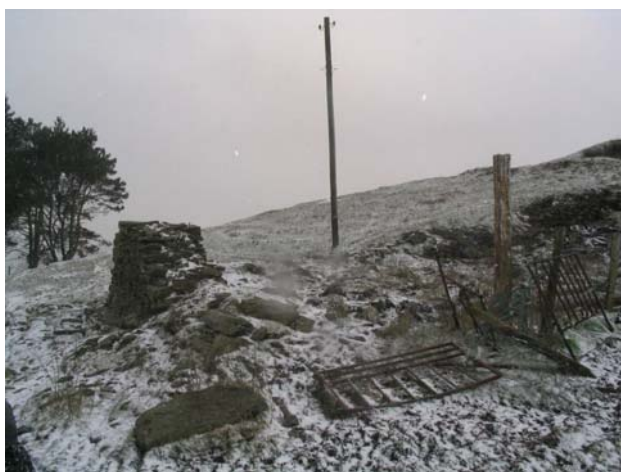
**The visible remains of Esgair-Wynion farmstead (looking west)**

The remains are not substantial, but map evidence suggests that this was a small farmstead rather than a cottage site. The site is marked and named as Esgair Gwynion on the Old Series Ordnance Survey map of 1834. It is also marked and named on both first and second edition Ordnance Survey maps. An estate plan of unknown date (acquired from the land-owner) depicts two parallel buildings in this location, but the farmstead appears to have had several changes in layout. A single building is marked on the second edition, whilst the first edition shows a single building and the remains of another (lying to the west of both buildings depicted on the estate map). The walls of this building are the only surviving above ground

remains now visible. These walls lie at the western end of a platform which is cut into a south facing slope. The map evidence cited above suggests that this platform probably accommodated other farm buildings in the past. There is no rubble on the eastern part of the platform now, and it seems likely that the remains of other buildings have been quarried as a source of stone for repair work over the years. Historic maps show enclosures to the north of the main steading area, and these are now represented by a series of low banks. A ruinous drystone cottage. Identified on the Ordnance Survey Old Series map (1834) and shown on the 1st edition map (1887) with associated enclosures.

The farmer wishes to use the flattened area on the eastern side of this site to position poly-tunnels for housing livestock. The visible remains of this farmstead are confined to the western side of the area, but there may be surviving sub-surface archaeological remains in the area. In order to avoid damaging any surviving below ground remains, no excavation should take place in the area. Material should not be removed to create a level platform; rather levelling should be achieved by depositing material to raft over the existing ground surface. Please contact Cambria Archaeology when work is to be undertaken on this site.

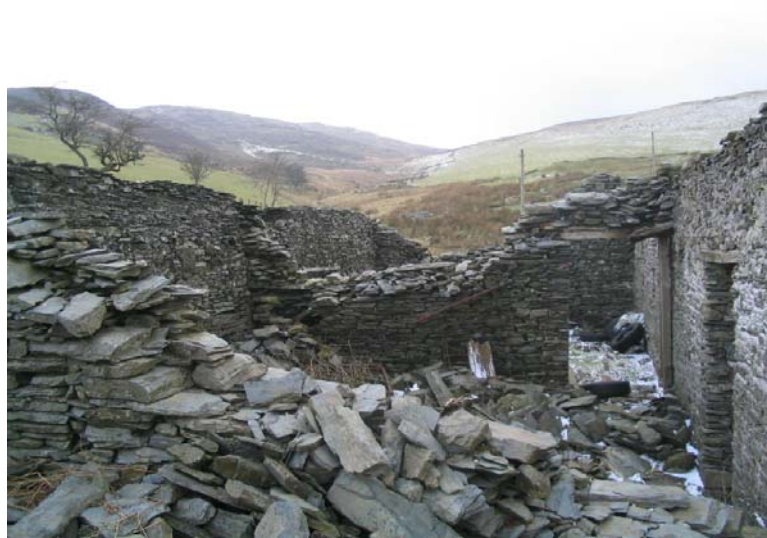
A two cell building of rubble-stone construction, measuring c. 11.5m lengthways, by c. 5m across, with central stone partition.

**Internal view of Nant-y-Maes looking east.**

The building is orientated east - west, along the contour, and is built into a south facing slope, with the northern elevation dug into the ground. The general construction, particularly the inclusion of two ventilation slits on the southern elevation, suggests that it was originally built as a barn, but it is known to have been occupied as a cottage during the 19th and early 20th centuries. There is structural evidence to suggest that the building has been modified in the past, including a blocked entrance with straight joints on the west facing gable end. The present entrance looks more recent - externally the arch has been constructed of bricks, whilst internally there is a wooden supporting lintel, and the stone-work on either side of the door is quite rough. This southern door may have been built to replace the western entrance (now blocked) at the time when the building was converted for human habitation.

The farmer wishes to undertake restoration at Nant-y-maes. The restoration would be for residential purposes and so falls outside the scope of funding within Tir Gofal. However, it is important that within the scheme traditional buildings are maintained sympathetically using materials and techniques appropriate to the locality. The building has been used for residential purposes in the past, and as such, restoration that would make it suitable for habitation again, would be preferable to allowing the

structure to deteriorate further. Information has been included with this report to provide guidance on appropriate materials and techniques.

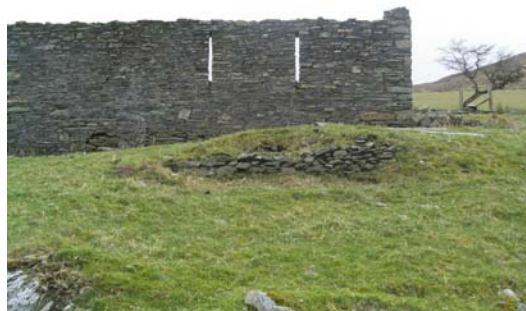
**Southern elevation of Nant-y-Maes, showing ventilation slits.**

The farmer remembers that the roof of this building finally collapsed about fourteen years ago. He believed that it was originally made of stone slates, graded in diminishing courses, although these were later replaced by standard grey slate. At the time of the archaeological farm visit there were examples of both types in the vicinity of the building. He also remembers that there was a wicker chimney hood in the eastern part of the building. Two small niches of unknown function on the internal face of the eastern gable end may represent

small bread ovens/ warming areas. The building is deteriorating at a steady rate, and portions of it have collapsed relatively recently. The front (southern) elevation has exposed foundations at its' base, which are currently being undermined, and will eventually cause this side of the building to collapse if left unremedied. The building is marked and named as Nant-y-maes on both first (1887), and second (1905) edition Ordnance Survey maps, suggesting that it was being used as a dwelling at this time. It is not shown on the 1764 Nanteos estate map (Nanteos 316, NLW). (Grid reference corrected from SN759 790 to SN7597 7902).

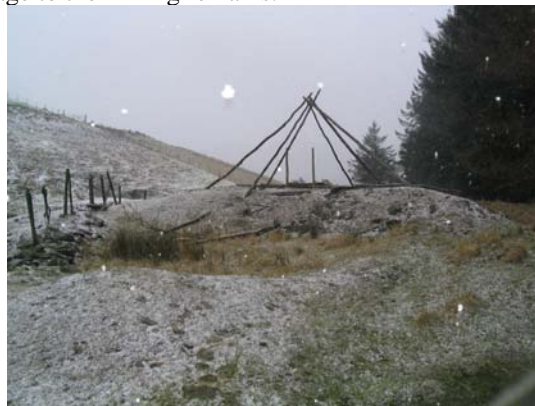
A minor metal mine working, marked as 'Level (lead)' on both first and second edition Ordnance Survey maps. Some surface traces of the workings survive; including an open adit and some spoil tips. The site occupies the bottom of a small stream valley (Nant Ysbyty Cynfyn), and is bisected by the Ty Mawr boundary fence. The remains within the boundary of the Ty Mawr holding consist of spoil heaps, the adit can be seen entering the bank on the opposite (south) side of Nant Ysbyty Cynfyn. The condition of this site at the time of the archaeological farm visit was stable. On a platform created by the western area of tipping, on the north bank of Nant Ysbyty Cynfyn, stand the modern remains of a teepee. This structure has not caused any perceivable damage to the mining remains.

**Spoil heaps associated with lead level 25,906 (looking northwest)**

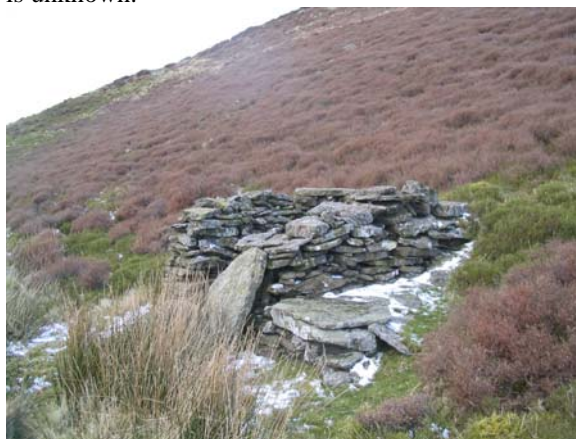
This small dry-stone structure is built into a south facing slope. It measures c. 2.6m x 2m, and the walls still stand to over 1.5m. It was used to pen geese by Ty Mawr farm within living memory - at the end of the day the geese had to be put away in the pen, which is over half a kilometre away from Ty Mawr farmstead. The entrance faces south, and on the east side, attached to the pen is a level platform built of the same stone, and capped with a slab. The function of this platform is unclear, but the farmer thought it may have been a stand for feed. The roof of the pen is now gone, but a sheet of corrugated iron is propped against the structure, and may represent surviving roof material. There are two flat stone slabs propped against the front (south side) of the pen, whose function is unknown.

‘Goose pen’ at Ty Mawr, showing platform on east side

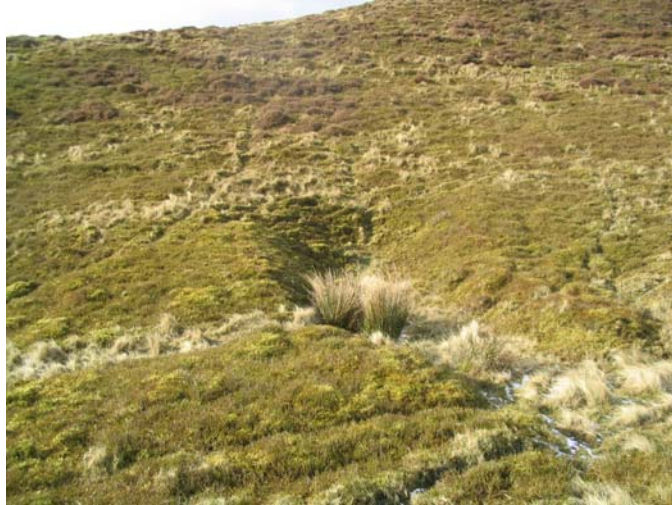
Linear depression in rough upland pasture, c. 4.5m in length by 1.5m wide. Probably a root vegetable clamp. Condition good.

**Linear feature 53,093**

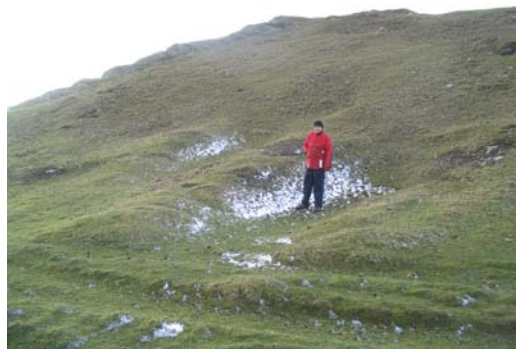
Two parallel linear depressions in tightly grazed upland pasture, each feature c. 6 - 7m in length by 2m wide. These can be interpreted as root vegetable clamps. Truncated at eastern end by old wheel ruts (now grassed over).

**Parallel storage clamps (53,094)**

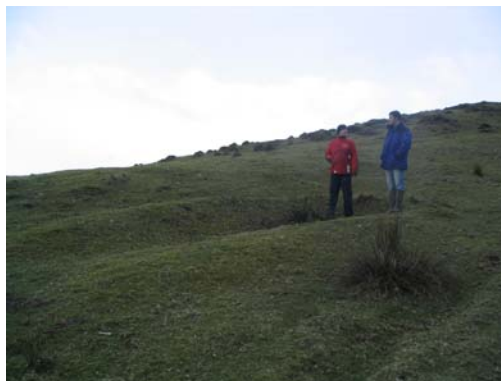
Linear depression in tightly grazed upland pasture. C. 4.5m long by 1.5m wide, likely to be a further storage clamp.

**Storage clamp (53,095)**

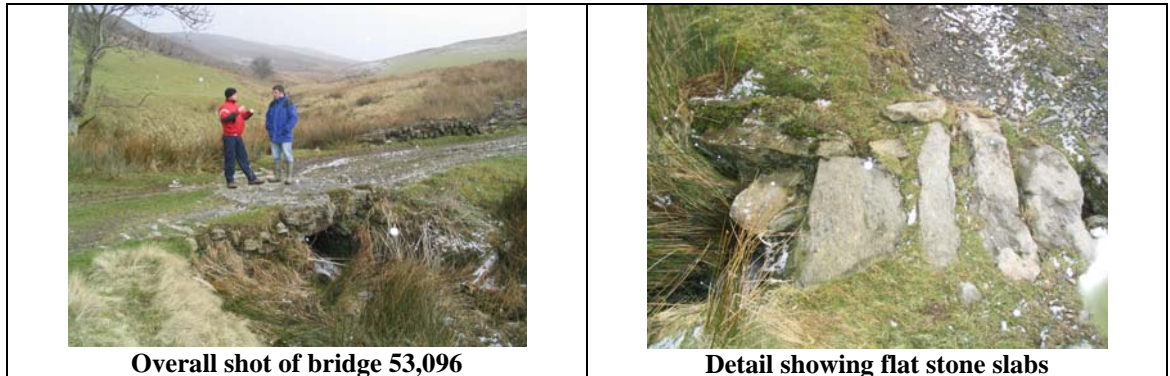
A series of long flat stone slabs underpin the more recent fabric of this bridge over Nant Gwynion

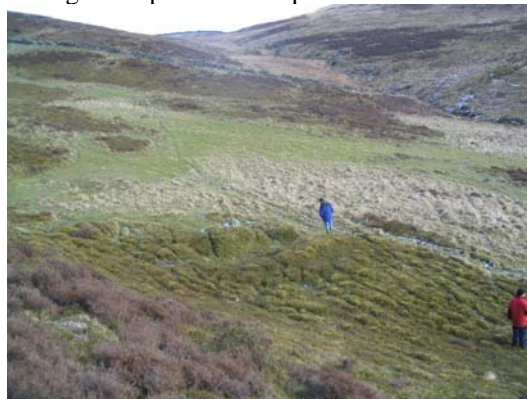
Linear depression in rough upland pasture. C. 4.5m long by 1.5m wide. Physical evidence and local knowledge suggest this was a storage clamp for root crops

**Storage clamp 53,098**

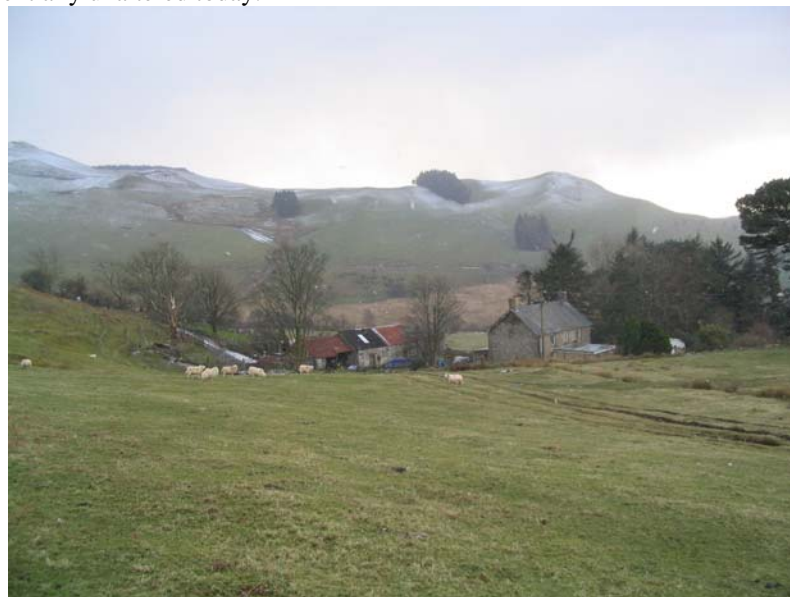
Ty Mawr is a working farmstead, with surviving traditional buildings. The complex retains many original features, including a goat pen, a pigsty and a threshing barn with original wooden threshing floor. The earliest known reference to Ty Mawr is provided on a map of the Nanteos Estate dated 1764, it is not clear whether any surviving building fabric dates from this time. By the time of the 1st and 2nd edition Ordnance Survey maps (1887, 1905) the farmstead is shown with buildings arranged on either side of the road. The house is set back on rising land on the northwest side of the road, whilst opposite on the southeast side is the barn range. This layout is essentially unaltered today.

**Ty Mawr farmstead (looking south)**

The farmhouse is of standard two storey, three bay type with central doorway and opposing chimneys in either gable-end. The chimney stacks have been rebuilt in brick, and most of the exterior is cement rendered. The western un-rendered gable end shows that the house is constructed of rubble-stone. A single storey, flat roofed extension has been added to the rear, and a glass conservatory area with pitched roof added to the front (southeast) elevation. The owners believe that an earlier house occupied the northeastern end of the now separate range of traditional buildings. There is no conclusive evidence of this, but a right angled stone wall, which could represent a former dwelling, now forms a retaining wall for higher ground, which carries the road running northeast out of the farmstead. Available earlier map sources (including the tithe map of 1845, and an estate plan of c. 1818?) suggest that the route of the road through the farmstead has changed. although

When replacing roof coverings, care should be taken to allow sufficient overhang at the eaves. Most traditional outbuildings did not have rainwater goods, but countered the potential problems caused by water running down walls, by providing larger overhangs at the eaves.

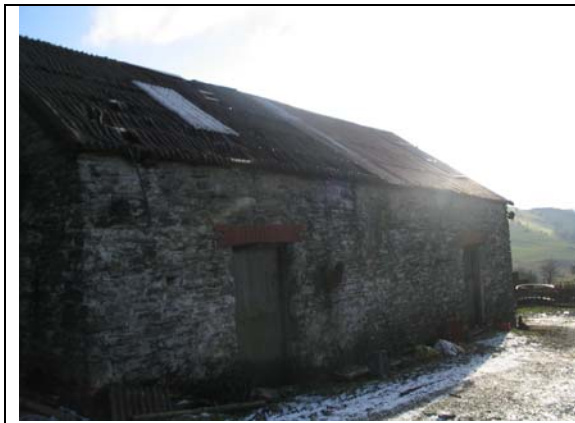
**Northeastern barn in the Ty Mawr range**

Ty Mawr has two separate barns. The buildings lie in a row, orientated northeast - southwest. The barn at the southwestern end is set back so that the front elevation is in line with the back of the northeastern barn. The northeastern barn is constructed of rubble-stone, and has two entrances with brick voussoirs to the front (northwest) elevation. This northwest elevation is one and a half stories high. The barn is asymmetrical - the rear (southeast) elevation rises only to single storey height. The rear roof runs down at a continuous pitch to meet the lower rear wall, providing an extra aisle at the back of the barn. Attached to the northeastern end of this building is a lower, open-fronted annex, with stone built gable end and back wall. The southwestern gable end of this building is stone built with two ground-level entrances and one window, all with brick voussoirs. A ventilation slit at second-storey level is constructed entirely of stone, and appears to be an earlier feature. The whole barn structure is currently roofed with a variety of corrugated materials. Much of the roofing material is in a poor state of repair, and water has entered, causing damage to roof timbers. The rear pitch of the southwest part of this barn has been re-roofed recently with corrugated metal sheeting. Unfortunately, there is no overhang to the roof at this southwest end of the barn. The ends of the purlins are exposed, as is the stonework at the top of the apex. If this problem is not rectified, water will penetrate the wall, causing instability, and eventual collapse.

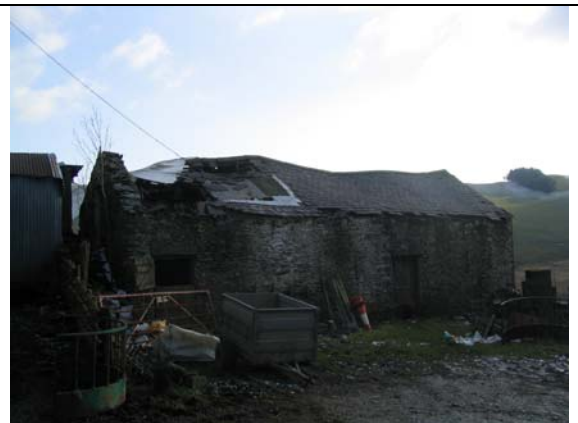
**Southwestern barn in the Ty Mawr range**

The southwestern barn appears to be the older of the main buildings within the farmstead. It is a threshing barn, and still accommodates a wooden threshing floor in the bay between tall front and rear entrances. Either side of the front entrance are two ventilation slits. The rear entrance has been modified to accommodate a metal door, and has been topped with breezeblocks, damaging the rigidity of this wall. The roof is slated, but is collapsing. Water has penetrated the roof and many of the supporting timbers are damaged.

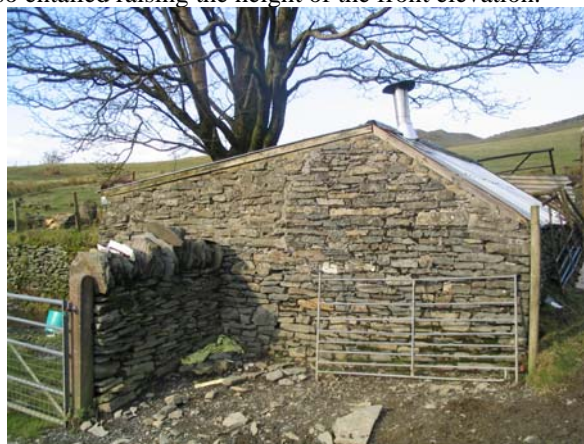
The pigsty lies to the northeast of the farmhouse, and is a rubblestone building with enclosure at the front, currently with corrugated tin roof, and protruding tin chimney. The building has been modified to create a drying room, which has also entailed raising the height of the front elevation.

**Pigsty at Ty Mawr farmstead**
