TIR GOFAL MANAGEMENT PLAN: HERITAGE MANAGEMENT INFORMATION (HE2)

Prepared for:
Waunfawr

Tir Gofal Reference No
W/11/4815

Report No. **2005/43**

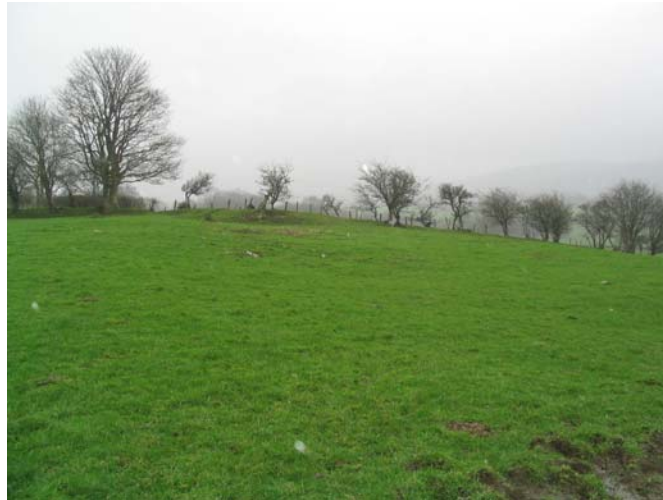
A small linear quarry shown on the OS 1st edition map (1890). Stone was extracted in recent years but the pit has since been filled in. A shallow depression in pasture now marks the site.

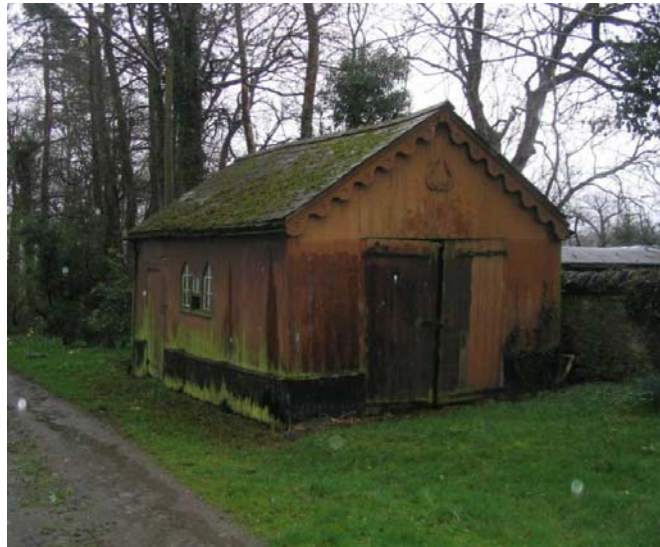
On the left side of the main drive to Waunfawr is an ornate coach house. It is of weatherboard construction with a slate roof and a low fringe of corrugated iron protecting the wall bases. Decorative detail includes the finely crafted barge boards and small pane windows with triangular heads. Internally the building is separated into two units; the coach house and tack room to the rear. A later nineteenth century date is likely as identified by map evidence (OS 1st edition).

The building is weatherproof and reasonably sound but has suffered from vandalism in recent years when part of the back wall was removed and the tack room damaged. Some sections of weatherboarding are beginning to decay.

The owner hopes to make repairs to the coach house and replace those parts which have been lost or damaged.

- Repairs should be based on an ethos of repair over replacement as far as is practicably possible in order to preserve the historic character of the building.
- Replacement materials should be on a like for like basis taking care to match new materials with old ones paying particular attention to details such as timber type, grain and finish for example. Seek specialist advice if necessary.
- Replacement features such as windows should be modelled on similar surviving examples.

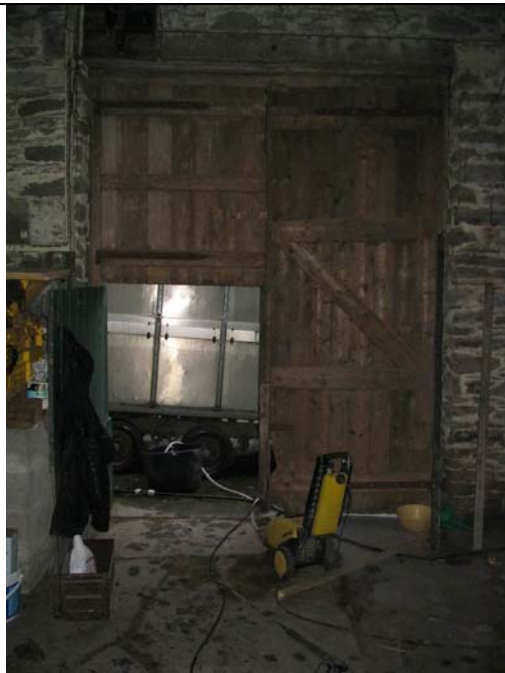
The barn doors appear to be original but are only partially complete with some half/ quarter sections missing. The intention is to renew or repair the doors as necessary following the original design.

The doors to the threshing barn are incomplete.

- Wherever practicable, repairs should be carried out rather than wholesale replacement of old fixtures and fittings.
- When repair is not possible, replacement features must be modelled on the originals, using the same materials and methods of construction.
- Door furniture such as original hinges, latches etc should also be re-used wherever possible and if not should be replaced on a like-for-like basis.
- Wherever possible historic finishes should be retained. Paying particular attention to any “estate colours” as appropriate.

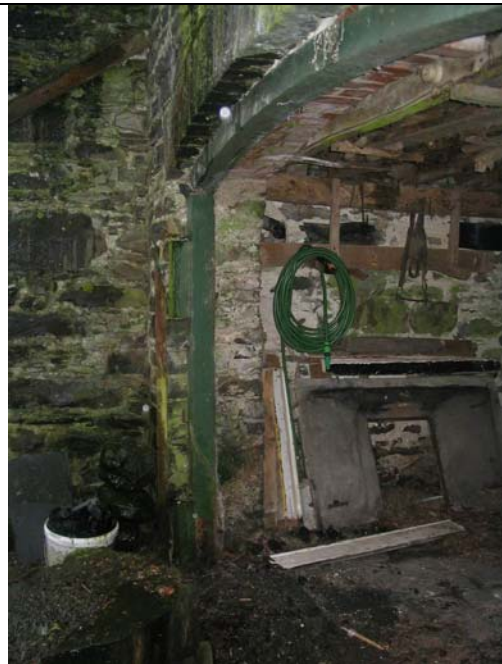
Only the frame of the cart door survives.

The cart shed door no longer survives and only the wooden frames remain.

- A replacement door should replicate the original, using the same materials and methods of construction.
- As the character of the original is not known in this instance it may be necessary to seek a replacement based on comparison with other cart shed doors. Some examples are included.
