TIR GOFAL MANAGEMENT PLAN: HERITAGE MANAGEMENT INFORMATION (HE2)

**Prepared for:
Glanystwyth**

**Tir Gofal Reference No
W/11/4975**

**ACA Report No. 2005-70
Project Record No. 52253**

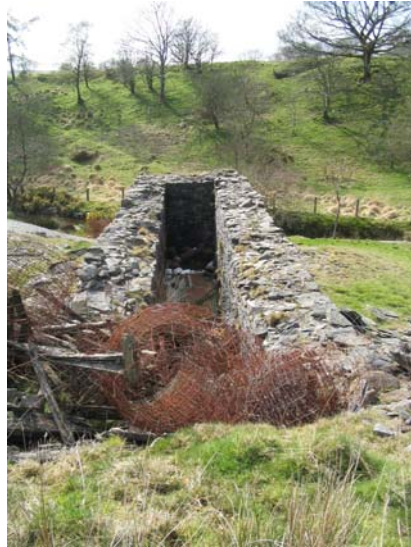
A wheel pit which forms part of the Llwyn-Malws/ Cwm Camddwr lead mine complex (PRN 26,566). This was previously recorded as a ruined drystone cottage in 1979. The wheelpit is stone built and lies at the western end of an aqueduct (both features are shown on the OS map of 1888). At the time of the archaeological farm visit, the wheelpit was still extant, and structurally in reasonable condition. However, there is loose stone at the tops of the walls, and the pit has been filled with farm rubbish (wire fencing rolls, corrugated tin, etc.). *Visited 21/04/2005 (HGM)*

Bwlchteulu wheelpit, looking west.

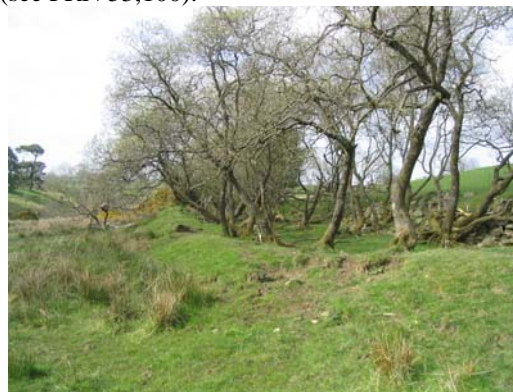
The site of the reservoir (see description below).

A reservoir lies to the south of the complex. It is linear and orientated north south, with an intact embankment on the downslope (west side). The pool has become very silted, so that the surface now has a cover of grass, and there are trees growing out of the centre. Farm debris including fencing rolls and posts is scattered around the site of the mine, but is particularly concentrated around the wheelpit (PRN 9255).
Visited 21/04/2005 (HGM)

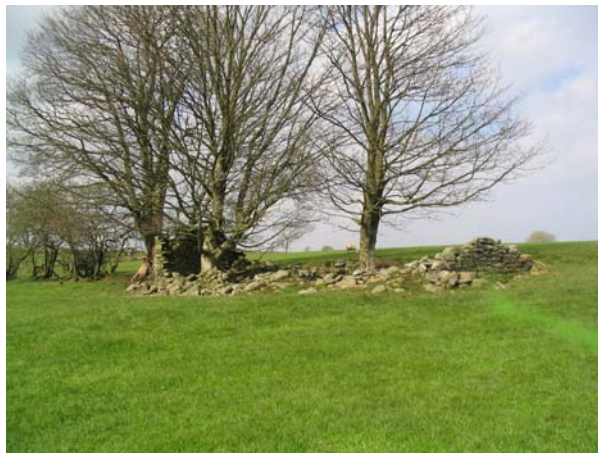
Ruined drystone cottage recorded in 1979. Shown as abandoned on 1964 1:10560 Ordnance Survey map. The remains of this cottage lie in improved pasture and comprise low rubble-stone walls with gable-ends at north and south surviving to a slightly greater height. Three mature trees currently grow within and around the walls, but other scrub has been kept to a minimum by grazing livestock. *Visited 21/04/2005 (HGM)*

The remains of 'Ynys'

Ideally the mature trees should be removed from this site.

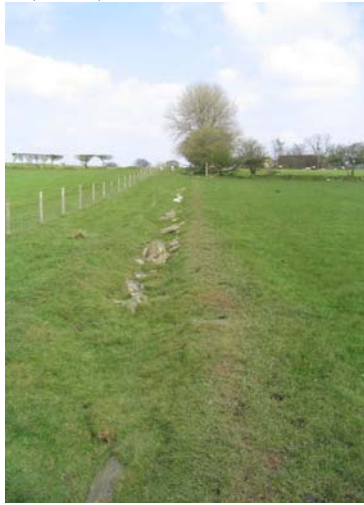
A long narrow channel running between the waterwheel at Bwlchteulu, and the main focus of Llwynmalws lead mine to the east. The earthwork is a very pronounced ditch in some places, which appears to have been

stone-lined along its entire length in the past. In some places the stone lining is intact, whilst in others large stones lie in heaps. *Visited 21/04/2005 (HGM)*

The stone-lined gully, used to house flat-rods

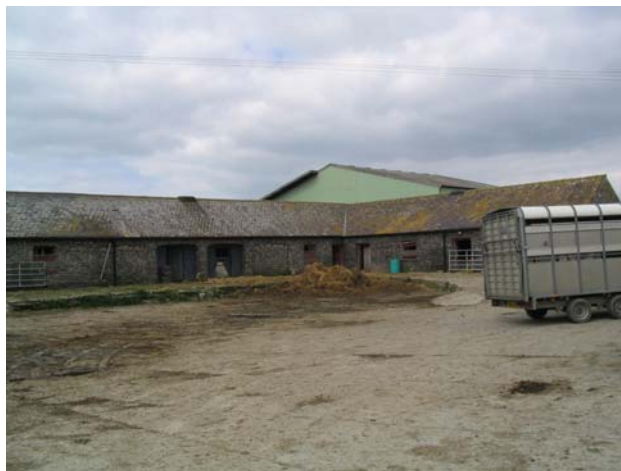
The traditional single-storey range of outbuildings at Glan-Ystwyth

The northern portion of the west side of the range has four wide, arched entrances, resembling cart-house openings. However, this is probably an open fronted stock-shelter rather than a cart-house. The ground level

immediately in front of the arches is raised above the level of the yard, and has a stone retaining wall (which appears to be an original feature). Two of the four openings have been blocked with stone of the same type as the surrounding structure, whilst the central two openings have had wooden panels added which accommodate single doors. Two buildings are slightly off-set from the main single-storey range. A two-storey rubble-stone barn with external staircase, and second-storey pitch-holes lies parallel with the southern row of stock sheds.

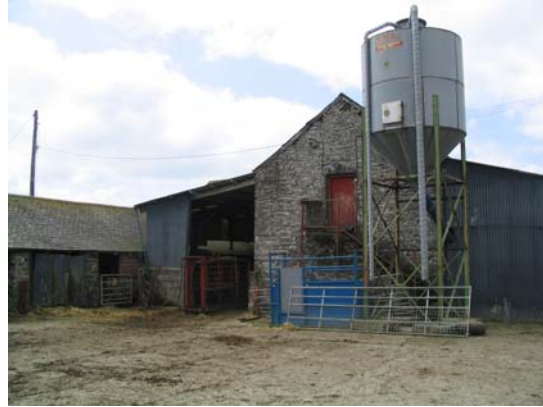
The two-storey stone barn with external staircase.

This is now flanked on north and south sides by modern shelter sheds. On the north-east corner of the yard is a long, low stone building, aligned north to south. The low entrances facing west distinguish it as a pigsty. Historic maps show that there were formerly pens on the west side of the building. The uniformity of material and style show that the traditional range was constructed in one phase. The separation of the outbuildings from the house, and their formal layout suggests that Glan-Ystwyth was a relatively wealthy farm. The function of the buildings points to this wealth being largely founded on rearing livestock. *Visited 21/04/2005 (HGM)*

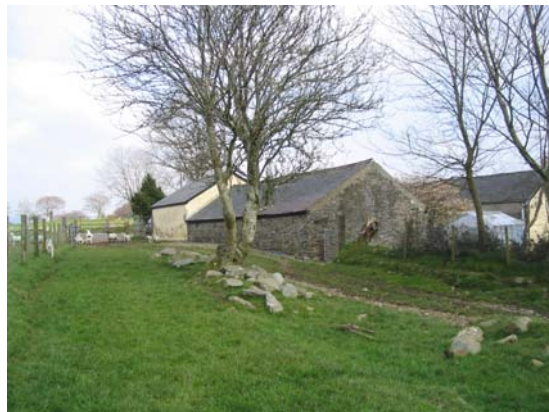
The present layout of this upland farmstead is the same as the layout shown on the first and second edition Ordnance Survey maps. Two almost parallel rows of buildings are orientated east to west, with the farmhouse to the south, and a row of outbuildings to the north. One building has exposed stone with pointing, and the remainder have been cement rendered. The farmstead was tenanted at the time of the archaeological farm visit, and so was not examined in detail. *Visited 21/04/2005 (HGM)*

Bwlch-Teulu farmstead viewed from the west.
