TIR GOFAL MANAGEMENT PLAN: HERITAGE MANAGEMENT INFORMATION (HE2)

Prepared for:
Troed -y-rhiw

**Tir Gofal Reference No
W/11/4878**

Report No. 2005/10
Project No. 52254

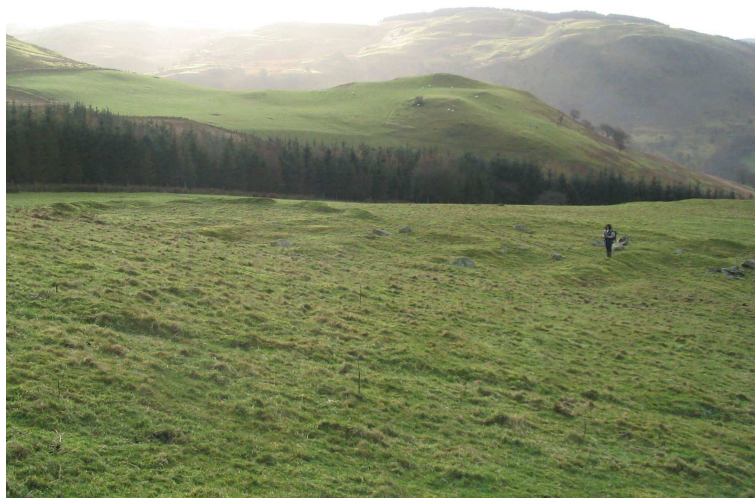
An upland deserted rural settlement complex overlooking the Teifi valley towards the ruins of Strata Florida Abbey and beyond. It consists of a series of building foundations with associated enclosures, which can be divided into three separate areas. The western part of the site is centred on a long rectangular building with an enclosure with raised beds to the west and another enclosure to the east with an attached small building. A relict field boundary links this to the central area. It has a rectangular building within a kidney shaped enclosure, with a figure of eight shaped enclosure and smaller building to the east. The eastern area lies some 100m to the southeast and consists of the footings of a very large stone building.

Looking southwest across the western part of the site.

The condition of the site is similar to that described during previous visits by Cadw. The livestock erosion mentioned in the central area is reduced due to a new fence line restricting access from the neighbouring field.

1. To cut and remove bracken from the central area. Work should be undertaken when conditions are dry and debris should be removed from the scheduled area. The monument may require subsequent protection and reseedling (using a locally sourced seed-mix) to establish grass cover;
2. To control any regeneration scrub on the monument by continued light grazing;
3. The removal of any discarded farm rubbish;

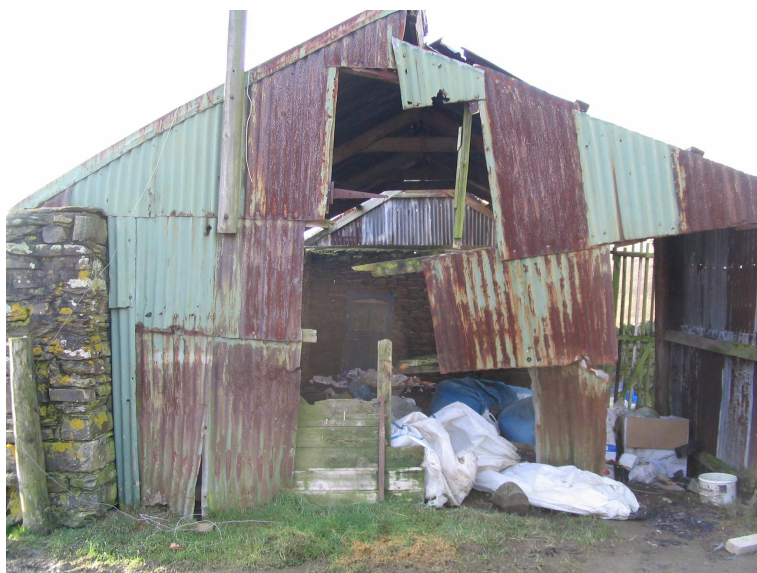
A working upland farmstead. The house is detached from the outbuildings which are centred on an adjacent yard. Troed-y-rhiw is shown on the Old Series Ordnance Survey map (1834) with buildings depicted in the present layout on the 1st edition map (1888). The house, in the regional vernacular style, of rubble stone with a slate roof and stone end stacks is sensitively maintained with a whitewash finish. Traditional farm buildings are ranged around three sides of a rectangular yard in a fashion typical of the nineteenth century. Buildings reflect a bias towards stock rearing typical of farming in upland areas. On the north side is a combination building incorporating cart shed, stable/ granary and ?threshing barn. Opposite, on the south side of the yard, is a derelict building, which retains only the original south and west outer stone walls. Its function is uncertain. There is a long low cow shed with end stall to the north. Recent years have seen modifications to traditional buildings but the basic nineteenth century layout remains intact and the farmstead retains good historic character.

Few original elements remain of the building on the south side of the yard.

It is proposed that a new shed will be erected on the site of the traditional building at the south end of the yard. *In addition to the generic management prescriptions listed above, the following management is recommended.*

The building is part of the historic farmstead plan, intact in 1888 and little altered today. Despite the current condition it still contributes to the group value of the farmstead by partly defining the south yard.

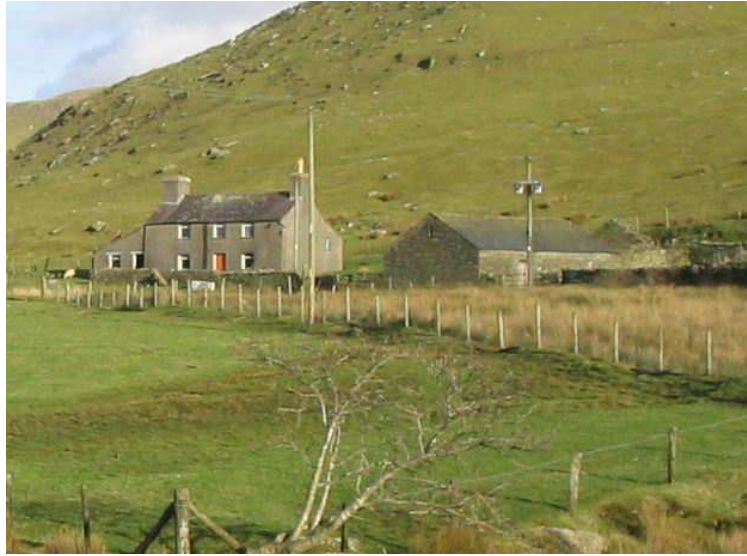
The cow shed is a long single storey range of rubble stone with a slate roof and retains many original features. There are three units; cattle housing, a stable and a separate end room. Wooden stalls and some original cow ties illustrate that cattle faced a feed passage across the length of the building. Also present is a hay rack and stalls in the stable, and sections of slate slab and pitched flooring throughout.

The house and yards are in good order but the cow shed is in a less stable condition. The end room is roofless and the partition wall with the stable is now only partially intact.

Looking northeast towards Fron-goch farmstead.

There is potential that the cow shed at Frongoch will be targeted for building restoration under capital works options offered within the Tir Gofal scheme. *In addition to the Generic Management Prescriptions listed above the following management is recommended.*

If building restoration is not undertaken the management aim is to slow down the deterioration of the building.
