TIR GOFAL MANAGEMENT PLAN: HERITAGE MANAGEMENT INFORMATION (HE2)

**Prepared for:
Tregwynt Farm
Tir Gofal Reference No
W/13/5251**

**ACA Report No. 2005-69
Project Record No. 52260**

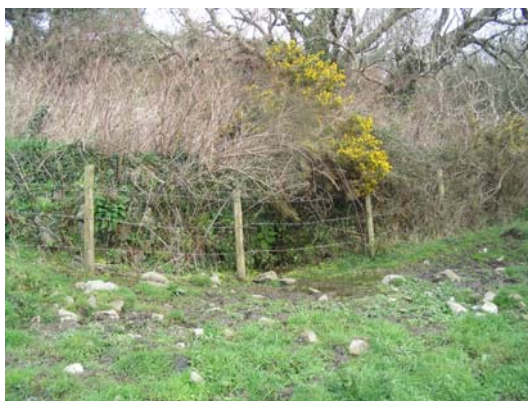
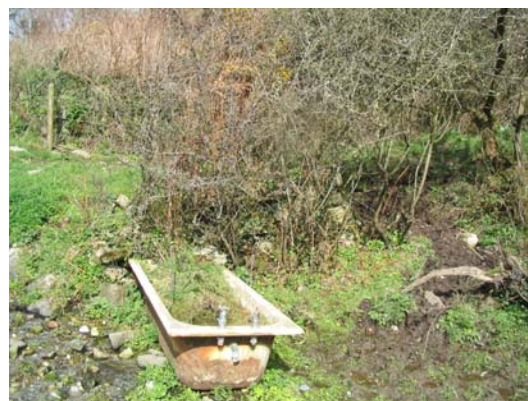
A well marked on the 1st edition Ordnance Survey map of 1889, called Llewellyn's Well. Still marked and named on current maps. Wells often represent landscape features of some antiquity, and may retain the vestiges of stone built standing structures around them. Wells were very important prior to the advent of mains pumped water. Many wells were imbued with religious and ritual significance in the past, and retained this significance until recent times. This well should be maintained as a feature of the historic landscape, and there are a number of management issues which need to be addressed. At the time of the archaeological farm visit the location of the source of the well was not obvious. Some water emanates from an enclosure up-slope of the main stream, and this enclosure appears to be associated with the well. Even though the scrub was not in leaf, the enclosure was sufficiently overgrown to be inaccessible.

Two views of Llewelyn's Well, showing location of possible source (left), and possible structural elements with bathtub used as watering trough (right).

There may be significant associated features which are currently covered by scrub. In the stream below the enclosure, some sort of stone structure was visible, which was very overgrown with thorn bushes, and had an old bath tub below it (being used to collect drinking water for livestock). Livestock watering around the well are causing very severe poaching, so much so that it is very difficult to approach the site of the well without sinking into deep mud. There is a public access footpath running close to the site, and the feature should be more visible and accessible. *Visited 06/04/2005 (HGM)*

Scrub clearance should be carried out inside the enclosure to the east, from which the water emanates. Scrub should be cut back, not uprooted.

Also scrub in the vicinity of the stone structure should be cut back to a manageable level (not removed as thorns were often integral to historic well sites).

Livestock should be excluded from the area around the well to prevent further poaching. However, scrub should continue to be controlled, and this may be best achieved by occasional light grazing when the ground surface has had chance to recover.

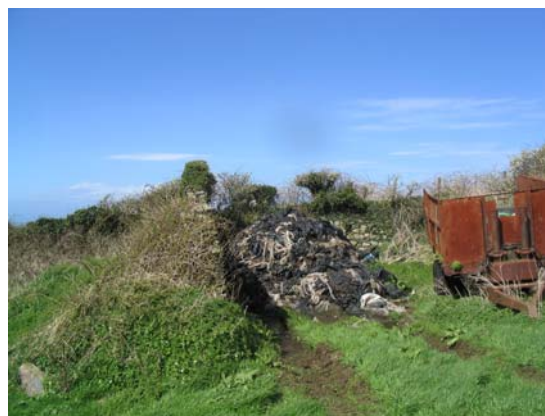
Marked on the first edition Ordnance Survey map as a rectangular building with a small enclosure to the northeast, and a larger enclosure to the southwest. Its location at the centre of the area marked as 'the warren' (PRN 12,015) may be significant. The back of the building is formed by a wall that divides 'the warren'. One stone built gable end survives, but is very overgrown with scrub. The area has been used to dump farm rubbish, and store machinery. *Visited 06/04/2005 (HGM)*

Building at the centre of 'the warren', looking northwest.

A building marked on the 1st edition Ordnance Survey map of 1889. It is aligned north - south, built of rubble-stone, and is now roofless. Enclosures to the west and south have substantial stone wall boundaries. Three prominent gable-ends stand to what appears to be original height, at the northern ends of three small cells, with single, offset entrances in the western elevation. The eastern elevation is formed by the boundary bank of 'the warren', which is faced with elongated stones, set vertically. The internal walls of these cells have remnants of mortar on them.

Farm rubbish and machinery should be removed from the area surrounding the remains of this site. Scrub clearance should also be undertaken to enhance visibility and prevent further deterioration of the remains.

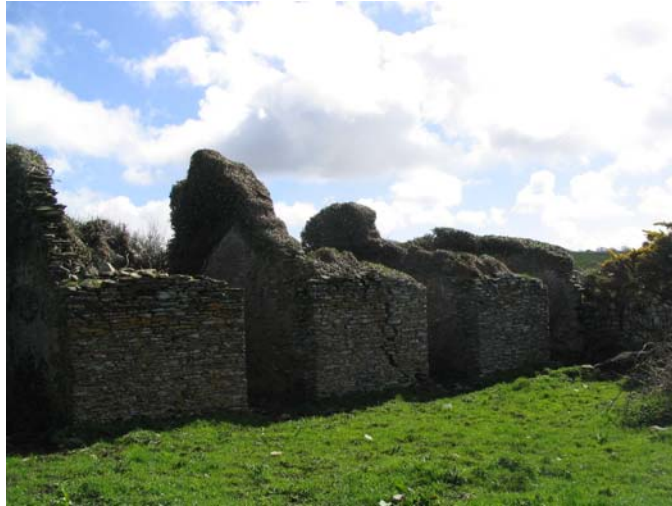
Northern portion of building, showing prominent gable-ends.

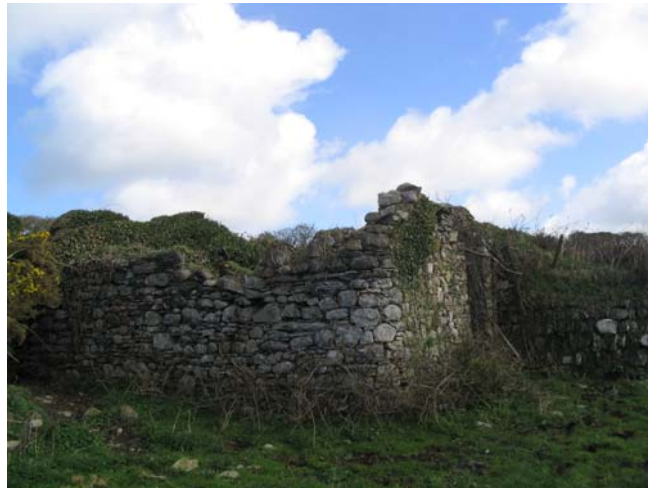
The southern portion of the building has a different layout. The inside was not accessible due to scrub growth, but externally the western elevation has no openings, there is one doorway to the south, but the eastern elevation (formed by 'the warren' boundary - see PRN 12,015) has two wide entranceways, which face into the warren.

Southern portion of building

The building is almost certainly an estate feature, as the associated small enclosures to the west and southwest incorporate the signature 'drum' shaped gate pillars, which appear on other gateways around the Tregwynt estate. The function of the building is unclear. It has been suggested that the northern part was stables, however it would seem strange for stables to be separated by such a distance from the remainder of the farmstead. The buildings position with relation to the boundary around 'the warren' is interesting. The boundary diverts from its otherwise uninterrupted curvilinear course, to accommodate the building, giving the impression that the two were built contemporarily. This suggests that the building was associated with management of the warren. In this light, the individual cells with stone gable ends, described above, may represent kennels. Dogs were sometimes kept as a means of capturing animals within the boundary of warrens. The two wide entranceways facing into the warren are difficult to interpret, but also suggest that this building's function was intrinsically linked with management of the warren. Scrub growth threatens the

structural integrity and visibility of this building, whilst livestock are free to roam within and around the buildings, causing poaching in this area. *Visited* 06/04/2005 (HGM)

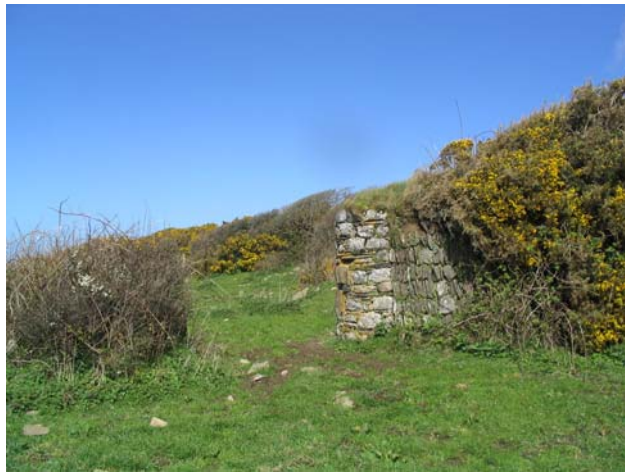
Enclosures associated with the building feature distinctive estate features including drum-shaped gate pillars and boundaries faced with vertically set stones.

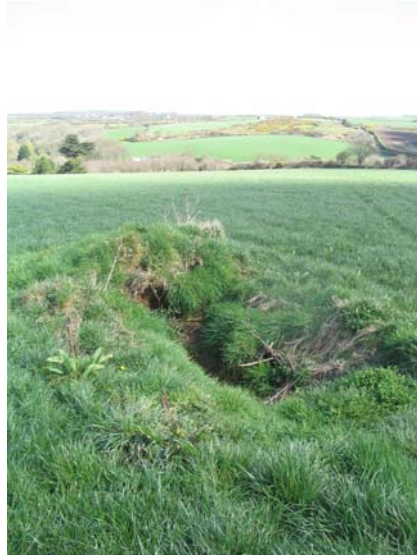
A stone marked on the 1st edition Ordnance Survey map of 1889. This may represent a prominent natural feature or possibly a deliberately placed monument such as a standing stone or boundary marker. During the archaeological farm visit this site was investigated and in the location marked 'stone' on the first edition was a deep scar which looks very like a socket for quite a substantial sized standing stone. The field appears to have been ploughed in the recent past, and the lack of infill, and the fact that there is no growth within the hole suggests that whatever was there has been removed relatively recently. There is a pile of large stones in the corner of the field which may contain the original stone. *Visited* 06/04/2005 (HGM)

Possible socket for former standing stone, looking north

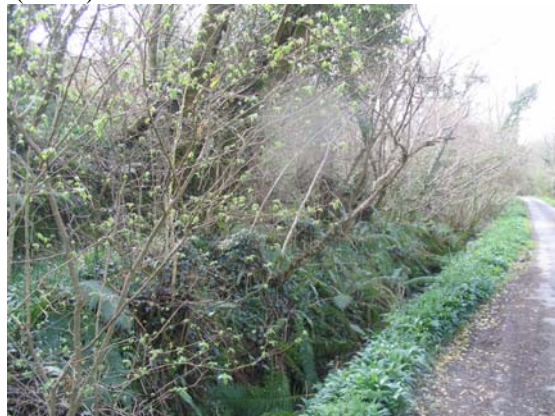
A mill race associated with Great Mill (PRN 4636), marked on the 1st edition Ordnance Survey map of 1889. The course of this race is still visible running along the northern boundary of the farm and alongside the road. *Visited 06/04/2005 (HGM)*

Mill race (feature to the left of roadside drainage ditch), looking west.

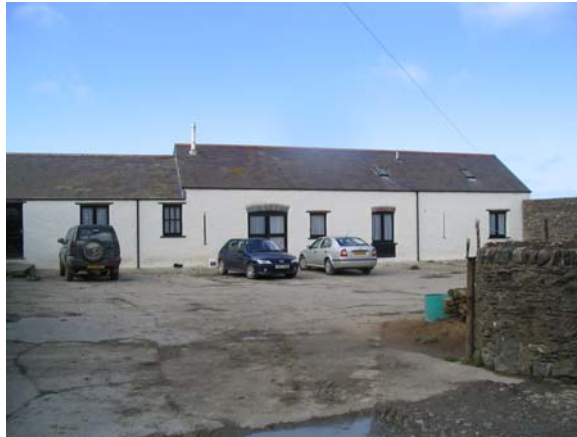
TRE-GWYNT (53757)	Post Med farmstead	SM8897734608	B	LB2*	Generic
A farmstead complex associated with Tregwynt Mansion (PRN 6893). The mansion is described as Georgian but with earlier origins. The farmstead complex in its' present layout, is marked on the 1st edition Ordnance Survey map of 1889. It includes a grade II* listed farm range (although the part of the range which falls within the boundary is not described in the Cadw listing).					
The farmstead elements that fall within the holding are detached from the main house.					
They include an L-shaped range, on the southwest and northwest sides of a cemented yard, which is enclosed on the other sides by a stone wall. The northwest part of the L-shaped range originally appears to

have been stock shelter sheds, with arched entrances and distinctive ventilation slits. This portion of the range is slated, rendered and whitewashed. It is in a good state of repair and has been converted for residential purposes. It is used as accommodation by the farmer.

The northwest arm of the L-shaped range, now used for residential purposes

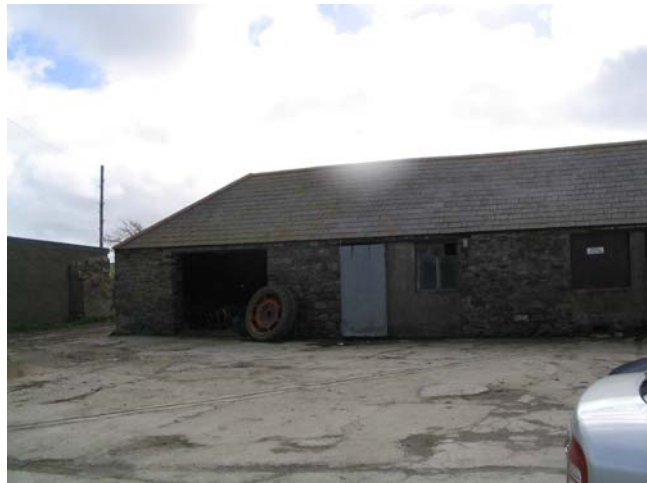
There are however, a number of traditional outbuildings, which are still being used for agricultural purposes. The southwest arm of the L-shaped range is bare stone, slated, with a hipped gable end. It appears externally to be in a reasonable state of repair, and is currently being used as workshop and storage. The function of the L-shaped range appears to have been to house stock.

Southwest arm of L-shaped range.
