## **TIR GOFAL MANAGEMENT PLAN: HERITAGE MANAGEMENT INFORMATION (HE2)**

**Prepared for:  
Upton Farm**

**ACA Report No. 2005/27  
Project Record No. 52264**

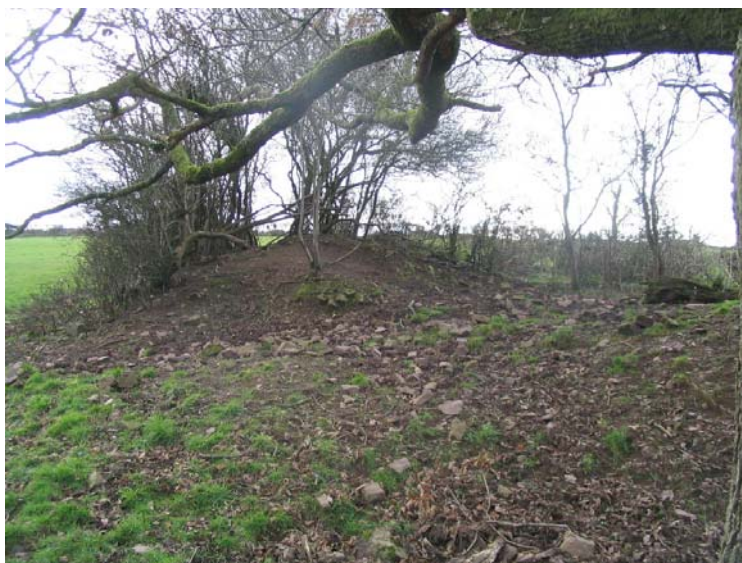
Livestock erosion in the south corner of the enclosure.

The enclosure lies within a pasture field which is grazed periodically by cattle. Grass is the dominant vegetation with intermittent bramble patches present. The site is vulnerable to erosion where the ground surface is shaded out and grass cover is poor. There is evidence that cattle congregate around areas of scrub and trees for shelter, rubbing etc. Erosion is most acute in the south corner where the rampart material is exposed and its profile worn down.

- Establish and maintain a permanent grass cover over the exposed areas of the site;
- Remove bramble growth to improve the appearance of the site;
- Prevent disturbance of the ground surface.

- Cut or spray back brambles on the interior and defences. Remove cut vegetation from the area of the earthworks. These areas may require subsequent protection and re-seeding to establish grass cover.
- Graze at a level which will prevent the breakdown of grass cover. Erosion scars on the earthworks should be allowed to recover naturally by fencing out the site for a period, but if this does not occur the area should be reseeded.
- Take care over the siting of new fencing. Fence posts should be placed a minimum of five metres away from the base of the ramparts in order to protect below ground archaeological remains.
- Consider leaving a minimum five metre cultivation buffer from the base of the ramparts in future in order to protect the ditch profile and below ground archaeology.
- Monitor mature trees on the earthworks. Consider felling mature trees which are at risk from windthrow.

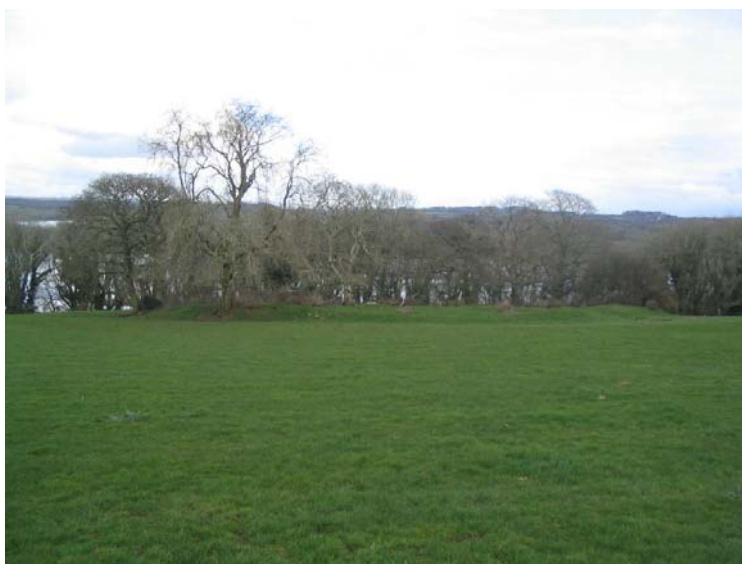
Looking north towards the enclosure and the Carew River beyond.

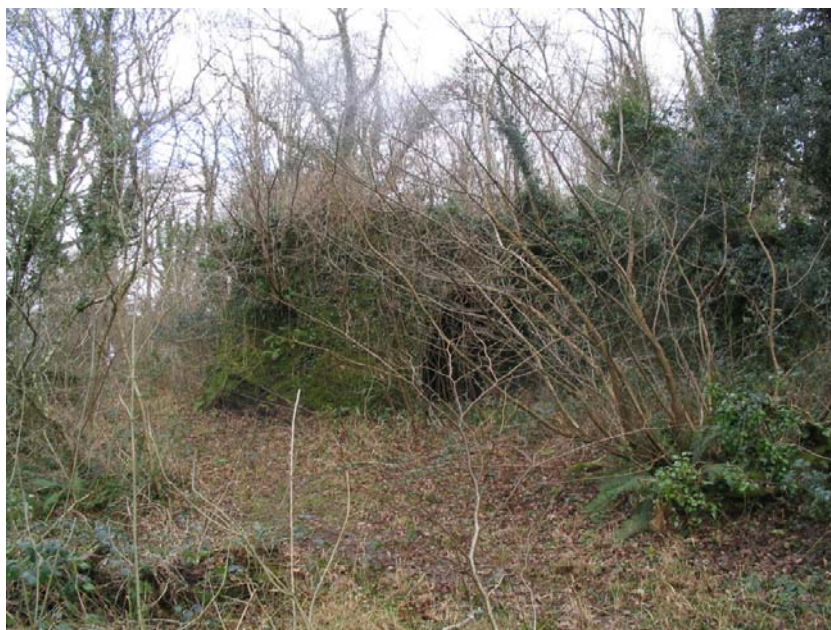
A lime kiln shown on OS 1st edition map (1887) at the head of Pill Susan. It is of the 3/4 circle draw kiln type, and set into a steep natural earth bank with charging platform to the rear. A stone kiln wall encloses the kiln pot. Opposing drawing arches with brick roofs and poking holes and kiln eyes still visible, are situated in the north and south. The kiln is relatively well preserved but the base of the northern arch has slumped inwards.

The limekiln lies within an area of unmanged woodland and is engulfed with scrubby vegetation. Moss and ivy obscures the structure and young ash trees have rooted in the walls. Several mature trees in the vicinity of the structure were felled by the National Park some years previously.

The limekiln as viewed from the south.

The limekiln is obscured by vegetation and root damage to the walls is occurring inevitably.

The management aim is to enhance the visibility of the kiln and reduce damage by vegetation.

- Cut or spray back the trees and ivy on the kiln walls leaving the roots *in situ*. Spot treat to prevent regrowth.
- Monitor mature trees close to the structure. Consider felling mature trees which are at risk from windthrow.
- Consider following vegetation removal with a programme of masonry consolidation and re-pointing using a traditional lime mortar mix. As a general rule repointing is not necessary until mortar has been weathered back to a depth equivalent to the joint width or is very loose. Seek specialist advice on an appropriate mix.

Work should only be undertaken if it is considered safe to do so.

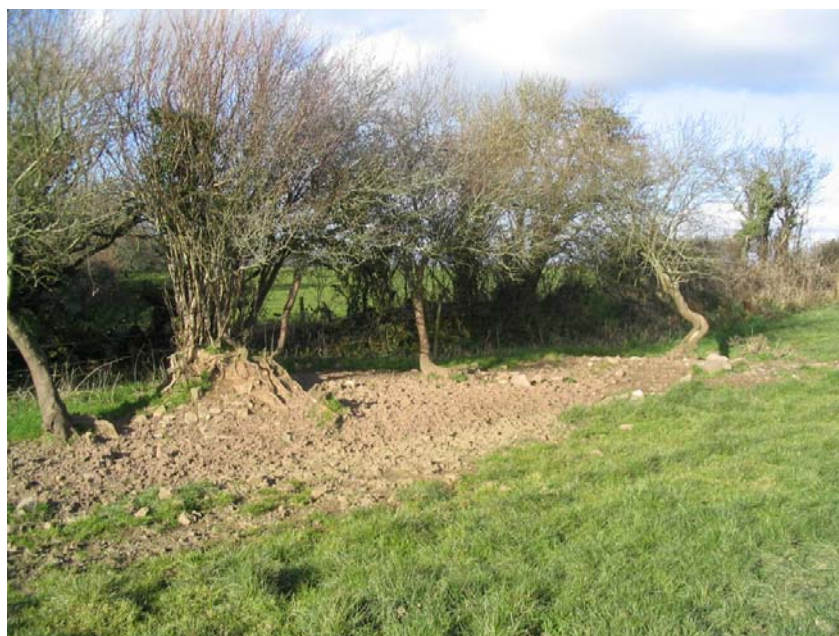
A cottage marked on the OS 1st edition map (1875) but not on recent cartographic sources. Only the wall bases survive. The site is in the corner of a pasture field and poached by livestock.

The former cottage site of Little Mayeston.

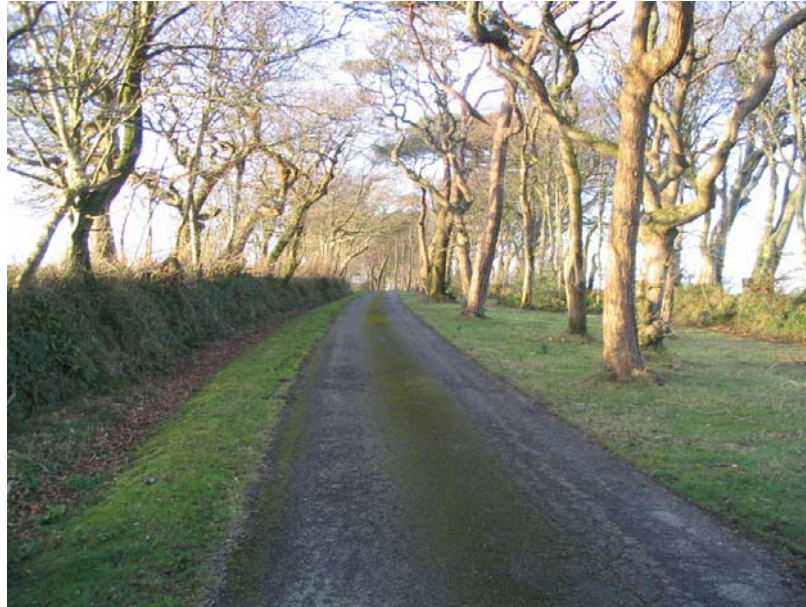
The main drive to Upton Castle. The drive runs north from Upton Lodge to the castle. At the entrance are two fine gate piers which stand with ball finial to about 2m. The grass to either side of the drive is planted with exotic shrubs and trees (Cadw/ ICOMOS 2002).

The condition of the drive is unchanged from that described previously.

Specimen trees flank the main drive to Upton Castle.

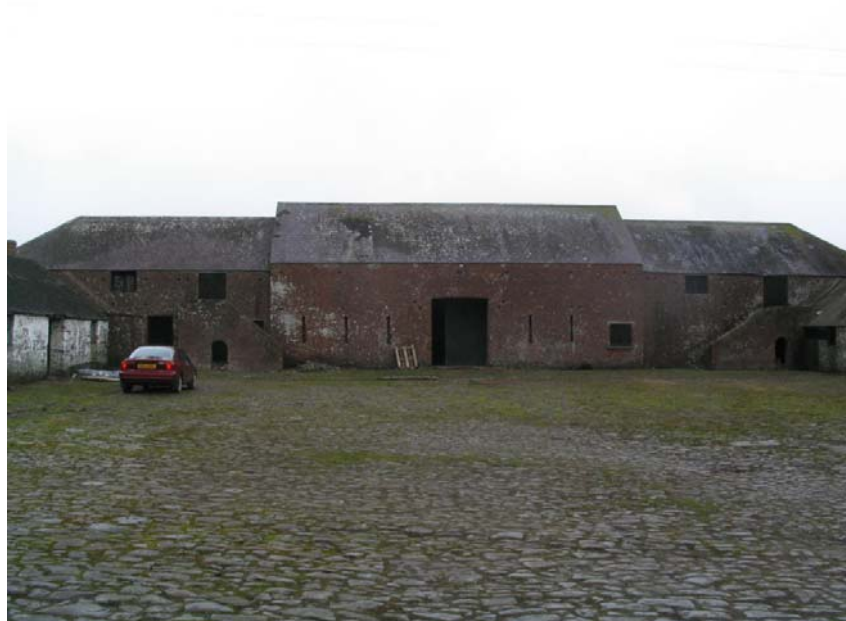
The home farm of Upton Castle. The farmstead is arranged around an intact cobbled courtyard with extensive late eighteenth/ nineteenth century farm buildings. A fine symmetrical hipped barn range at the head of the yard is exceptional in that it is built almost entirely of brick when similar barns in the region are exclusively of stone. Low rubble stone livestock sheds flank either side of the yard. In addition to the buildings mentioned above there are several outlying outbuildings, but none as impressive as the threshing barn. The house is at the south end of the yard and would originally have featured fine formal gardens (OS 1s ed.).

The farmstead has largely escaped modernisation and the current farm buildings are situated behind the courtyard to the north. The present layout is essentially unaltered from that recorded on the OS 1st edition map and probably much earlier. Farm buildings retain good historic character and are weatherproof but original slate roofs have been replaced in some examples.

The brick threshing barn at the head of the courtyard at Upton Farm.
