## **TIR GOFAL MANAGEMENT PLAN: HERITAGE MANAGEMENT INFORMATION (HE2)**

**Prepared for:  
Trehill Farm**

**Tir Gofal Reference No  
W/13/5306**

**Project Record No. 52266**

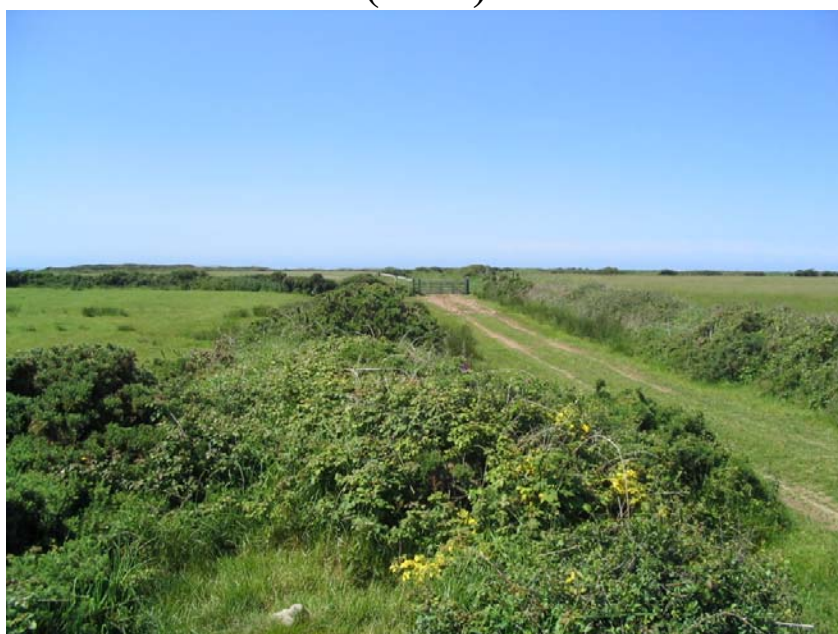
*View along the trackway lying to the north of Marloes Mere*

Trackway which historically formed the boundary between Marloes Mere to the south and farmed land to the north, of former strip fields which were latterly enclosed. This trackway is still a highly distinctive feature in the landscape, enclosed by two large stone and earth banks. The northern banks is fenced out from the enclosures beyond and is overgrown with scrub. The southern side is unfenced from the enclosures beyond which are grazed by cattle. In places this is causing some wear and erosion on the bank.

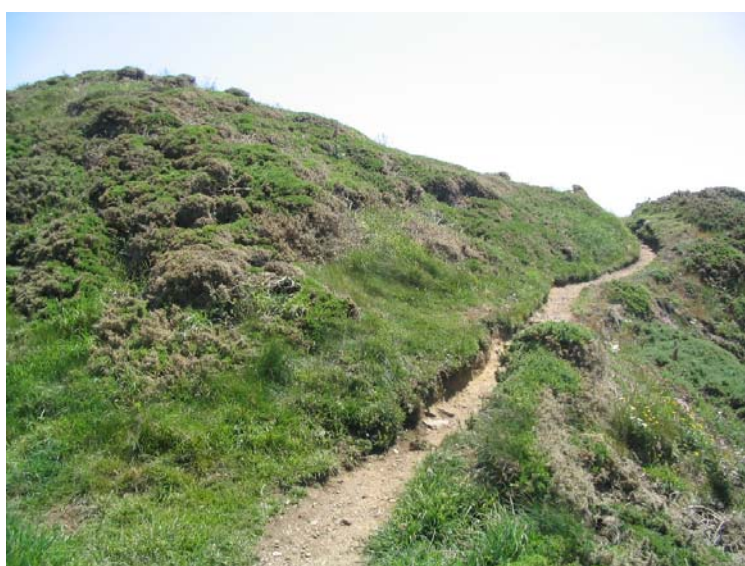
An Iron Age hillfort, consisting of a semi-circular triple bank and ditch system defending the promontory. Hillforts are generally recorded as having being constructed in the Iron Age (circa 600 BC - 100AD) but scientific dating of some archaeologically excavated sites has indicated that they may be Bronze Age in date (c2000 - 500BC). Hillforts are usually viewed as defensive structures built with the intention of defending and securing property. They are also locations for dwellings that were used on a seasonal or permanent basis. Sites such as these may have been used over very long periods of time and, therefore, were probably put to many different uses. The last Cadw FMW visit was made on 24/4/2002 (L. Mees). The condition of the site was recorded as worsened due to the problems with footpath erosion over the defences and through the interior. There was also some active animal erosion on the eastern bank (lying within a pasture field of Trehill Farm). The problems of erosion, described by the Cadw Field Monument Warden in 2002 are still evident; these are caused by the coastal footpath cutting across the ramparts at either end. In addition, erosion by livestock (at the time of the visit, June 2005, cattle were present) on the eastern banks (to the east of the stream) is particularly severe, causing scars in the profile of the bank approximately 0.30 m deep.

View of the western defences and the line of the coastal footpath cutting through the banks

The scheduled ancient monument of Watery Bay Rath is currently suffering erosion where the line of the coastal footpath cuts across the earthworks and also from livestock on the eastern defences. It is proposed that work is undertaken to address these problems. In consultation with Cadw and the National Trust the following management strategies are proposed with the aim of reducing erosion pressure on the monument and establishing a stable ground cover over the site;

- 1) A diversionary footpath should be established around the north side of the monument, to ease pressure on the pinch points where the current path crosses the defences.

- 2) Repairs to the erosion scars on the ramparts will be required. This should be discussed with the Tir Gofal Project Officer and Cadw. These works will require Scheduled Monument Consent.

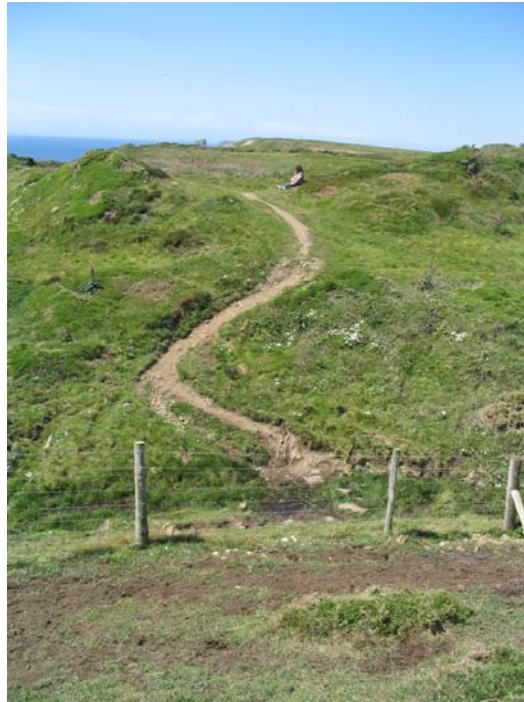
The eastern ramparts of the hillfort are also eroded by walkers on the coastal footpath

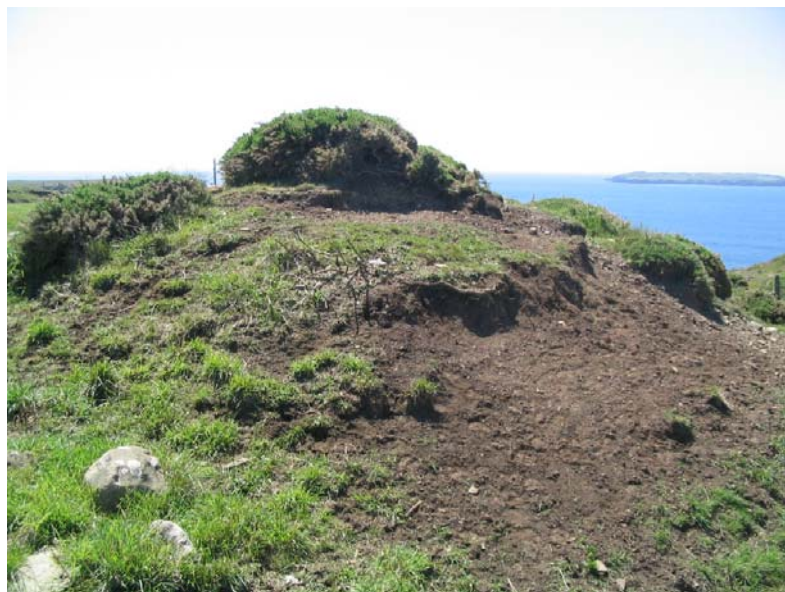
The easternmost banks of the hillfort are also under pressure from livestock grazing and congregating around the fenceline

- 4) Access by livestock to the earthworks which lie on the east side of the stream should be restricted by moving the existing fence at least 5 metres beyond the outer edge of the earthworks. The existing fence posts should be removed by cutting through at ground level and leaving the bases in place. The erection of a new fence will require Scheduled Monument Consent if it lies within the scheduled area. Any fencing should be carried out by driving in fence posts rather than digging out postholes.

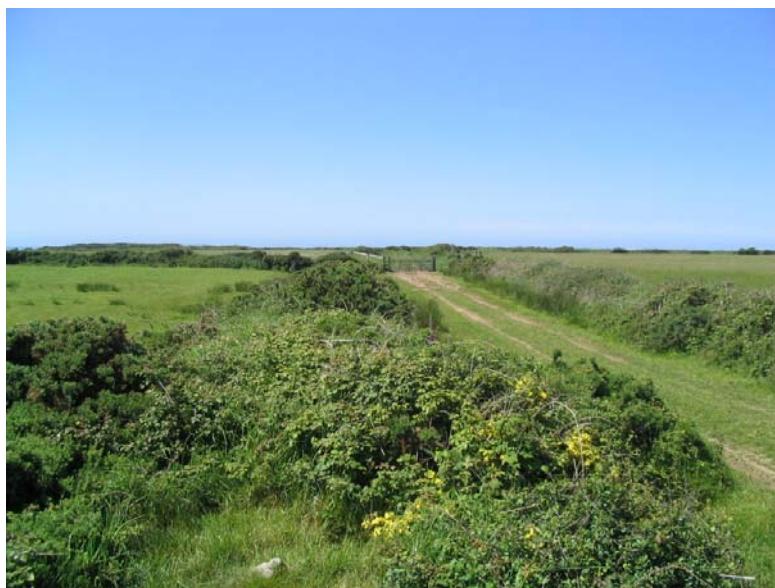
The trackway lying between the historic Marloes Mere and the farmed land to the north

The southern bank of the trackway should ideally be fenced in order to prevent cattle wearing a path over the bank.

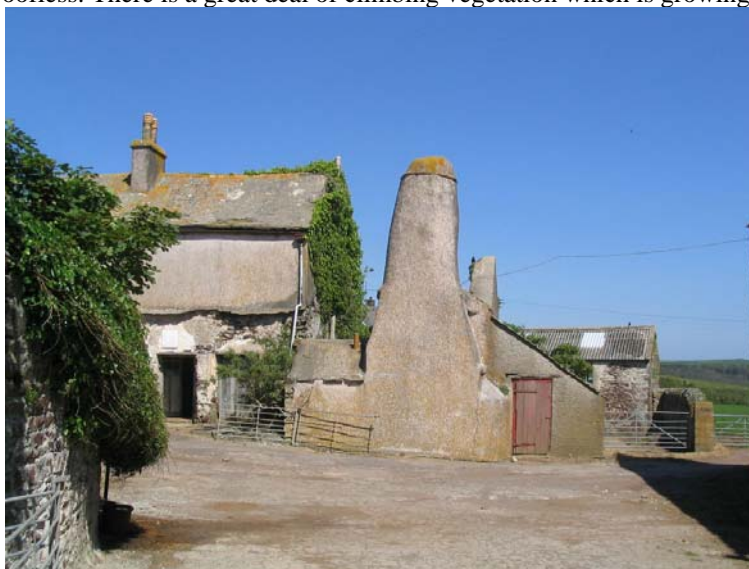
Historic home. Philbeach is first mentioned in the 13th century. Noted as being abandoned in 1986, part at least of the ruins of the old house appear to survive alongside a modern farmstead complex known as Philbeach Farm. The single room section at the southern end with a large round chimney is grade II listed as one of the last of the massive round chimneys surviving in this region. Adjoining this chamber is an late 18th / early 19th century farmhouse apparently occupying the site of the earlier medieval house which Fenton in 1811 describes; 'in this old house till very lately remained the old baronial hall, with a long oak table placed across the floor at the upper end, raised as in college halls, on a dais or steep'. It is possible that the medieval remains survive encased within the later building. The house is currently unused and derelict. The previous owners removed the internal floors to make use of the building as an agricultural store. The roof to the main farmhouse is still intact and appears fairly watertight, however the chamber adjacent to the round chimney is roofless. There is a great deal of climbing vegetation which is growing over the roof.

The historic house of Philbeach with the rare round chimney

The vegetation which is growing over the roof of the farmhouse should be cut back at root level and the stumps treated to prevent regrowth. The vegetation should be left to die in place and its removal should only be undertaken if it can be done with no further damage to the underlying roof covering or masonry.
