TIR GOFAL CALL OUT REPORT

Wireless Telegraph Station near Philbeach Farm, Marloes

**Tir Gofal Reference No
W/13/5306**

**Project Record No. 52266
Cambria Report No. 2007/12**

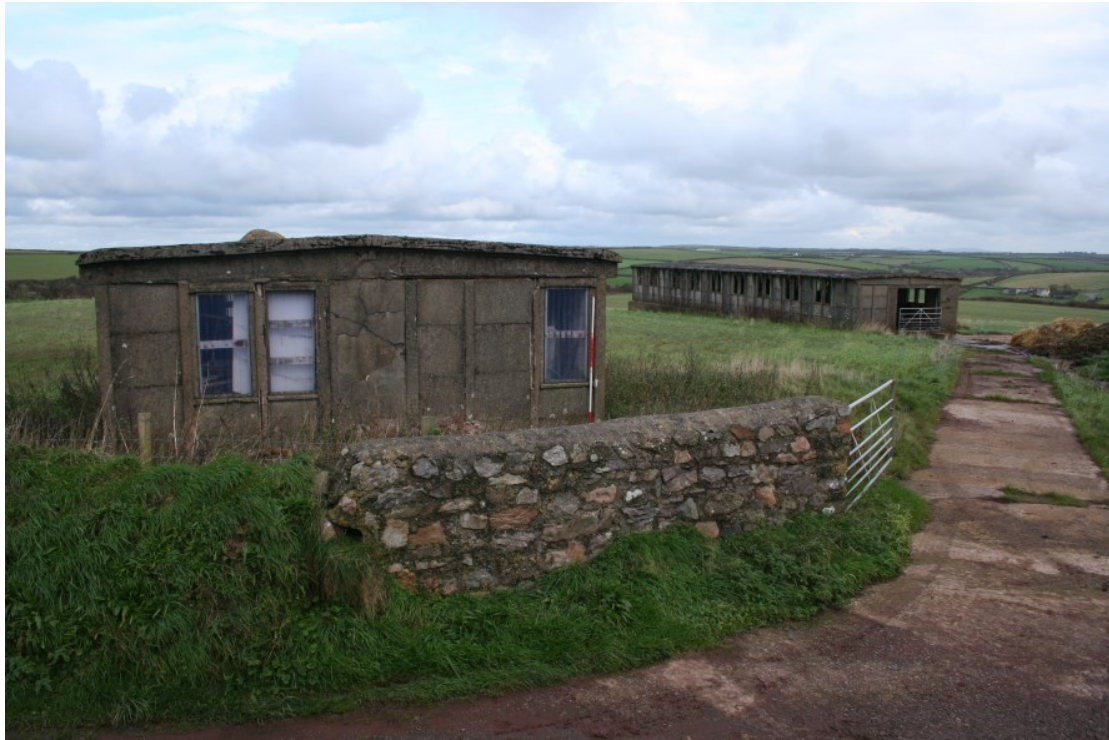
Plate 1 - General view of Wireless Telegraph Station; Guardman's hut (PRN 28643) lies in the foreground.

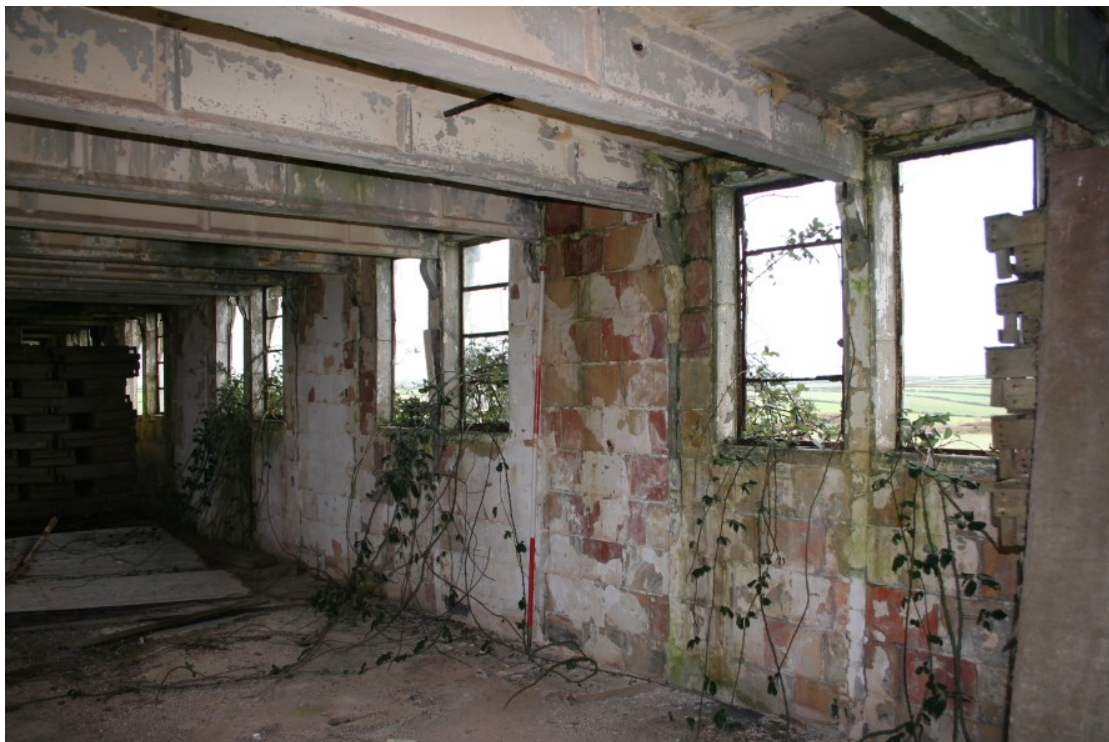
The two structures are essentially of the same construction, both are British Concrete Federation huts, built of pre-cast concrete and reinforced with steel rods. The huts are built in sections with concrete posts and beams and concrete panels between. Internally the concrete panels are lined with hollow clay bricks laid on edge (Plate 2). The huts are built on brick plinths, terraced out to provide a level platform on the gentle north facing slope.

Plate 2 - Interior of Wireless Telegraph Hut (PRN 28642) showing interior clay blockwork and concrete roof trusses.

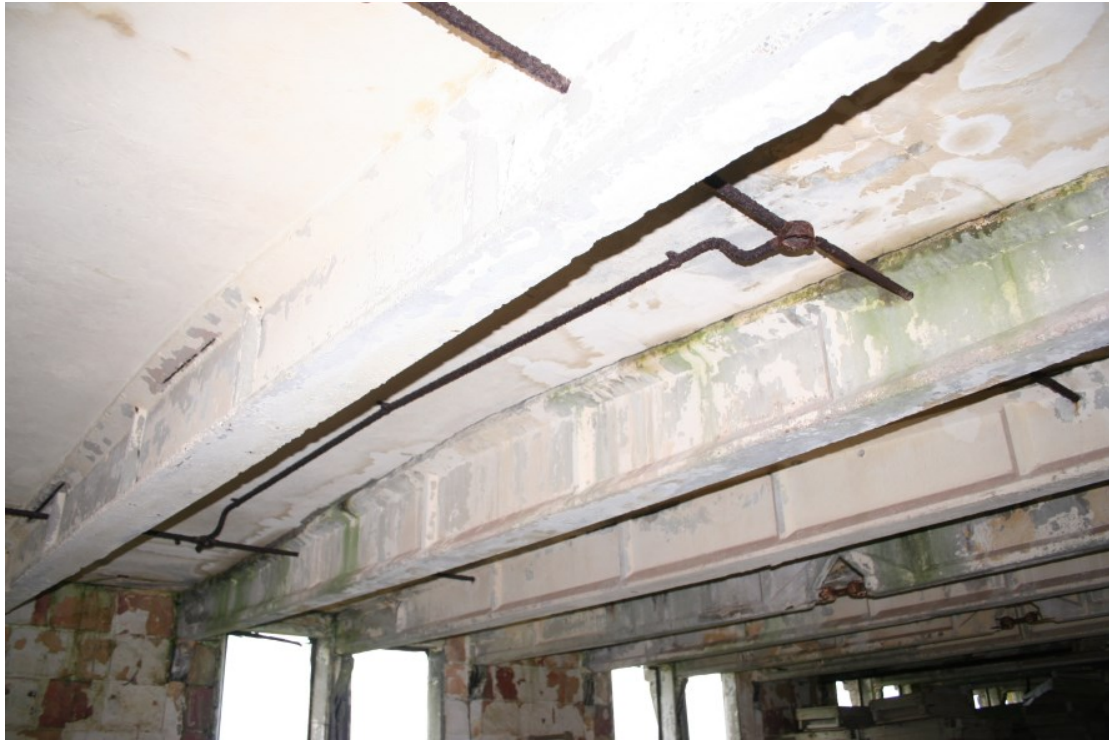
The huts have concrete, depressed gable roofs which appear to have been painted over with several coats of tar. The roof structure is constructed of closed concrete reinforced trusses with the occasional truss having an exposed steel threaded rod at the centre which, it is presumed, is to provide tension. Piercing the roof trusses are a series of steel electric conduits which run down the length of the buildings branching off in places to run services to various parts of the building (Plate 3).

Plate 3 – Interior of Wireless Telegraph Hut (PRN 28642), showing electrical conduits, also note steel tensioning in two of the concrete roof trusses.

- identifying subdivisions or partitions within the buildings
- the layout of electrical conduits
- internal decoration and paint schemes

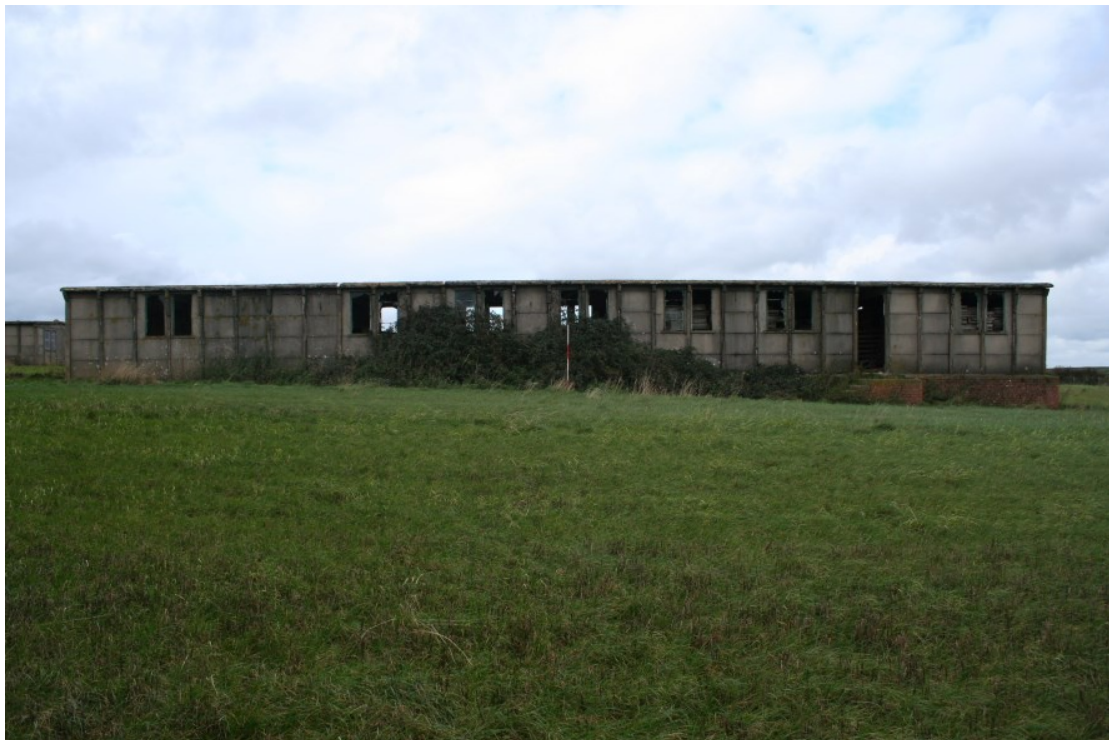
This hut is rectangular in plan and 29 bays long (Plate 4). No internal wall divisions remain although scars on the floor surface indicate partitions, however the quantity of storage materials obscured most of the interior. The flooring, where visible appears to be made up of concrete overlaid with asphalt.

Plate 4 – Eastern elevation of Wireless Telegraph Hut (PRN 28642)

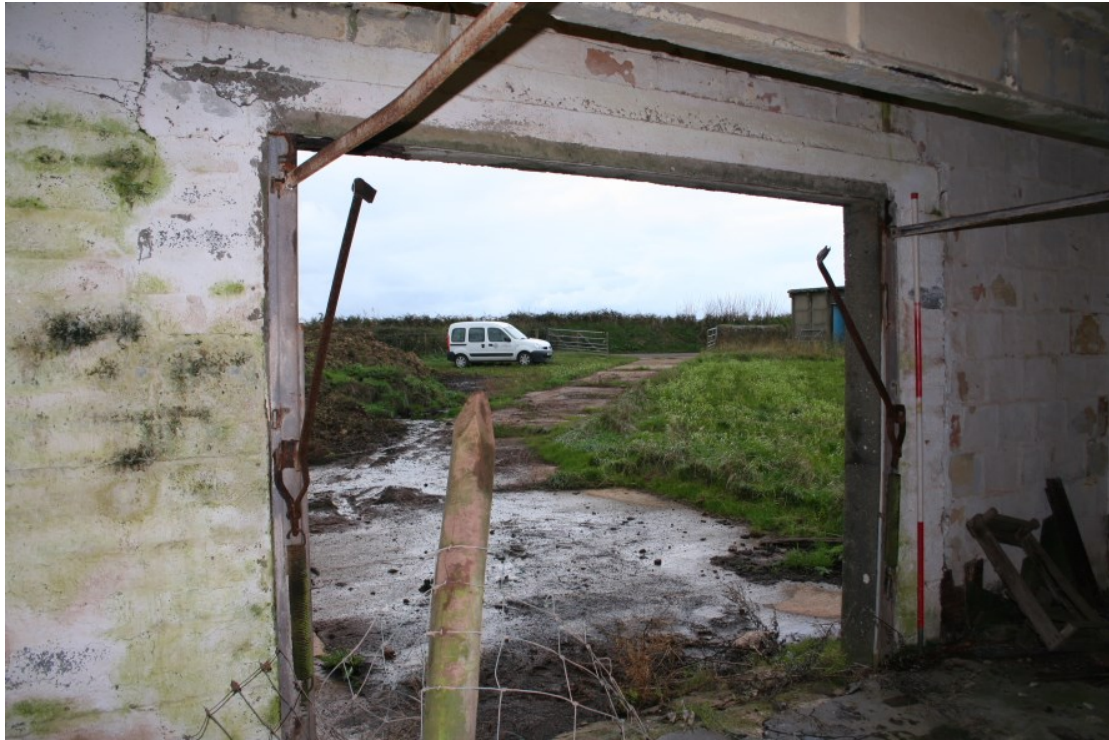
A large entrance at the southern end has been inserted into the building and the remains of an 'up and over' door mechanism survives (Plate 5). The entrance is placed east of centre in the south elevation.

Plate 5 – large inserted entrance in Wireless Telegraph Hut (PRN 28642)

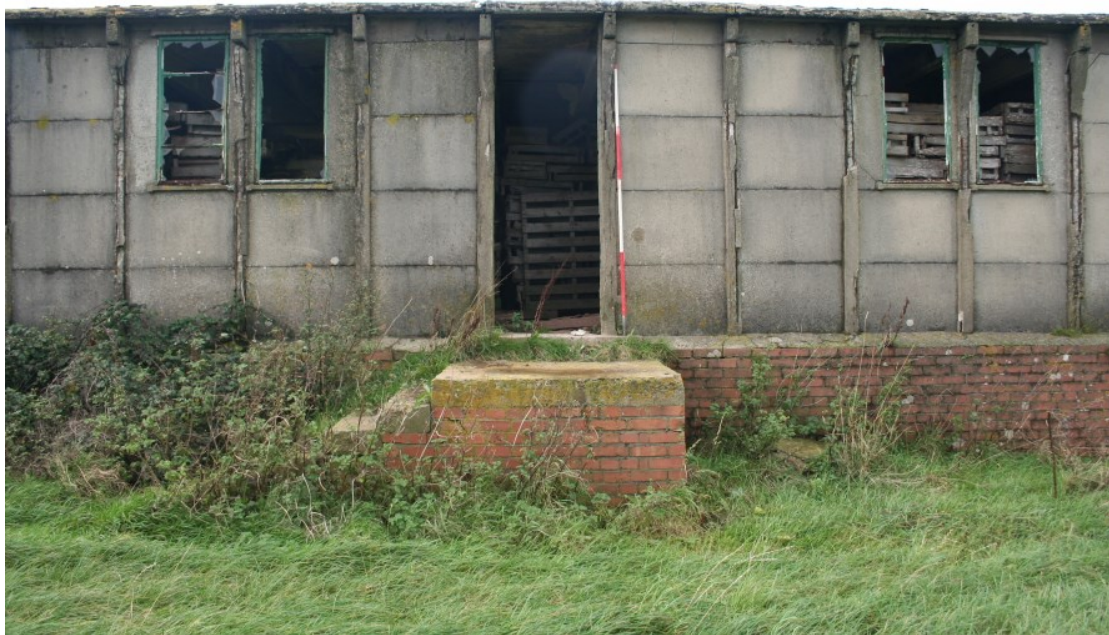
A further, original, doorway survives at the northern end of the east elevation, reached by a series of brick and concrete external steps (Plate 6). A wooden plank door with latch lies on the floor of the hut – and although this is clearly the last door to be hung at the doorway, it is unlikely to be the original door.

Plate 6 – Doorway and external steps in the eastern elevation of Wireless Telegraph Hut (PRN 28642)

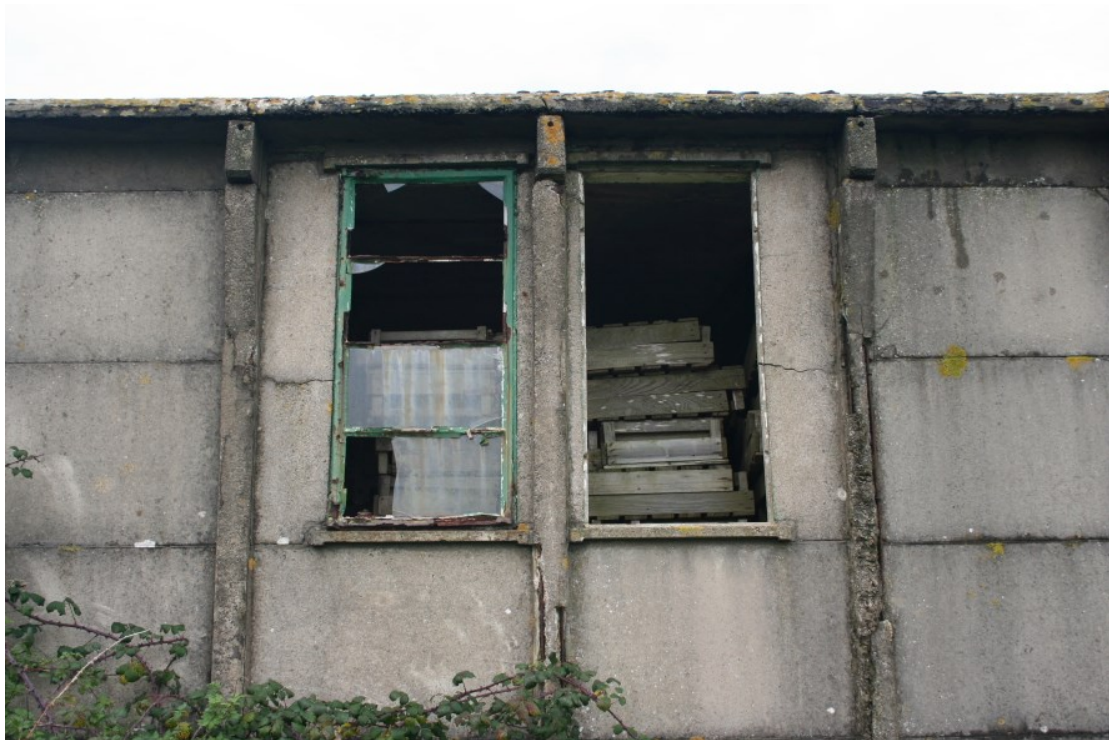
Pairs of metal, side-hung casement windows punctuate the long elevations (Plate 7). Each casement has 4 panes of glass and the frames have been painted bottle green. There are no openings at the northern end of the building although there is a wider central panel to accommodate a doorway.

Plate 7 – Exterior detail of casement windows in the eastern elevation of the Wireless Telegraph Hut (PRN 28642)

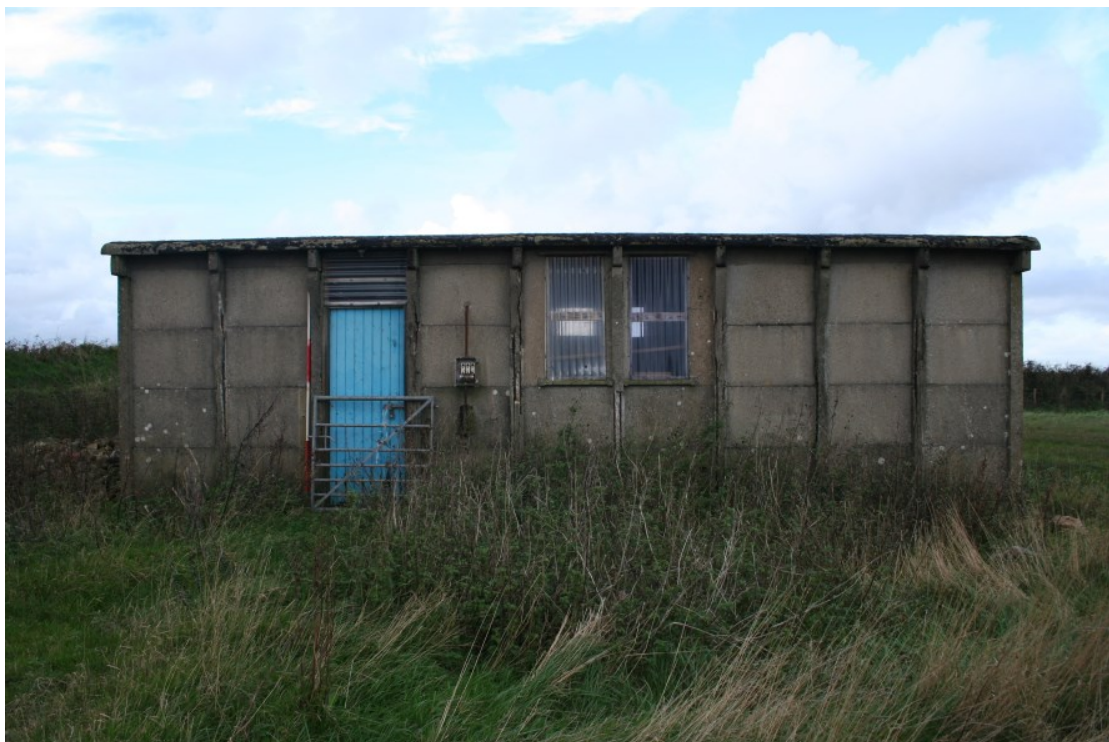
This is the smaller of the two structures and lies adjacent to, but set back from the public road. The hut is 9 bays long, no internal divisions survive (Plate 8).

Plate 8 – Eastern elevation of the Guardsman's Hut (PRN 28643)

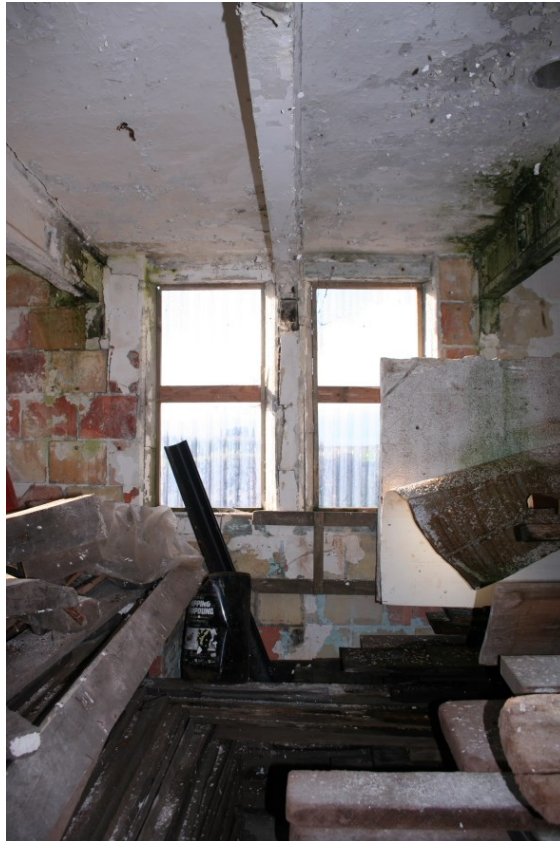
The internal elevations have been painted blue below window level and there are traces of green around the doorway. Latterly the interior has been painted over with white paint (Plate 9).

Plate 9 – Interior of the Guardsman's Hut, note the blue paint scheme which shows below the window.

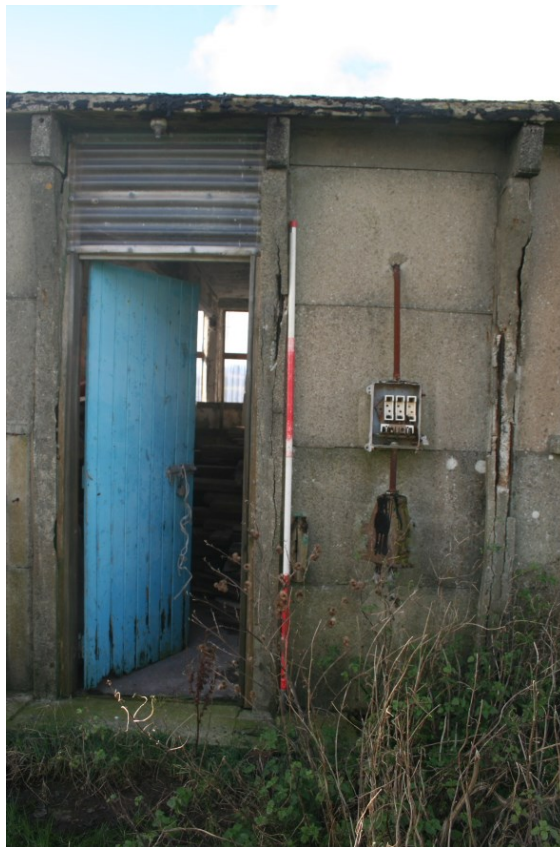
Cabling pierces the east wall on the north side of the door, and on the exterior an electrical distribution board is located (Plate 10), presumed to have an isolator switch for the power supply.

Plate 10 – Doorway and exterior electrical distribution board on the eastern elevation of the guardsman's hut

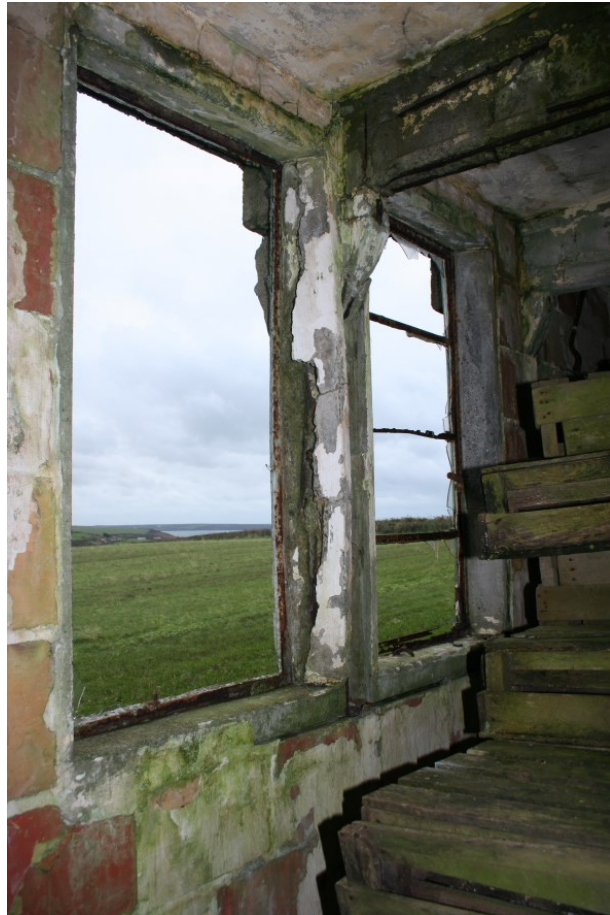
As is common with pre-cast reinforced concrete buildings which were constructed to only last for the duration of the war these buildings are showing signs of deterioration. The reinforcing rods which run through the structural posts are corroding and consequently the rigid concrete casing is blowing apart (Plate 11). Whilst the buildings may remain standing for some years to come, the active corrosion of the structural members is cause for concern. Whilst it is possible for reinforced concrete structures to be repaired and conserved this would entail specialist knowledge and therefore is likely to be expensive.

Plate 11 – showing corrosion of steel reinforcing rods which run throughout the buildings.

In terms of their future; ideally these buildings should be retained and reused. Plans to incorporate them into a new farmstead development proposed by the land owner might ensure their future survival and would be worthy of consideration, although this decision will ultimately lie with the local planning authority.

However, if there is no alternative but demolition of this complex then Cambria Archaeology would strongly recommend that further recording should be undertaken when the buildings are emptied in order to record those areas where access was not possible.
