TIR GOFAL MANAGEMENT PLAN: HERITAGE MANAGEMENT INFORMATION (HE2)

**Prepared for:
Freestone Hall
Tir Gofal Reference No
W/13/5423**

**ACA Report No. 2005-68
Project Record No. 52272**

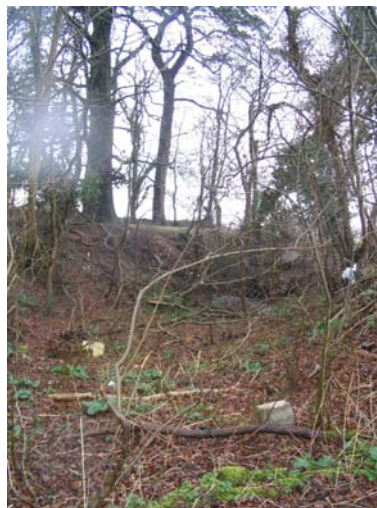
Name (& PRN)	Period/Site type	NGR	Status SAM/listing	Management required
2	<u>(52209)</u>	Post Med gravel pit	SN0538305629	B	Specific
A gravel pit marked on the 1st edition Ordnance Survey map of 1865. Visible on the ground as a linear depression with saplings, scrub and some tipped rubbish. <i>Visited 16/03/1905 (HGM)</i>

Gravel pit, looking west

Site 2 on MAP 1 (52209) **SN0538305629**

This site would benefit from clearance of dumped rubbish and scrub.

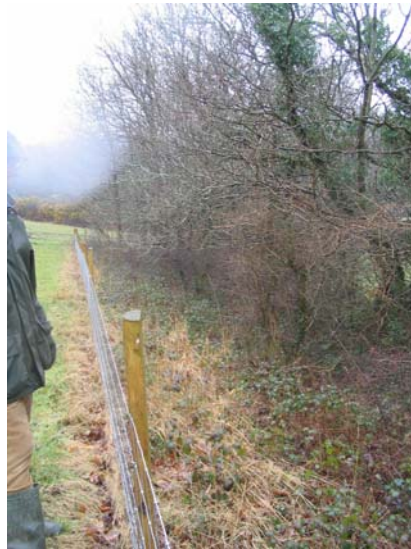
What appears to have been a trackway, sunken below surrounding ground, now covered with scrub. Two stone gate pillars mark the north end. This does not appear as a current route on any of the available historic man sources. or on modern mans. suggesting that it pre-dates these. and may be associated with coal mining

at the end of the eighteenth and beginning of the nineteenth century. *Visited 16/03/1905 (HGM)*

Former trackway, looking north

Site 4 on MAP 1 (53107) **SN0547605708**

Some scrub clearance would enhance this feature's visibility as part of the historic landscape.

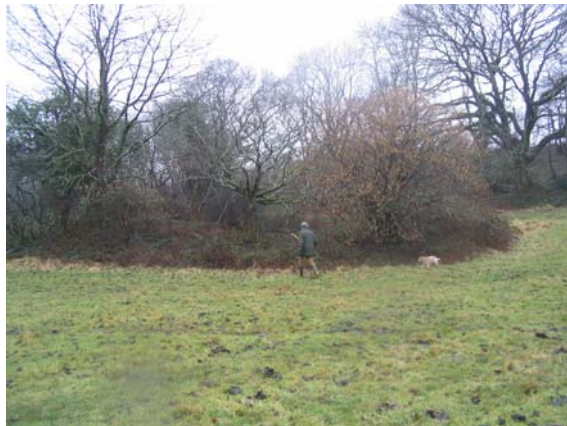
A refuse heap large enough to be marked on the 1st edition Ordnance Survey map of 1865. The site visit demonstrated that this was in fact a coal tip, and presumably by the time of the 1865 OS map it was being used to dump rubbish, probably from the house and farmyard. The fact that it is not labelled as 'old coal mine' on the OS map of this date suggests that it had been out of use for some time. Trees and scrub have grown on top of the remains, which consist of a central depression surrounded by raised piles of earth, presumably tips from mining activity. Its labelling as refuse heap during the late nineteenth century also suggests further archaeological potential in terms of dumped remains. *Visited 16/03/1905 (HGM)*

Refuse tip; coal mine viewed from northwest

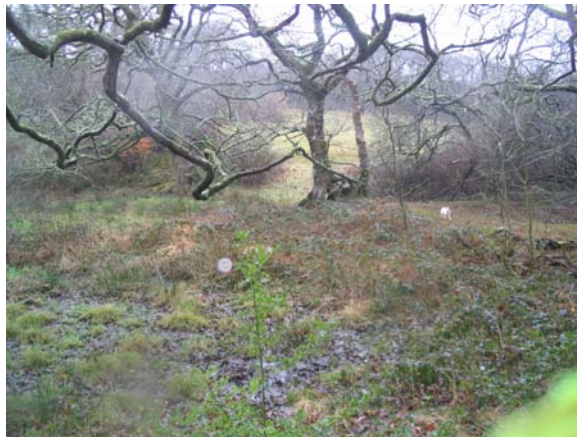
An area of marshy ground close to the stream edge, which has been subject to the creation of areas of banks and drainage channels. It is not clear what these represent, or what activity they are related to. *Visited* 16/03/1905 (HGM)

Marshy area with banks and channels

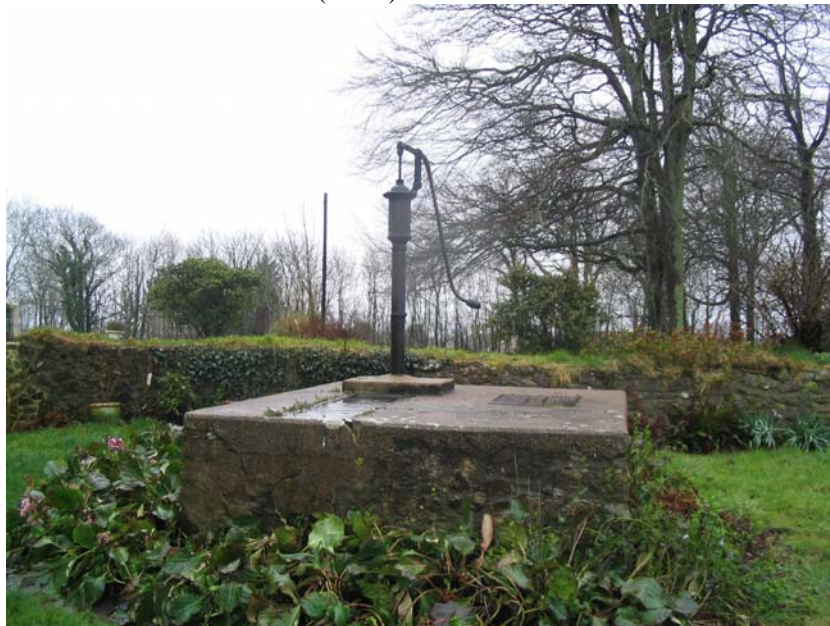
Well with cast-iron hand pump set in concrete capping. The capping surmounts a stone structure, and covers a deep stone-lined shaft. *Visited* 16/03/1905 (HGM)

Well with hand-pump.

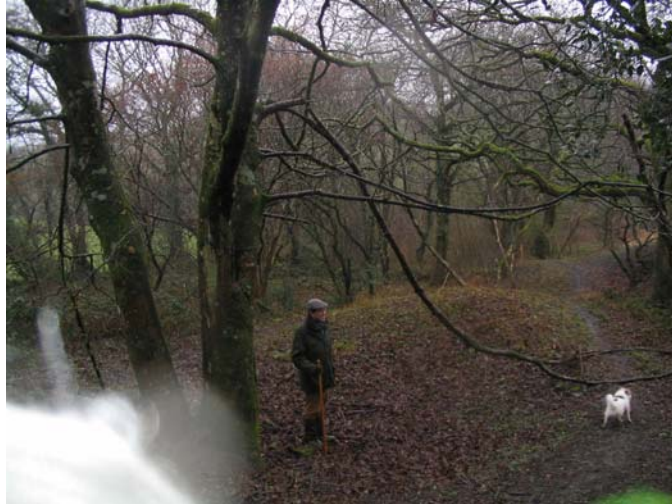
An area of depressions and banks, under woodland with some scrub. It is not clear what these earthworks represent, and it was difficult to ascertain their full extent, but their scale and location suggests they may be related to mining activity. *Visited 16/03/1905 (HGM)*

Area of banks and depressions.

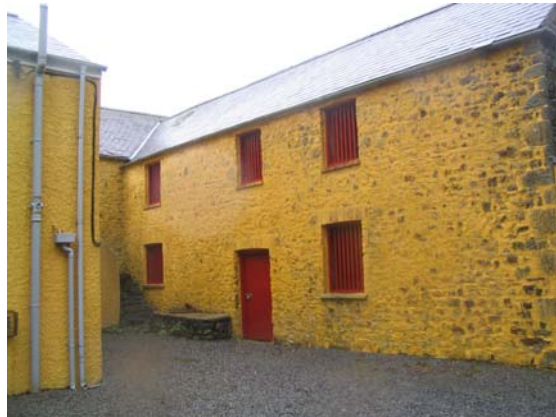
Immediately to the rear of the mansion house are the servants' quarters. The two-storey range, with a chimney stack on the southeast gable end, is joined at right angles to the rear wing of the main house. Both front and rear elevations have a central door and two window openings to the ground floor, and three window openings to the first floor. These are currently unglazed and covered with painted wooden slats. The building is in reasonable condition and is currently used for storage purposes.

Southwest elevation of servants' quarters

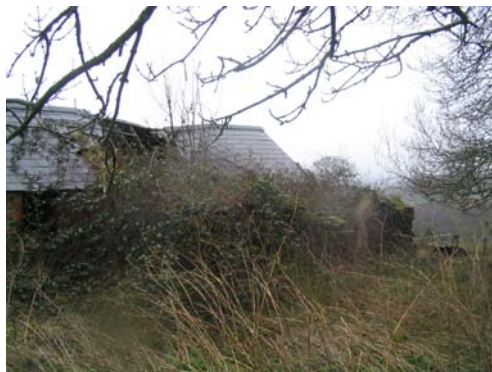
The eastern row of outbuildings runs southwest - northeast, in line with the northwest rear wing of the mansion house. Next to the rear wing, is a one and a half storey outbuilding with a slate roof, which appears to be in good condition, with no obvious damage to the exterior (the original function of this building is unclear). Following these buildings in the row is a gap of c.3m, and then a narrower row of two single-storey buildings on the same alignment, which were probably pigsties. The row runs down the contour of the slope, with entranceways accessed from the yard (northwest side), and small pens to the rear (southeast side). These buildings are in a poor state of repair, with collapsed roof, and breezeblock infill on the northeast end. The pens to the rear are becoming over-run with scrub and brambles.

Pens to the rear of the pigsties, showing scrub growth and collapsed roof

The area to the north of the servants' quarters, where the former pig pens and 'ty bach' are located is becoming over-run with scrub and brambles. Clearance of scrub in this area would not only ensure visibility of this part of the farmstead, but would prevent further structural damage to the buildings through excessive scrub growth.

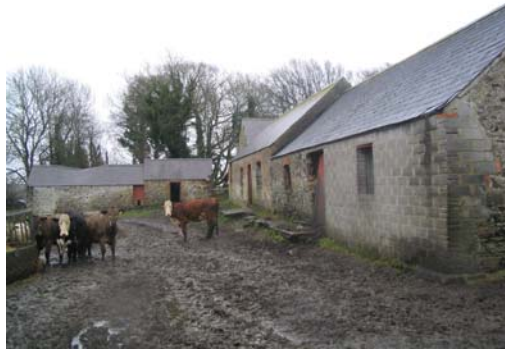
At right angles to this range, and separated by a gap of c. 3m is the central row of two single-storey buildings, which were probably stock houses. The slate roofs on these buildings appear to have been replaced quite recently, and are in good condition. However, the northeast elevation is literally 'falling off', and the slab thresholds have been left hanging c. 40cm above the present ground level. due to erosion of the

ground surface in the northeast yard by livestock. The frontage of the western building has been replaced with breezeblocks, presumably due to collapse of the original stone front. Cracks can be seen forming in the gable ends, and further collapse may be imminent if the frontages are not stabilised.

Two single-storey buildings (northeast elevation), showing structural problems caused by poaching.

Throughout the northern area of the farmstead poaching is causing serious structural problems by lowering the ground level and undermining the traditional outbuildings. Areas where collapse has occurred are evident (some walls have been repaired using breeze-blocks). Buildings that haven't already collapsed are in danger of doing so in the future.

Ideally the original ground level should be reinstated, and consolidated. Stock should be excluded from the area around the buildings until the ground is stabilised.

Professional advice should be sought on the most effective way to stabilise the fundamental structures of the buildings surrounding the northern yard.

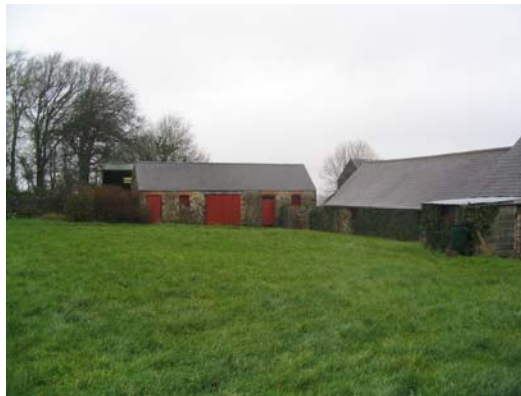
The parallel range on the opposite side of the farmyard consists of two rubble-stone buildings of one-and-a-half, and two storeys. The southwestern one-and-a-half storey building forms part of the end of the walled garden (PRN 53,103). The only opening in the northwest elevation, is a blocked doorway at ground level to the north. The southeast elevation has paired door and window openings at either end (perhaps stables), with a wider entrance (possibly for a cart) in the middle.

Southeast elevation of possible stables and cartshed

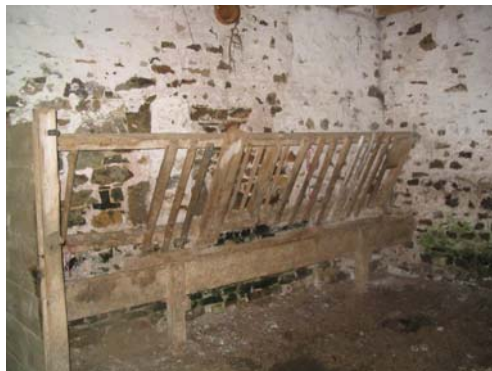
Original wooden stall

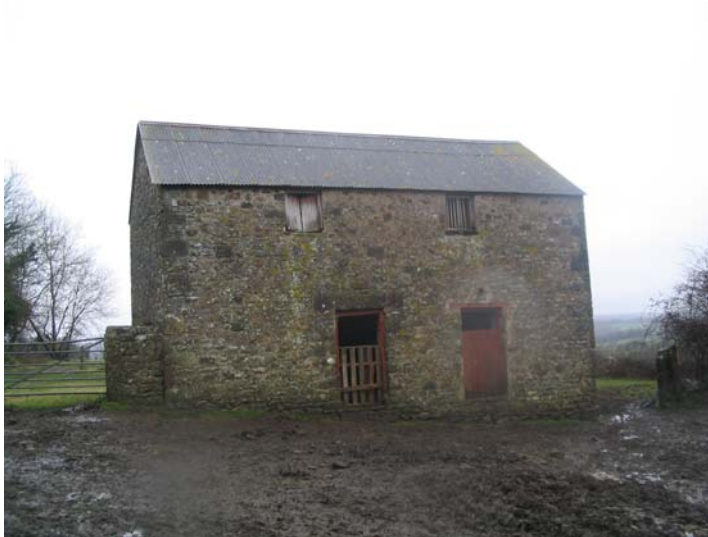
The northeastern two-storey building is roofed with corrugated tin. To the rear (northwest side) of the building, there is a single entrance at ground-level, and a single second-storey window opening covered with wooden slats. To the front (southeast side) are two doors at ground level, and two windows to the second storey covered with slatted wood, which may be the original window fittings. This building retains an original wooden stall internally. On the southeast side of this building, the ground level is now considerably lower, due to poaching of the ground-surface by livestock sheltering and being fed in the former yard. This has exposed un-mortared foundations, which will cause serious structural instability if not remedied.

Southeast elevation of two-storey building described above, showing lowered ground surface and exposed foundations

Poaching has significantly lowered the ground level throughout this part of the complex, as livestock are being kept and fed in this area. The structural integrity of all the buildings that surround the yard has suffered for this reason. Those that haven't already collapsed may do so in the near future as they are becoming undermined.

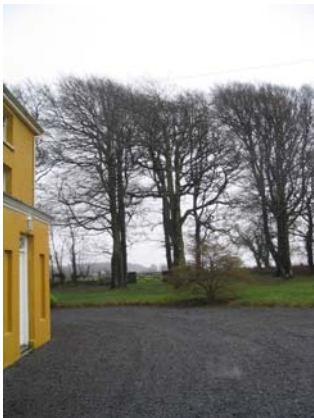
Name (& PRN)	Period/Site type	NGR	Status SAM/listing	Management required
3	FREESTONE HALL <u>(53103)</u>	Post Med garden	SN0542205536	B	Specific
<p>An area to the front (south side) of Freestone Hall mansion where there is evidence of designed space and formal planting regimes. A summer house/ grotto (PRN 53,108) occupies the northwest side of the garden, close to the wall that defines the driveway. There are depressions and some low stone edging in the vicinity of this building, which appear to represent contemporary garden features.</p> <p>The first edition Ordnance Survey map shows trees planted in a v-shape, widening away from the front (southwest) elevation of the mansion, to encompass a vista to the southwest.</p> <p>Immediately to the southeast, in line with the front of the mansion, is a double row of mature trees leading to a modern gate, flanked by two broad pillars. This may represent the location of a former driveway. However, no further evidence for this was visible on the ground, and none of the available historic map sources show a drive going in this direction.</p>

Double row of mature trees, marking location of probable former driveway.

Cambria Archaeology should be informed of any excavation or earth-moving in the field immediately adjacent to the southwest (front) elevation of the mansion.

Ploughing depth should not be increased in the walled field to the west of the mansion.

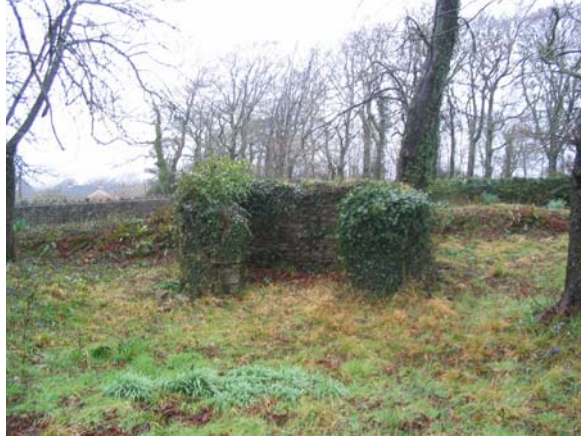
A small, square, roofless stone building with entrance facing southeast, set in slightly sunken ground. This feature is an important, and still visible aspect of the designed garden landscape associated with Freestone Hall. Covered with ivy. *Visited 16/03/1905 (HGM)*

Possible summerhouse/ grotto viewed from the southeast

The visibility and structural integrity of this feature should be maintained by undertaking scrub clearance, and ensuring that the underlying stonework is stable.
