## **TIR GOFAL MANAGEMENT PLAN: HERITAGE MANAGEMENT INFORMATION (HE2)**

**Prepared for:  
Corston Farm**

Tir Gofal Reference No  
**W/13/5472**

ACA Report No. **2005/58**  
Project Record No. **52274**

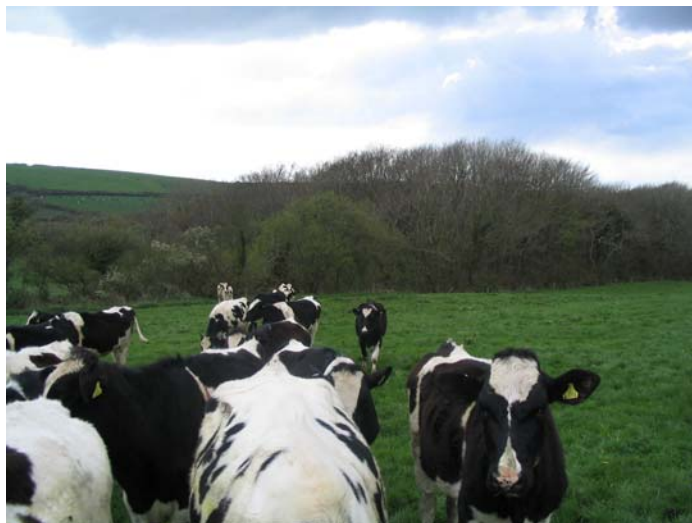
Name (& PRN)	Period/Site type	NGR	Status SAM/listing	Management required
<b>AXEN HILL</b> ( <a href="#">27962</a> )	<b>Post Medieval; Modern dwelling</b>	<b>SR93009892</b>	<b>B</b>	<b>Generic</b>
Dwelling not extant at the time of the 1st ed OS map of 1864. It was shown on the 2nd and 1974 editions. The site has been levelled and no obvious trace of any dwelling remains.

View south towards the site of the cottage.

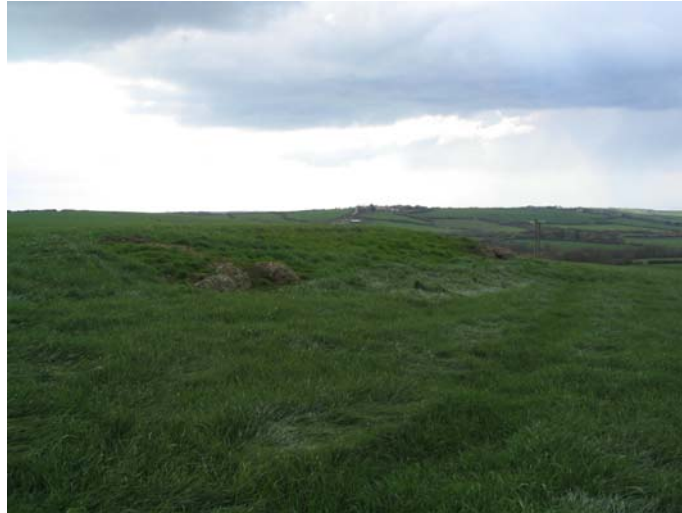
A line of low earthwork depressions accompanied by three large blocks of coarse conglomerate or concrete. It is uncertain whether the site was a quarry or of military use, possibly a target area. The description of this site is unchanged from previous visits.

The large concrete blocks seen from the east.

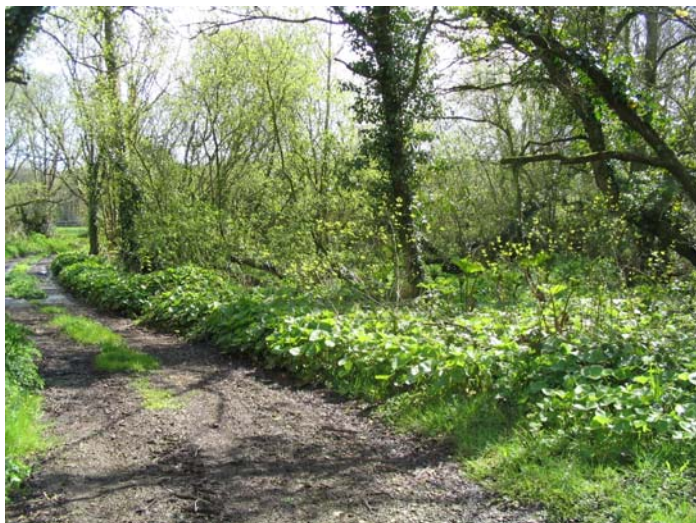
A pond marked on the 1st edition Ordnance Survey map of 1876, water controlled at the southwest corner by a sluice and with a pump to the northeast. Marked on the OS 1st edition map of 1876. Now overgrown with marshy vegetation.

The now overgrown pond.

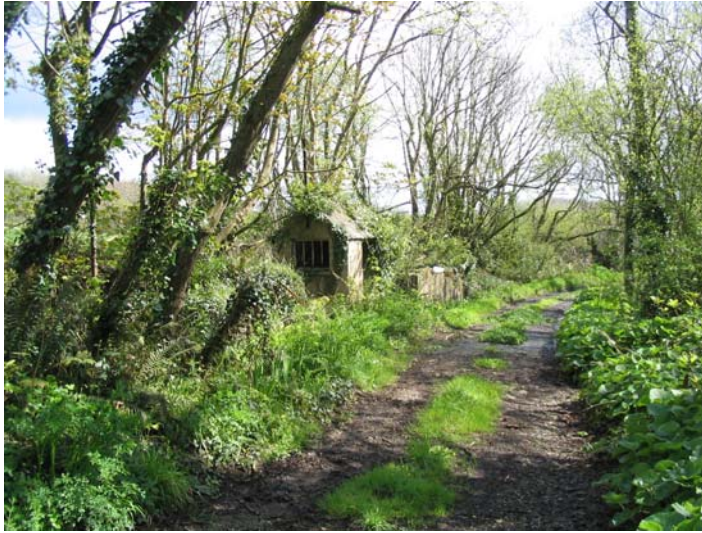
A pump house of red brick under a slate roof with concrete holding tank nearby. Early twentieth century date as not shown on the OS 2nd edition map (1908). It replaced an earlier pump at the same location (PRN 54276). The site lies within an area of regenerating woodland.

Looking south towards the pump house and holding tank.

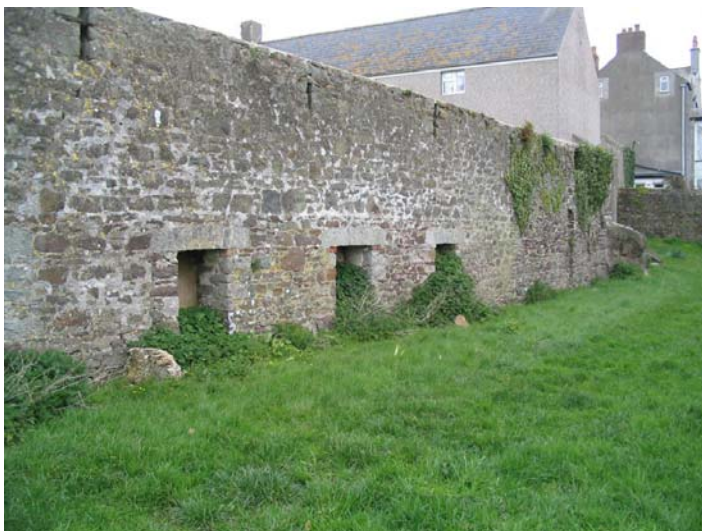
Former dog kennels at Corston. A building with five attached small enclosures is marked at the southern end of a service yard on the OS 1st edition map. The building has been destroyed and the site landscaped but the front wall and kennel openings (1.2m high by 0.5m wide) survive on the down slope side.

The surviving south elevation of the former kennels.

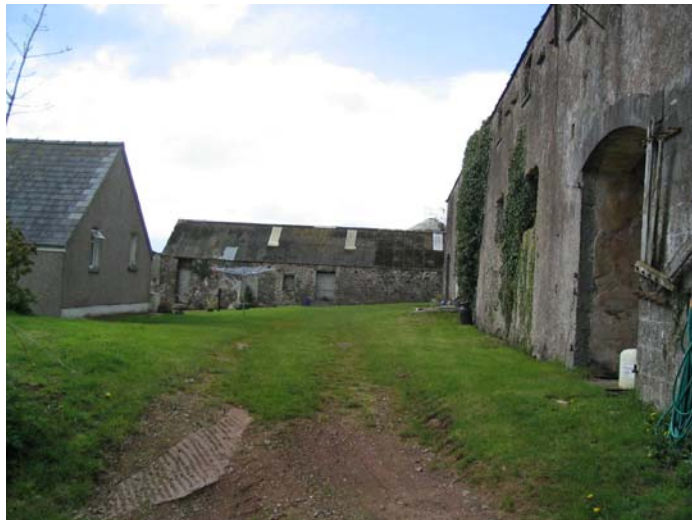
A model farmstead associated with Corston House (PRN6443). The OS 1st edition map (1876) shows three yards of outbuildings in a layout typical of the nineteenth century. This arrangement now only partially survives with only two of the yards intact and many of the buildings now lost or modified.

A service yard surrounded by stables, kennels and a coach house/ granary is positioned next to the house with a farmyard to the east outlined by a threshing barn, shelter sheds and another building (now lost). A ?fold yard with cow sheds to the north has been replaced by modern agricultural units.

Buildings in the service yard at Corston Farm.

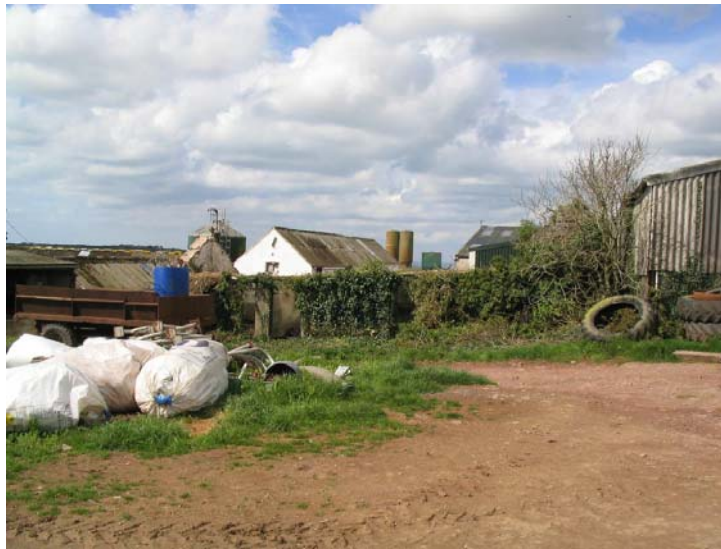
A roofless cow shed at Corston. It is of stone rubble under slate roof with three doorways in the front wall and nesting holes in the end gable wall. Now adapted with much of the rear wall having been rebuilt and an external render. Breeze block partitions divide the building into three units internally. The building cannot be positively identified on the tithe map (Monkton parish c.1841) but wooden pegged roof trusses suggest an earlier nineteenth century date. The OS 1st edition map (1876) identified the building as part of longer range, the other elements of which have since been replaced by modern sheds. It is now roofless and covered by ivy growth. The north end gable wall is cracked and leaning inwards slightly.

The ruinous cow shed seen from the east.

The cow shed is part of the historic farmstead plan, intact in 1876 (OS 1st edition) but now only partially surviving. It originally defined part of a rectangular yard in the north of the complex. The yard is now gone having been replaced by modern agricultural buildings. Further to this the historic character of the building is lessened by later alterations with little of the historic fabric still visible.

It is a stated Tir Gofal objective to promote the survival of traditional buildings on the farm. However, the group value contribution and historic character of the building are lessened and there are safety concerns with the north gable wall.

Given these circumstances it is considered acceptable to remove the cowshed on the condition that an appropriate record is made. The photographs and field notes taken during the Tir Gofal visit are considered adequate for this purpose.

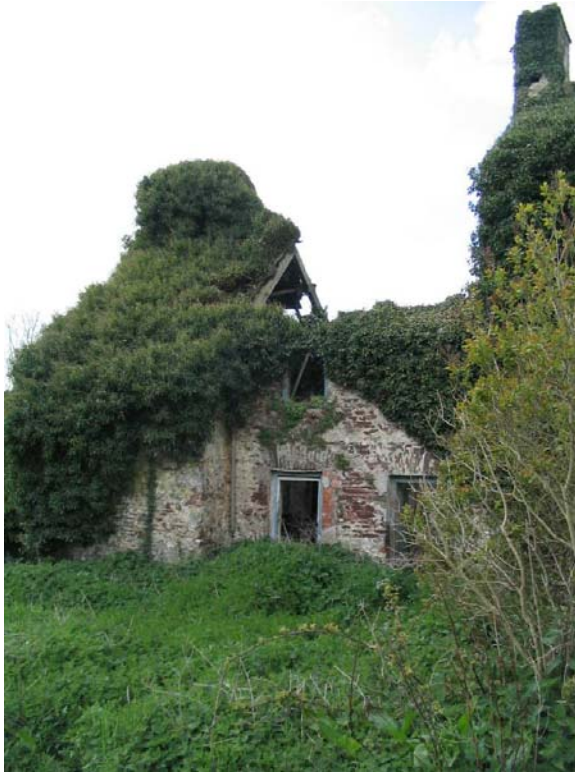
A multi-period farmhouse with sub-medieval elements. The earliest element is a three bay house with a massive masonry end chimney and stone chimney stair. A new house was constructed alongside in the 19th century and the windows and façade wall also date from this period. A later shed/ byre was added at either end of the building complex. The house is derelict, partially roofless and engulfed by ivy and other climbing vegetation. Part of Bridge farmstead (PRN 54274).

The earlier three bay house at Bridge Farm is now derelict and engulfed by vegetation.

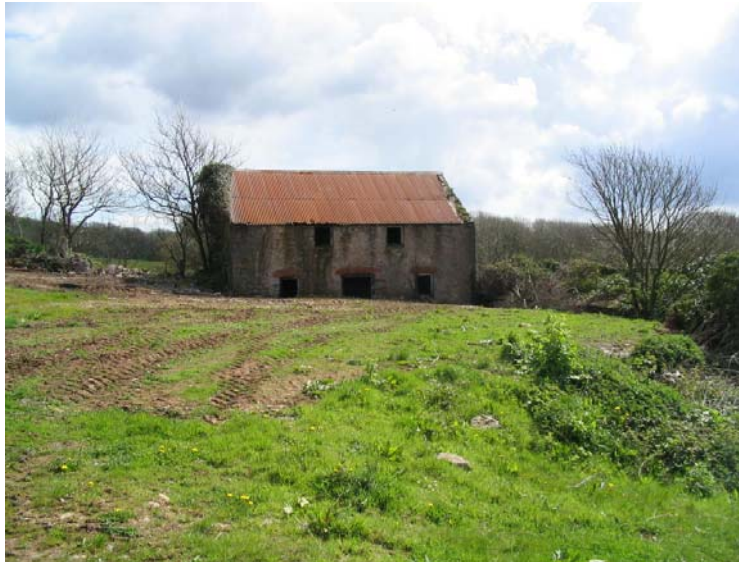
A derelict farmstead complex with adapted and enlarged sub medieval three bay chimney stair house (PRN 8749). Associated farm buildings (stable/ granary, cow shed and cart shed) date to the late nineteenth and twentieth century. The farmstead has been redundant for some years but a quarry has been recently opened in the slope at the top end of the yard.

Spoil is dumped behind and graded to raise the yard profile by upto 1.5 metres against the stable and cowshed wall. Excavation is to within three metres of the cart shed at the northwest end.

Spoil tipping has raised the level of the yard by up to 1.5metres

Quarrying activity is changing the profile of the farmyard and potentially damaging to below ground archaeological remains and standing buildings.

- No further quarrying to be undertaken within 6 metres of standing buildings or elsewhere within the farmstead. No further spoil or other material to be dumped within the area of the farmyard or elsewhere within the farmstead.
