TIR GOFAL MANAGEMENT PLAN: HERITAGE MANAGEMENT INFORMATION (HE2)

**Prepared for:
Glynhir Mansion**

**Tir Gofal Reference No
W/12/4889**

**ACA Report No. 2005/52
Project Record No. 52291**

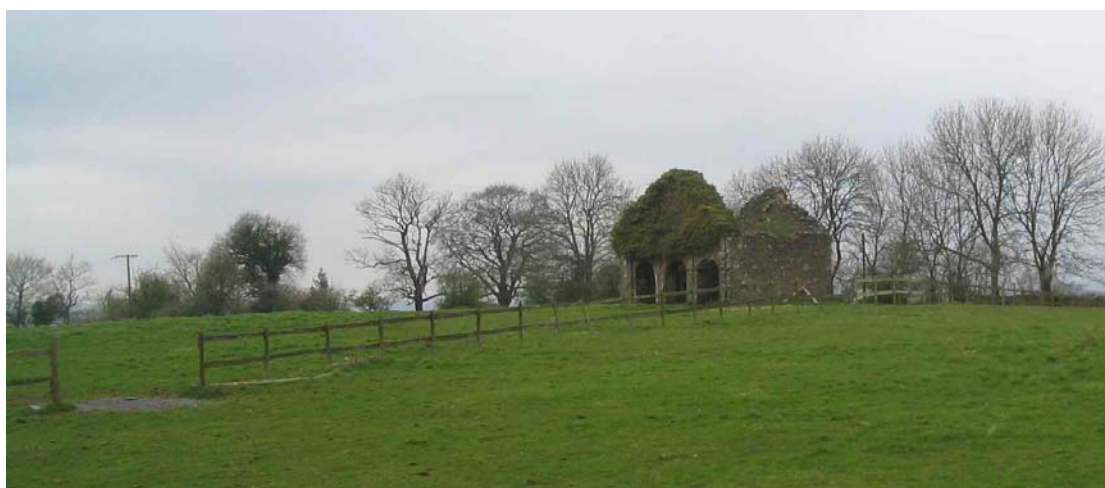
A hay barn designed as an eyecatcher in the parkland at Glynhir

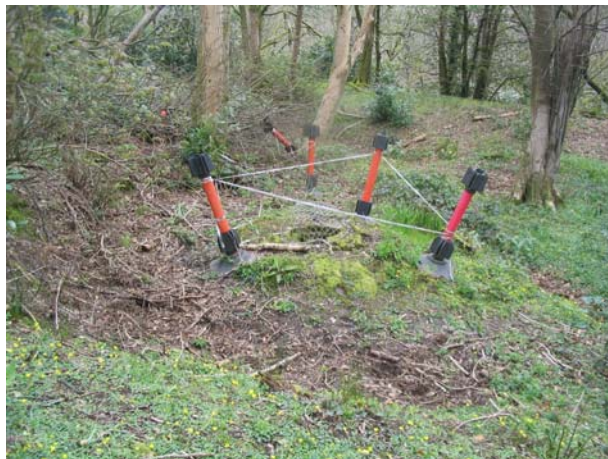
The ice house consists of a domed egg shaped chamber largely submerged into the ground level, entered by a passage way which dog-legs twice. The doors no longer survive but the recesses for doorframes can be traced in the passageway wall. The chamber is constructed in stone, with an internal rough render finish. In the domed roof is a circular aperture, where a lantern or vent must have sat. The passageway is barrel vaulted and the entrance is set at the end of sunken holloway, with stone revetment walls to either side. The listing description suggests that the ice-house was constructed by Peter DuBuisson in 1770. The ice-house is located within woodland and self seeded ash trees have established themselves on top of the passageway and in close proximity to the structure. The stonework of the passageway has cracked and shifted due to root damage. A number of stones have also collapsed out of the entrance roof.

The ice house lies within woodland

The survival of the ice-house for the long-term is threatened by the encroaching woodland. It is hoped that the ice-house may be subject to restoration and a application may be made to the Historic Buildings Council for a grant. Advice on making such an application should be sought from a Cadw Conservation Architect in association with the Cadw Inspector for Park and Gardens.

In the short term, regardless of the application for HBC restoration funds, the problem of the trees on or near the structure needs to be addressed. There are concerns about how best to fell trees on or near the structure and it is thought best to seek advice from a stonemason with knowledge about domed structures. It is suggested that the Carmarthenshire County Council Landscape Officer Graham Hamnett should also be contacted for advice, 01267 224192.

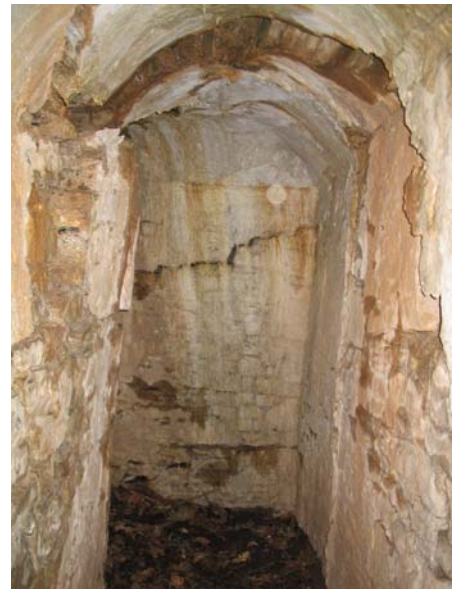
The entrance passage, cracked and contorted by tree roots

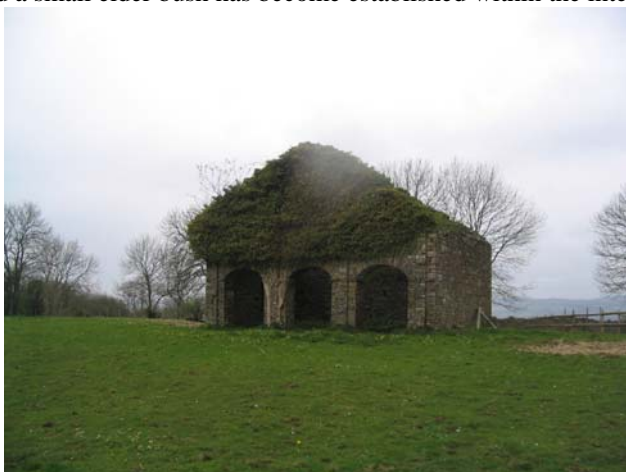
A supposed hay barn, extremely finely built with three arched openings to the front, southeast facing side with a pediment above. Internally are rows of sockets to support a 1st floor and an opening at 1st floor height in the apex of the northwest wall. Two further large rectangular sockets pierce this rear wall also. The building is roofless but the walls appear to stand to full height. However, there is much ivy growth over the southeast facing wall and a small elder bush has become established within the interior.

The supposed hay barn or folly is located on a line of site to the mansion

The folly/hay barn. The ivy stems should be cut at root level and the roots spot treated to prevent regrowth. No attempt should be made to remove the ivy unless further masonry consolidation can be undertaken at the same time. Any saplings which become established within or close to the building should be cut off at root level and removed from the building.

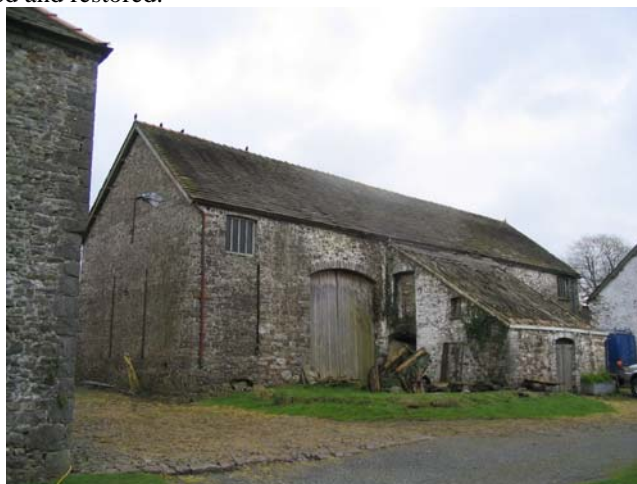
A fine double threshing barn in local sandstone rubble, with selected thin stones for the segmental arches of the four great doorways. The lowest metre of the walling is slightly battered. Local sandstone also used for the roof, with C19 red ridge tiles including a small finial at the south end. At the west side of the barn is a catslide extension with similar materials. Two tall slit ventilators in each gable end, four in each long wall. High level hatch opening at each end of the long walls with cambered arches. Probably pre-dates the acquisition of Glynhir by Peter DuBuisson in 1770. The stone base for a horse gin for early mechanical threshing survives in front of the left barn door on the west side. Interior: Nine bays, with collar and tie beam trusses. Inserted floor at north head with shafting from former machinery. Marks of lost inserted floors in the centre and in the south head. Stone paving in the heads and centre and stone pitching in the threshing bays. Listed Building Record No. 22219. The main barn is in a reasonable condition at present although occasional roof slates are missing, however the catslide extension to the west is in a very poor state. The stone roof tiles were removed and stored by the present owners in order to prevent them being lost. Water penetration has caused deterioration of the timbers internally. It is hoped through the scheme that this extension can be repaired and restored.

The double threshing barn and cat slide extension

Repair works to listed buildings should be carried out in consultation with the conservation department of Carmarthenshire County Council and may require listed building consent. Consultation with the conservation officer on the farm visit confirmed that repairs to listed buildings using 'like for like' materials and techniques do not need listed building consent. However, this should be agreed, in writing, with the conservation department in advance by the submission of a condition report and a schedule of works which will detail what elements need to be renewed and giving a detailed specification of the materials which will be used in the repairs.

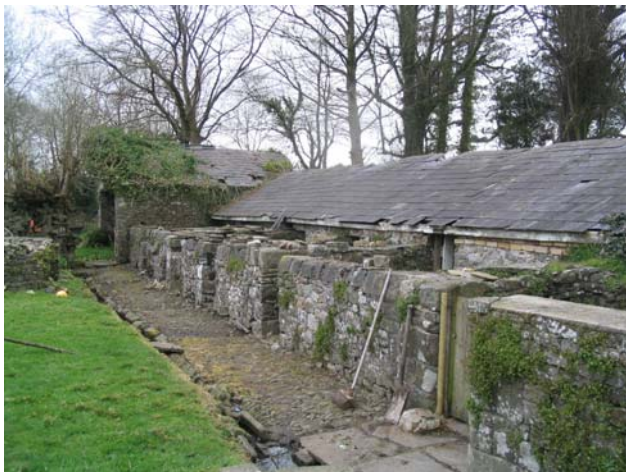
The following text, is taken from the Cadw Listed Building description; 'A set of six sties, the sty to the north being a little larger than the others. Local sandstone rubble masonry, with some yellow brick at eaves. Slate roof. One feeding chute survives. Taller sheds with their gables to the front terminate the row at each end. In front of the sties is a pitched-stone apron, with an open drain at the outer edge, and a circular well, of about 3 m diameter, filled.' Listed Building No. 22224 The building to the north end is an abattoir. Currently the pigsties are in a deteriorating condition, many of the slates have slipped and ivy is encroaching over the building.

The long range of pigsties with a pitched stone apron and drain to the front.

The pigsties. Ivy growth should be kept in check and cut through above the roots and spot treated to prevent regrowth. No attempt should be made to remove the ivy unless further repairs or consolidation works are about to be undertaken. Where possible slates should be replaced. Ideally repairs should be carried out on the pigsties, however in the absence of this the following steps should be taken. Any works other than maintenance works should be carried out in consultation with the conservation department of Carmarthenshire County Council.

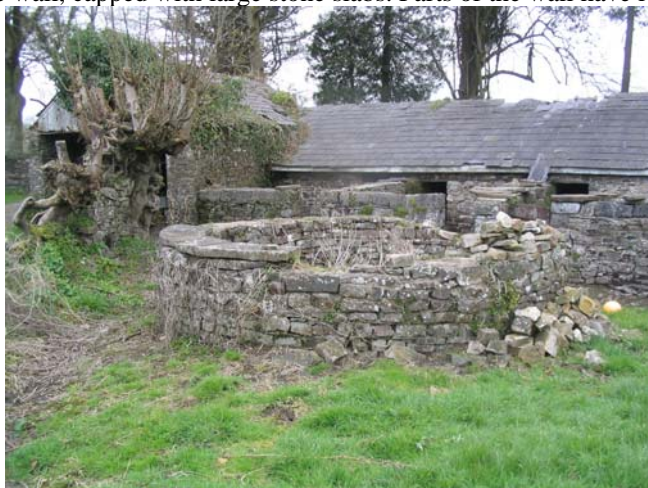
A well is situated in the western corner of the farmyard between the pigsties and the brewhouse. It is enclosed by a low stone wall, capped with large stone slabs. Parts of the wall have lost the top courses.

The well lies in the western corner of the farmyard

The well. The top courses and the capping should be reinstated using appropriate techniques and materials.

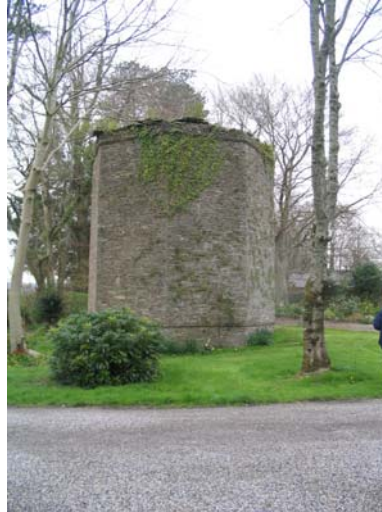
Grade II listed as a fine late 19th century dovecote despite the loss of its original domes roof and cupola. The dovecote is becoming rather overgrown with a sapling growing within it.

The hexagonal stone dovecote
