**TIR GOFAL MANAGEMENT PLAN:
HERITAGE MANAGEMENT INFORMATION
(Call Out)**

Prepared for: Capel Tydist

**Tir Gofal Reference No:
W/12/4967**

**Report Number: 2005-93
Project Record Number: 52300**

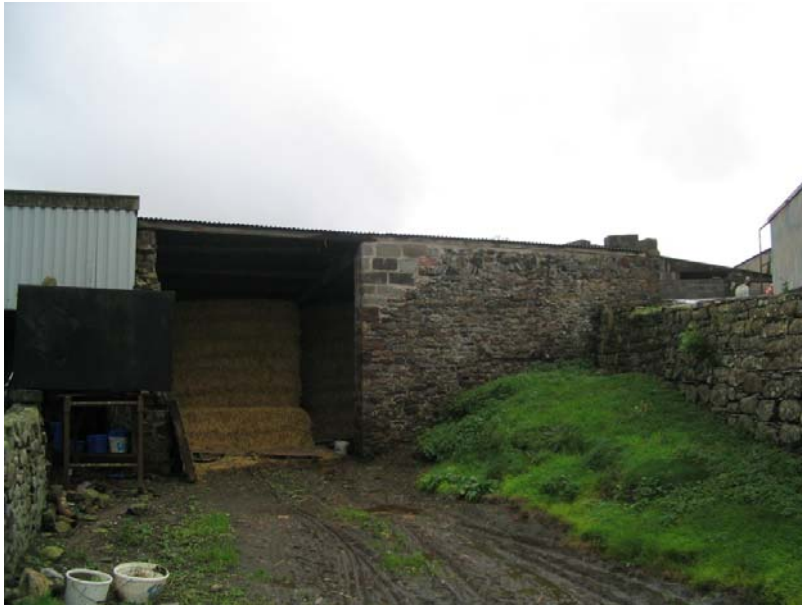
Ordnance Survey maps, from the 1st edition of 1887 to current editions, mark the southern range, also aligned roughly east-west, as the site of the Chapel, specifically the western end of the range. Significant sections of the eastern and western ends of this traditional barn range survive, but only the southern wall of the main central section survives. Several phases of development are visible in the westernmost barn in this range, currently used as a hay store. Although the walls record changing uses for this barn over the years there are no obvious architectural traces of a medieval chapel. The natural bedrock begins to rise in this area, the whole range is built on slightly different levels. Where this has cut into the bedrock the foundations, graves and other below ground chapel elements may have been removed. Equally remains may have been preserved where the ground has been built up to level off the floors. A large build up of earth and stone to the rear of the western end of this barn range may mask below ground remains.

The westernmost barn of the southern barn range at Capel Tydist farmstead. This is the area marked on Ordnance Survey maps as the site of the original chapel.

Ideally the walls of the southern barn range should be maintained in their current condition. If any work is planned that would affect the structure of these walls then it is suggested that more detailed building recording work is undertaken as this may reveal elements of the chapel structure not currently obvious.

Ground breaking work should be avoided in the area both within and surrounding this barn range due to the significant possibility of disturbing archaeological remains of the former chapel and its graveyard.

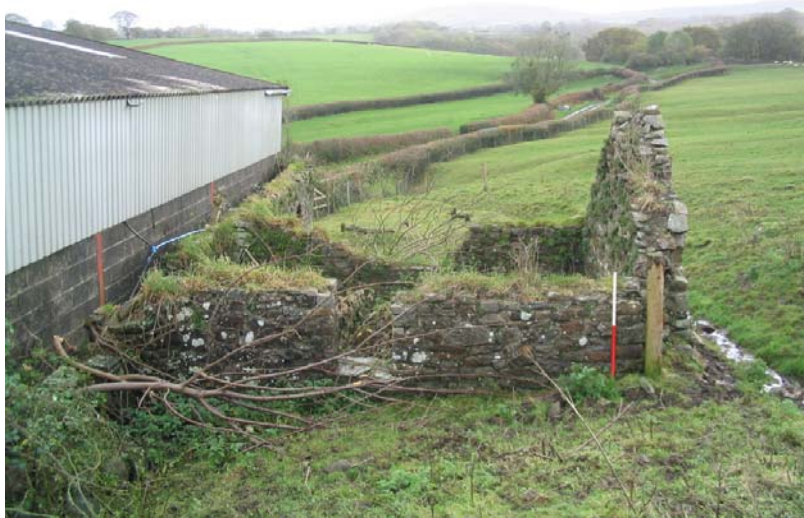
To the rear of the central barn in this range is a small ruined building which has also been thought to represent the remains of the chapel. This building is built of mortared random rubble, roofless, aligned north-south, and attached to the southern wall of the main barn range. There is a raised entrance in the western wall, an entrance from the main barn range, and a ventilation slit in the southern gable wall. This building is first marked on the tithe map of 1839. This building can be discounted as the site of the chapel, on closer inspection is attached to, and therefore later than, the main barn range. The chapel would have been aligned east-west and the ventilation slit in the gable wall suggests this building functioned as a small cow shed. Although discounted as the remains of the chapel this building is still an important element of the surviving traditional farm buildings on this farmstead.

East facing shot of the small barn building attached to the southern side of the main barn range.

The small barn building to the rear of the main range is roof less, with partly ruinous walls, although generally they stand close to their original height. Tumbled stone and scrub lies within the structure and around the walls, in particular where it adjoins the main barn range. Some of this scrub has recently been cut back. The building backs onto a field of pasture, although is divided from it by a small stream that runs behind the main barn range.

Scrub clearance to the rear of the barn range and around the small attached barn building should continue. Scrub should be cut back and treated, not uprooted, so as not to disturb upstanding masonry or below ground remains. Dead wood and vegetation should be removed from the area. Facing stones have fallen from the southwest corner of this building, this corner should be consolidated. Once vegetation has been removed from the top of these walls they should be capped to prevent further deterioration. Existing traditional barn walls should be maintained wherever possible.
