TIR GOFAL MANAGEMENT PLAN: HERITAGE MANAGEMENT INFORMATION (HE2)

**Prepared for:
Alltyfyrddin**

**Tir Gofal Reference No
W4/12/5054**

**ACA Report No.2005/66
Project Record No. 52314**

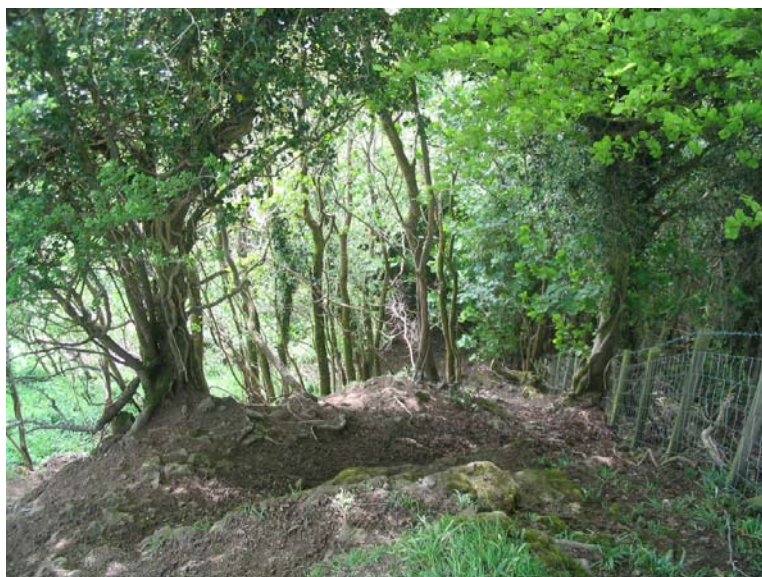
Name (& PRN)	Period/Site type	NGR	Status	SAM/listing	Management required
1	MERLINS HILL;MERLINS GROVE (1745)	Iron Age hillfort	SN45502150	A	SAM	Specific
	<p>Merlins Hill is a prominent local landmark crowned by a univallate Iron Age hillfort with a complex entrance and outwork systems to the east. According to tradition Merlins Hill contains the cave where Merlin lies imprisoned by the magic of Morgan le Fey. Such traditions may reflect the Prehistoric importance of the site. The hillfort appears to have been predated by a smaller enclosure, an occupation layer immediately underlying the main rampart has been radio-carbon dated to 360 + 60BC and 150 +70BC. The hillfort, at the time of the visit (May 2005), was grazed by Jacob sheep. The top enclosure is largely pasture, however gorse is established on the southern slopes, where it is quite mature and sheep appear to be using it for shelter without causing damage to the ground surface. There are areas of localised erosion however, in particular around a small cluster of thorn trees which are established on the break of slope above the quarry ditch to the north of the site. Here there is a great deal of wear around the base of the trees, causing scars in the ground surface up to 0.4 m deep. In addition on the southwestern side of the monument adjacent to the hedgeline there is little ground cover and active wear from stock sheltering under the thin young trees which have grown up on the very steep slopes. Elsewhere there is erosion against the fenceline on the east side of the monument. Here again the stock shelter on the old hedgebank under trees which overhang from the adjacent enclosure. The hillfort has been opened to the public since 2000 and an interpretation panel has been erected on the southern side of the hillfort. There do not appear to be any problems caused by visitor numbers, although there is some wear in the ground surface around the interpretation panel.</p>

Erosion of ground surface on the southwestern boundary of the hillfort

The management aim for the hillfort is the establishment of a stable ground cover all over the monument and to reduce wear on those areas which have been highlighted. This can be achieved both by tackling specific problem areas and also reducing the pressure generally over the site.

It is important that the condition of the site is monitored and problems addressed when they arise. Please contact Cambria Archaeology and Cadw to discuss any issues of concern.

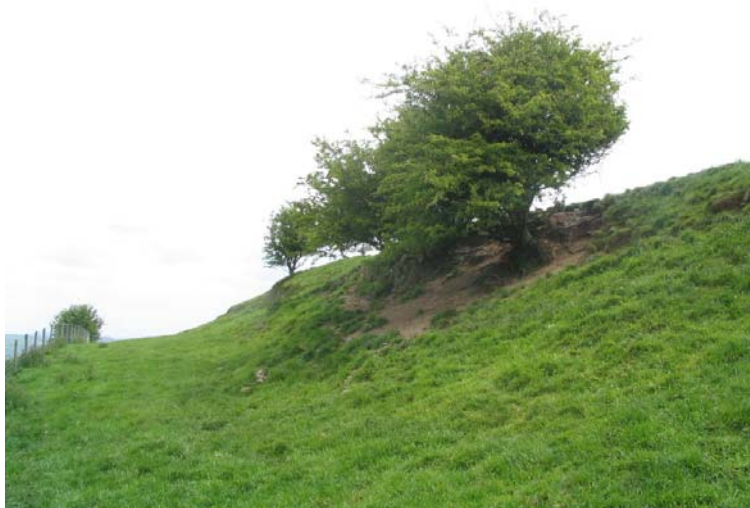
A ditch on the northern side of the monument looking east. The erosion around the base of the hawthorn trees is due to sheep using the trees for shelter.

The group of hawthorn trees which line the quarry ditch scarp on the northern side of the monument should be cut off at ground level and the stumps treated to prevent regrowth. The scars should be monitored to note if ground cover is established naturally; it may be necessary to reseed. Cambria Archaeology should be notified if this is the case.

It would be beneficial to either reduce the numbers of stock on the site or perhaps to restrict grazing to those months which enjoy better weather in order to reduce the pressure on those areas required for shelter.

In addition the monument would benefit from the reduction of scrub growing below the northern fence; this would allow greater visibility of the northern ramparts. Again this should be carried out by cutting off the vegetation at ground level and spot treating the stumps to prevent regrowth. Vegetation should be removed from the site.

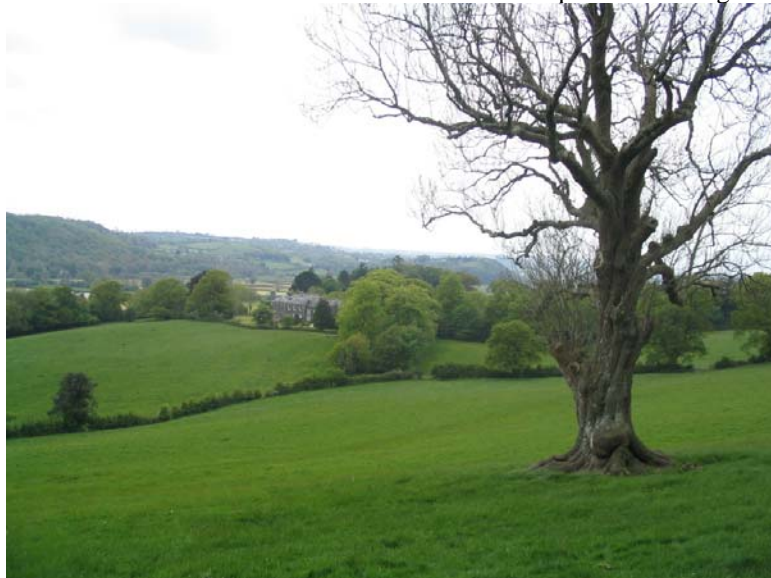
Parkland associated with the mansion of Bryn Myrddin (formerly known as Penybanc Uchaf). On the 1st and 2nd edition Ordnance Survey maps (1889 & 1906) the fields around the mansion had designed woodland plantings, including individual specimens and clusters of trees enhancing the natural topography. A number of trees have been lost over time which has diminished the parkland setting of the mansion.

A view of the mansion of Bryn Myrddin and the parkland that surrounds it

It would be beneficial to undertake tree planting to reinstate some of those parkland trees which have been lost.

A scheme of tree planting should be drawn up using the 1st edition Ordnance Survey map for reference points.

The species of trees planted should reflect the species profile that is represented in the existing plantings.
