PORTHGAIN SLATE QUARRY

ARCHAEOLOGICAL DESK-BASED ASSESSMENT

Report Prepared by
Cambria Archaeology
For
PCNPA

REPORT NO. 2005/1
PROJECT RECORD NO. 53030

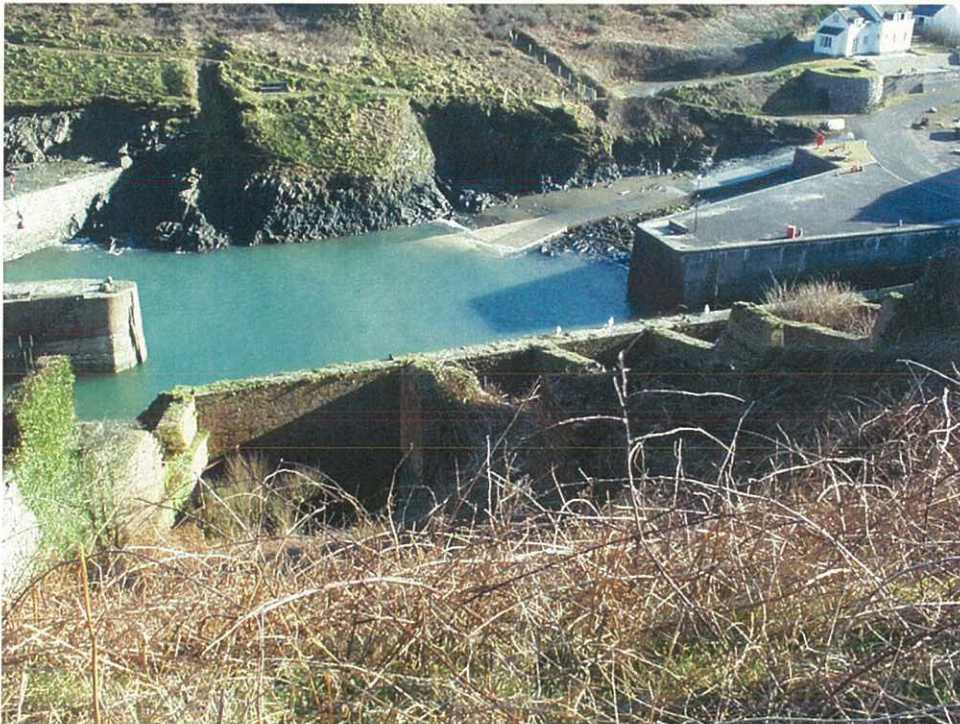
Plate 1: General view looking east over the hoppers towards the harbour.

The Porthgain hoppers and their associated structures that form the focus of this project occupy the west side of the harbour (centred on SM81363255) where they dominate the harbour and the village. They were constructed at the base of a low, steeply sloped cliff with a stone crushing plant situated on the cliff top above. It is the surviving hoppers and crushing plant structures that are to be cleared of vegetation and consolidated to enhance their long-term survival.

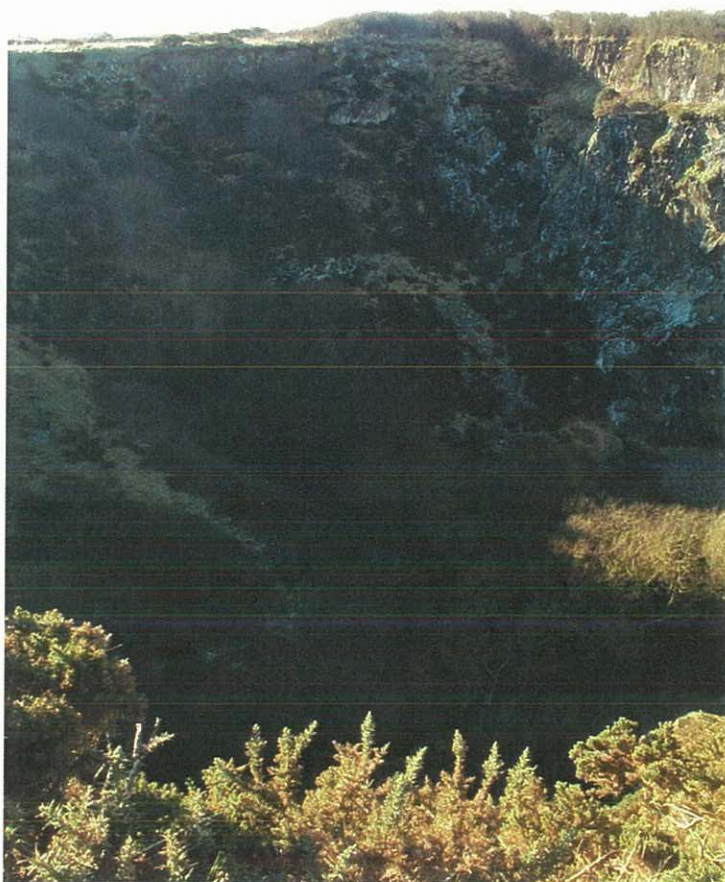
Plate 2: A general shot of the deep vertical face at Porthgain Quarry.

The most obvious and spectacular survival of the slate industry is the massive and impressive Porthgain Quarry (Plate 2), which is almost as deep as it is wide. The quarry lies on the edge of the Pembrokeshire Coast Path and is currently fenced off to deter visitors from approaching the edge.

The quarry was developed during the last half of the 19th century and material was initially removed via a double incline on the north side and a single incline on the east side, which linked to a double incline down the steep cliff slope to the harbour (Fig. 2). The northern incline linked to a system of tramways on the cliff top and may have been used for removing waste as there are finger spoil heaps on the cliff tops to the north. The east incline delivered slates directly to the harbour and dressing areas. A tunnel led north from the quarry to the cliff edge,

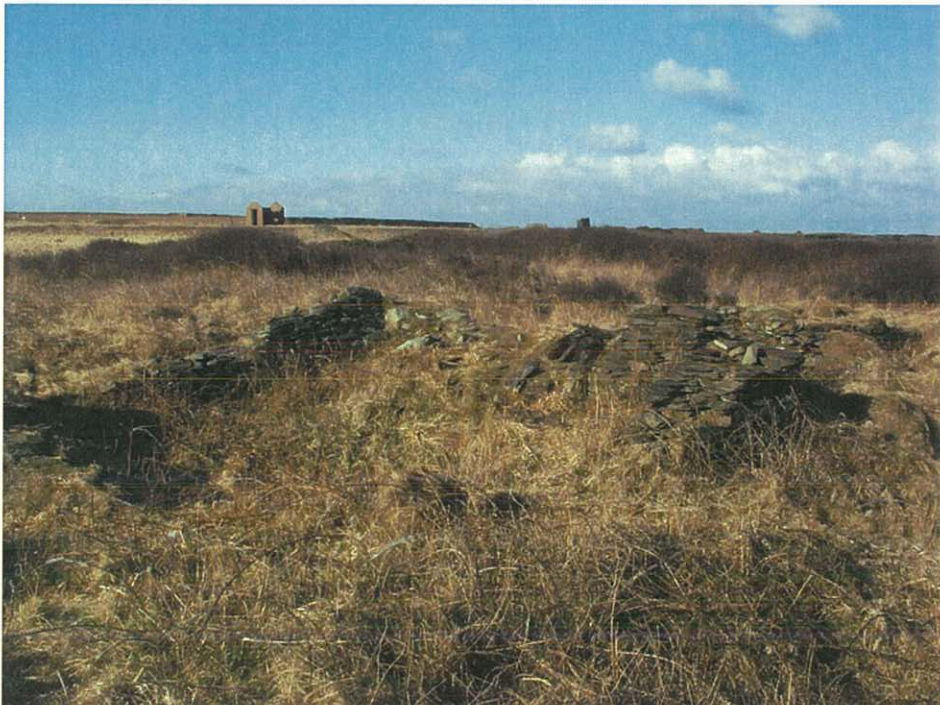
Plate 3: The northern end of Pen Top Terrace, now little more than a few low overgrown stone walls and mounds of fallen rubble.

An adjunct of the quarrying industry was the provision of worker housing, which included a row of seven or eight small slate-built cottages (Pen Top Terrace) on the cliff above the harbour and close to the quarry. The cottages originally had small garden plots and yards (James 1999, 5). Pen Top Terrace was constructed during the late 19th century, it is shown on the Ordnance Survey 1st edition map of 1889, but it had been partially abandoned by 1906. Some of the cottages were occupied until the late 1940s (Roberts 1998, 48), they have since been demolished (Plate 3).

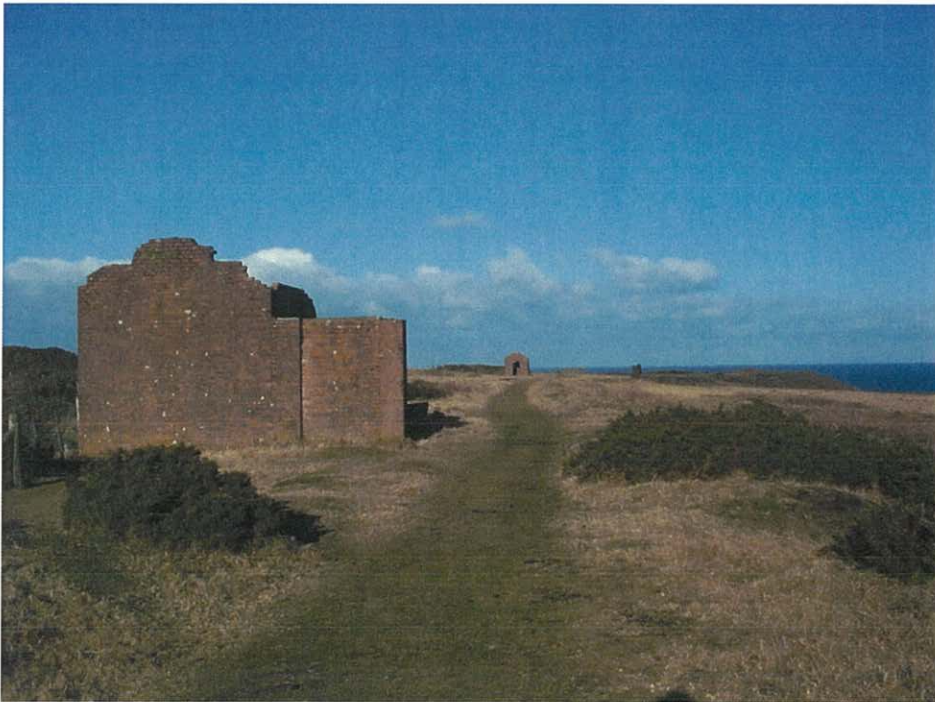
Plate 4: Abandoned locomotive shed (PRN 24728) alongside a former tramway. The brick-built weighbridge office is visible in the distance.

The remains of a brick-built locomotive shed (PRN 24728), constructed pre 1889, but abandoned by 1906, stand alongside a former tramway track, now a grass footpath, on the northwest edge of Porthgain Quarry. The shed had two railed bays and stands to its full height on its northeast corner (Plate 4).

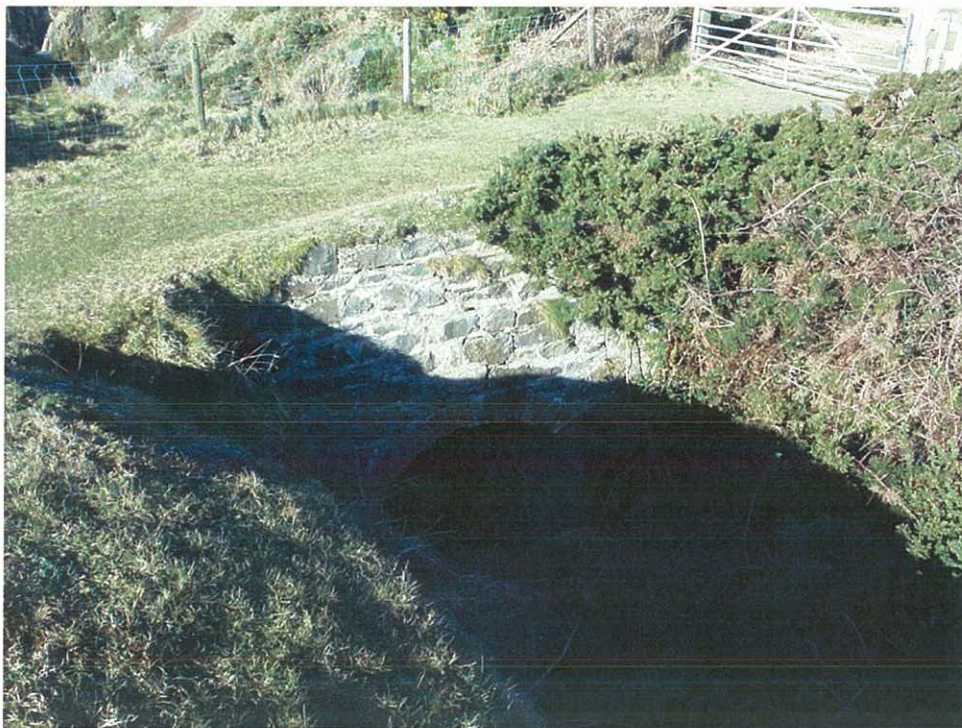
Plate 5: Incline bridge (PRN 24731).

A number of other structures associated with the quarrying phase of the site survive in various states of disrepair on the cliff top, some as virtually intact structures, others as low vegetation mounds, some as low stone walls and others have no above ground trace. One of the best surviving is the small stone-built, single-arched bridge (PRN 24731 – Plate 5) over the incline to the east of the quarry.

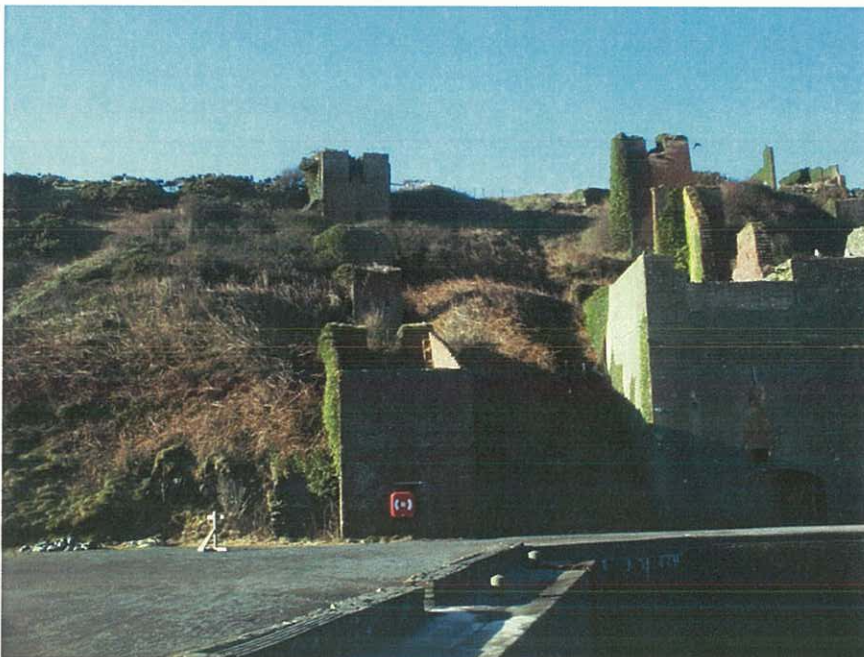
Plate 6: Hopper 1 and its associated structures.

Hopper 1 (Structure A) was apparently constructed sometime around 1909-1910. It is separated from the main bank of hoppers by the line of a former incline (Plate 6). The feeding platform (structure D) and the piers (structures B and C) that supported the feed chute also survive on the slope above the hopper. All are brick built and the hopper has a concrete floor that slopes towards the harbour to allow the crushed stone to be gravity fed into the boats.

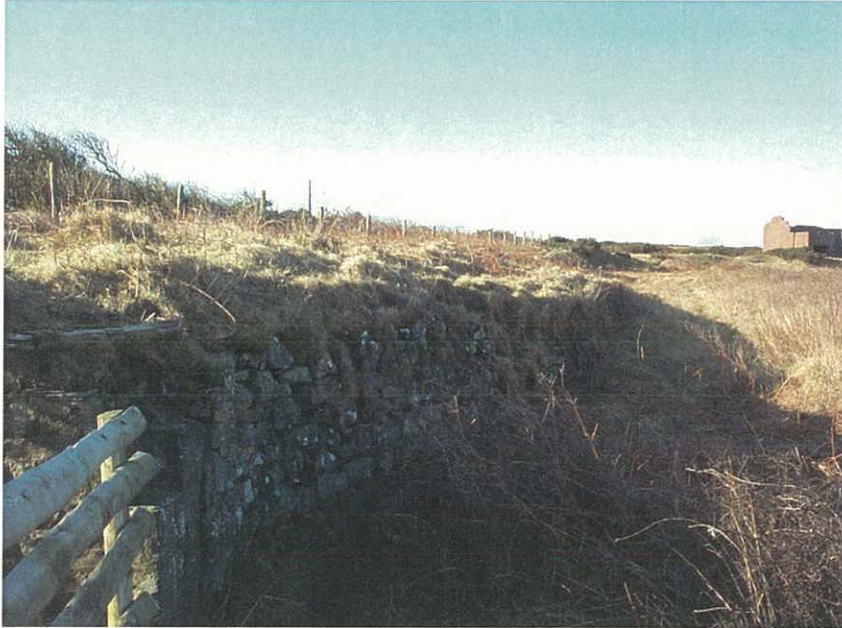
Plate 8: A view west along the raised tramway that fed the crushing plant. The disused engine shed in the background was associated with the quarry.

structural elements in their current condition, it appears that structures J and N were part of a platform and feed chute and structures G, L and M were part of the crushing plant (Plate 7). The crushing plant was fed from the cliff top by a raised tramway, which was faced and retained on either side by stone walls (Plate 8). The raised tramway was constructed to link the crushing plant to the tramway from the quarries at Pen Clegyr.

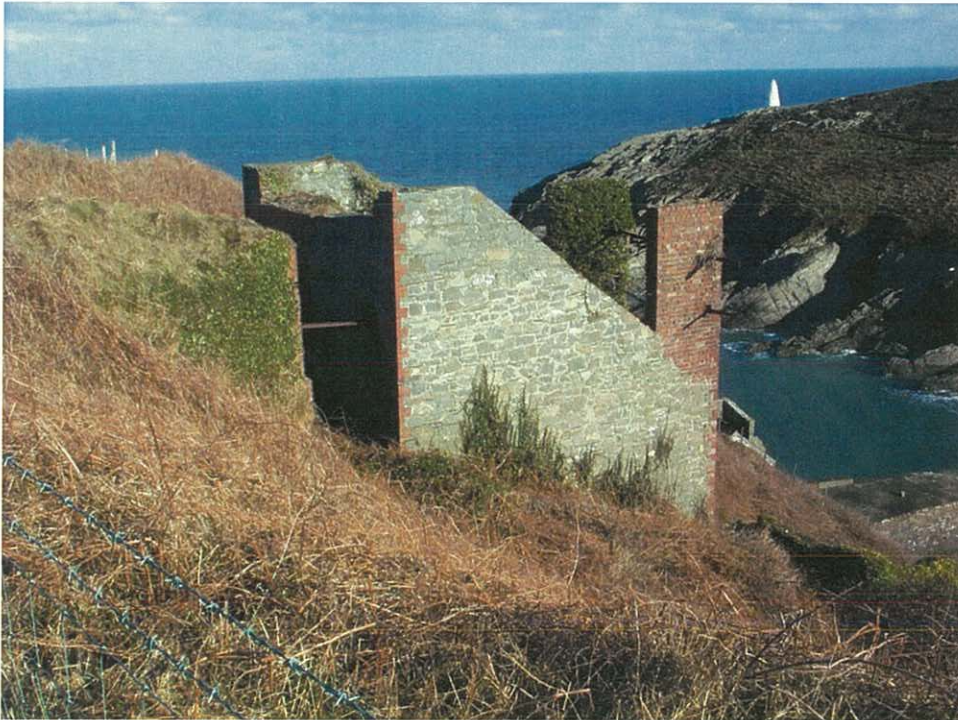
Plate 10: The feed platform for hoppers 13-15.

On the cliff top above the hoppers is a stone and brick built platform (structure K), which was used to tip the crushed stone onto the chutes to feed the hoppers below (Plate 10). The platform was serviced by a tramway on the cliff top that connected the hoppers with the tramway to the Porthgain Quarries at Pen Clegyr (Fig. 4). The tramway link to the hoppers was laid along a former path that went around the southern end of Pen Top Terrace (Figs. 2 and 4).
