# **TIR GOFAL MANAGEMENT PLAN: HERITAGE MANAGEMENT INFORMATION (HE2) YEAR 5 REVIEW**

Prepared for:  
**Cwm Nant Yr Eryr**

Tir Gofal Reference No  
**W/12/1193**  
Prepared by  
**Will Steele**

Report No. **2006/10**  
Project No. **53227**

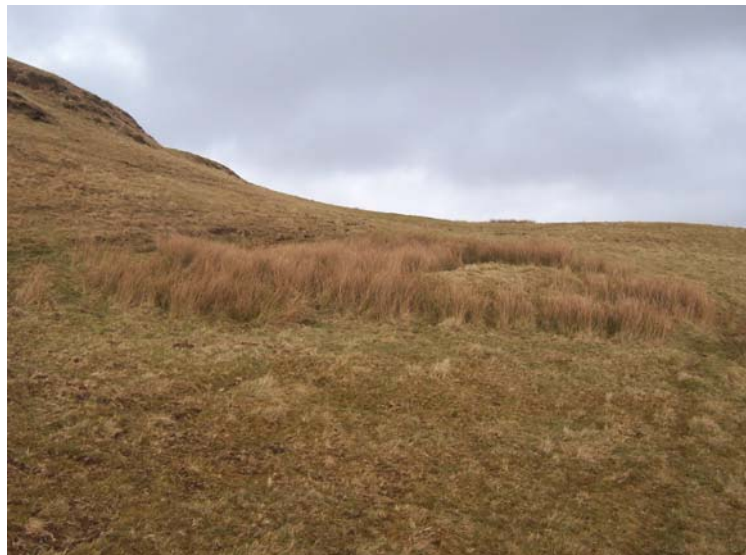
Name (& PRN)	Period/Site type	NGR	Status	SAM/listing	Management required
1	<a href="#">(56094)</a>	Post Medieval long hut	SN68004751	B		Generic

The grassed over remains of a rectilinear structure, long hut, on a terrace levelled out of the slope above a stream.

Comprises the well preserved earth and stone wall bases of E, S and W sides (10m EW by 5m NS), the north side being formed by a cut into the slope. There may be an entrance at the rear end of west wall. Appended to E end is a sunken compartment 3m EW by 5m NS open to S. Reed growth obscures further detail. The site is within an area of rough pasture. (WWS February 2006).

The grassed over remains of the long hut. Reed growth obscures further detail.

- Monitor the condition of archaeological monuments in these areas. Consider scrub control if their condition worsens by cutting vegetation close to ground level.

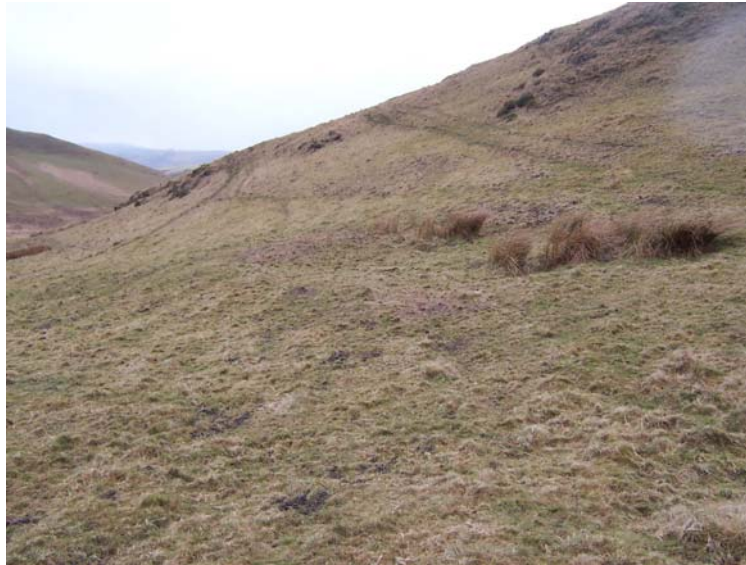
1	<a href="#">(56095)</a>	Post Medieval platform	SN68044754	B		Generic
---	-------------------------	------------------------	------------	---	--	---------

Probable platform aligned E-W along the contour and measuring approximately 11m long by 6m wide. In the same area are several other vague depressions which could also be man made (WWS February 2006).

View of the platform from the east.

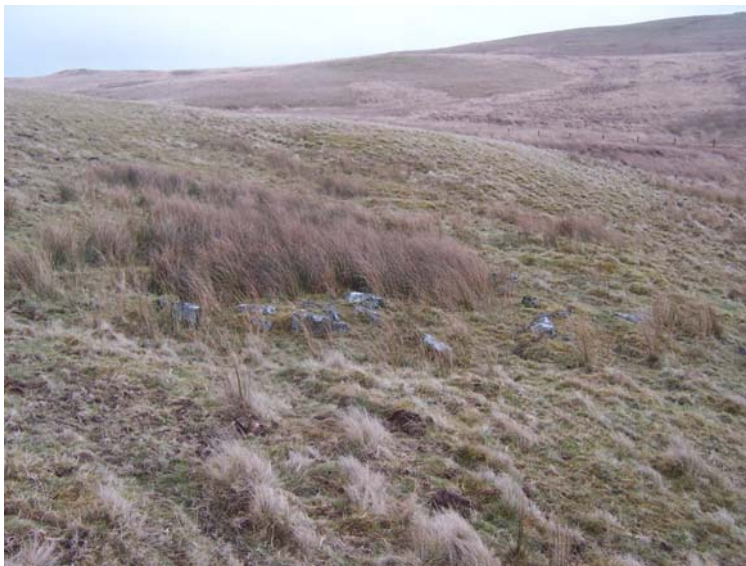
| 1 | <a href="#">(56096)</a> | <b>Post Medieval long hut</b> | <b>SN68284759 B</b> | <b>Specific</b> |

Ruinous single cell drystone structure, 7m N-S by 5m E-W, on ill defined platform in sheltered location by a stream. Comprises well preserved angular stone wall bases with a possible entrance in the east wall. Interior and much of surrounding platform is now reed covered but otherwise rough pasture predominates (WWS February 2006).

The long hut, now obscured by reed growth.

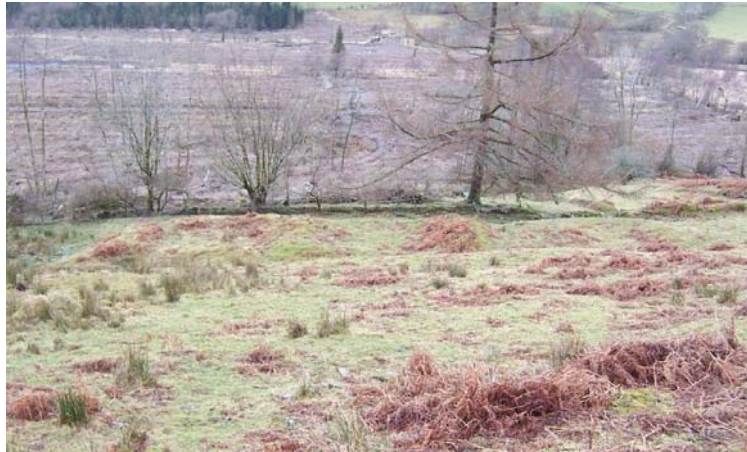
| <b>UNKNOWN</b> | <a href="#">(55486)</a> | <b>Post Medieval farmstead</b> | <b>SN67244858 B</b> | <b>Generic</b> |

Situated close to the edge of enclosed farmland below Esgair Hendre. Comprises the grassed over wall bases of a large two cell structure (15m long x 6m wide) and a smaller ancillary structure, (5m long by 5m wide) aligned on a terrace cut in the hillslope. A stone walled enclosure, possibly a garden, lies a short distance to the north.

The building and enclosure appear on the OS 1<sup>st</sup> edition map of 1888 but are un-named, presumably having been abandoned by that time (WWS February 2006).

The remains of the farmstead as seen from the south-east.

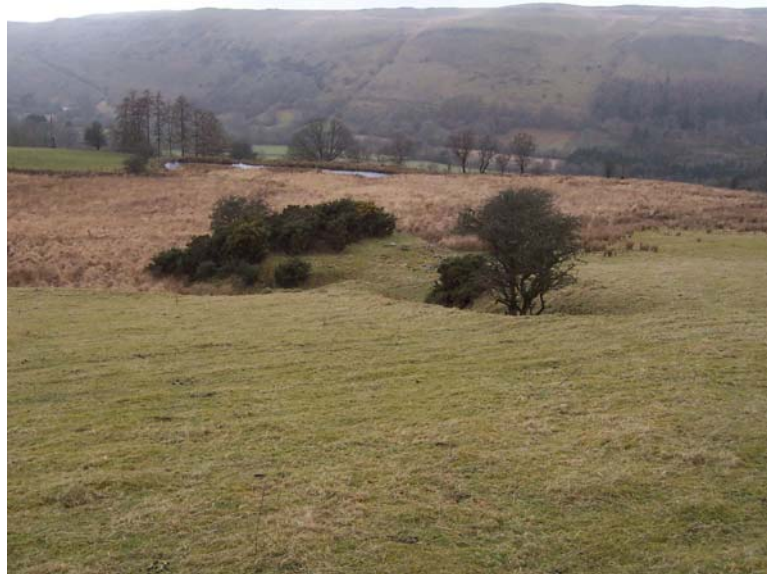
**TY CERRIG** ([55487](#))

Part of Ty Cerrig lead mine (PRN 26641). Comprises the dumps of an adit and an air shaft into it. (WWS February 2006 after Hall 1993). Marked as disused on the OS 1<sup>st</sup> edition map (1888).

The remains lie within a pasture field above an area of bog and are relatively free of vegetation except for the spoil tips, which are now obscured by scrub (WWS February 2006).

Looking north-west towards the remains of the adit and dumps.

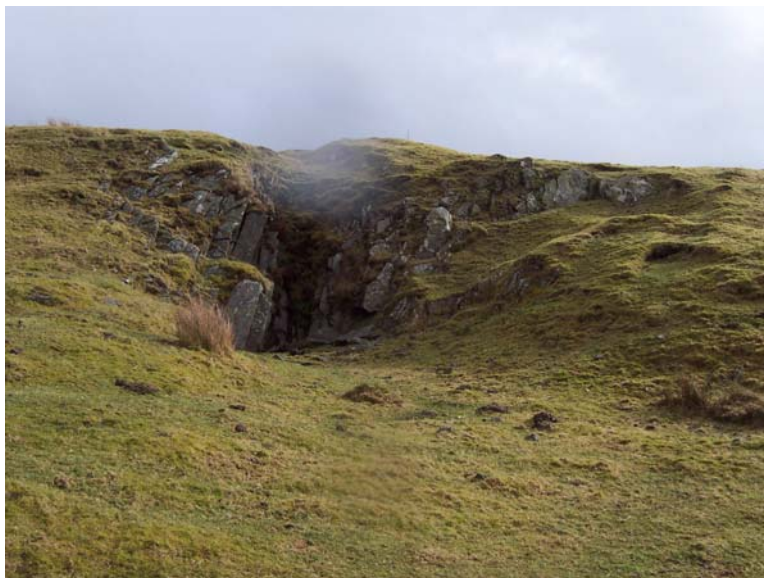
**TY CERRIG** ([55489](#))

Adit driven eastwards into the face of a small crag, the dumps situated below. Part of Ty Cerrig lead mine (PRN 26641). The adit is situated in an area of rough pasture. It is open and unfenced (WWS February 2006 after Hall 1993).

The mouth of the adit.

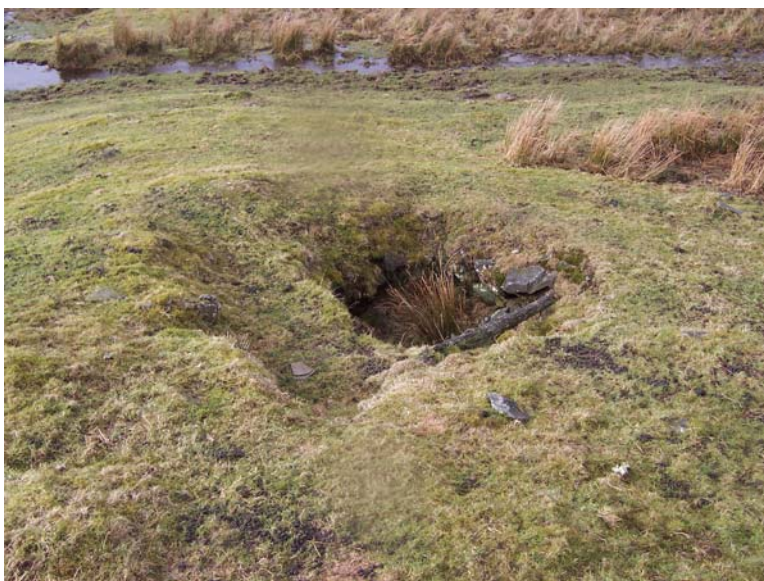
**TY CERRIG** ([55490](#))

An infilled shaft, or winze lying a few yards west of adit PRN 55489, part of Ty Cerrig lead mine (PRN 26641). It is stone lined, approximately 2m in diameter with a small rectangular platform 3m by 0.6m on the SW side. Situated within an area of rough pasture (WWS February 2006 after Hall 1993).

The shaft and platform as seen from the east.

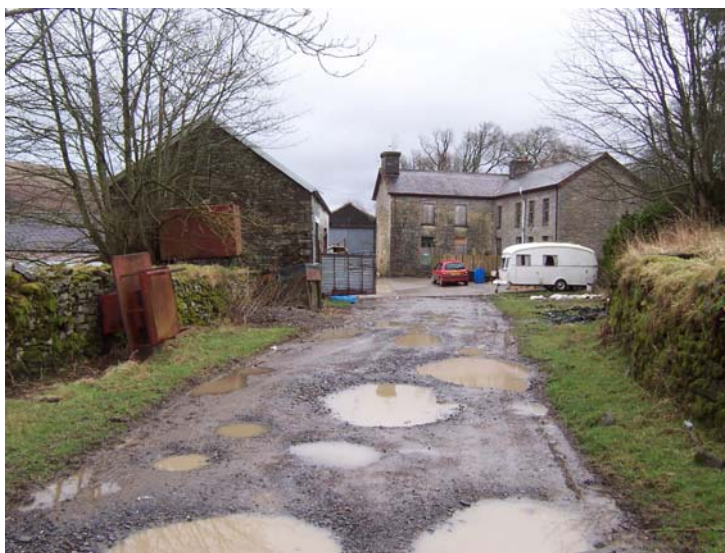
Name (& PRN)	Period/Site type	NGR	Status	SAM/listing	Management required
2	TY CERRIG ( <a href="#">56098</a> )	Post Medieval farmstead	SN66804822	B		Specific
<p>A working upland farmstead with large two storey L-plan house as its centrepiece and a number of outbuildings of character set around a rectangular yard. The current layout that is little altered from that shown on the OS 1<sup>st</sup> edition map of 1888. Buildings are of slate and stone construction with cut stone heads to door and window openings marking a single stylistic theme, and include many features typical of a mixed arable and livestock farm, including threshing barn, lofted stable, cow shed, granary and pigsties. It is said that water power was used to drive barn machinery (winnowing, threshing etc.) in the past but no evidence of this survives today.</p>

Pigsties and an open fronted shed in the north of the complex have been converted for alternative use but surviving buildings are generally in good order. A lofted stable and a cow shed within the complex are in need of attention if they are to be maintained in the long term.

Looking along the main drive towards Ty Cerrig. The threshing barn is on the left.

Ty Cerrig is an unusually well intact farmstead of the nineteenth century with many original features remaining. Surviving buildings are, for the most part in good order although a lofted stable and a cow shed within the complex are in need of attention if they are to be maintained in the long term.

- The priority is to maintain the farmstead complex as a whole, ensuring that all buildings are maintained in a weatherproof and structurally sound condition
- As a general rule, original features should be repaired rather than replaced, otherwise replacement features should be in the original style of the building.

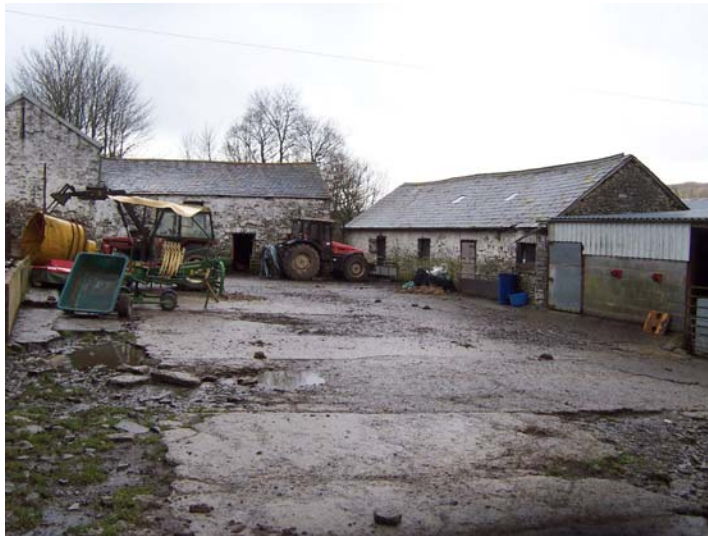
3	TY CERRIG ( <a href="#">56099</a> )	Post Medieval cow shed	SN66794822	B		Specific
---	-------------------------------------	------------------------	------------	---	--	----------

A nineteenth century cow shed on the west side of the yard at Ty Cerrig. It is a long, low building of whitewashed rubble stone with a slate roof and four evenly spaced doors with cut stone heads facing onto the farmyard. The rear wall is masked by modern sheds.

In overall appearance it is reasonably intact although two of the doorways have been blocked to create windows. No historic internal fixtures or fittings remain. It is in a reasonable condition but the roof on the

rear pitch requires attention where many of the slates are displaced.

The cow shed and lofted stable at Ty Cerrig.

In overall appearance, the cow shed is relatively intact, and a central element of the nineteenth century farmstead group. Restoration should be considered a priority.

It is intended that repairs will be made to the roof, re-slating and repairing roof timbers as necessary.

Care should be taken to re-use the maximum number of old slates possible. New slates should, ideally match the type, colour, texture, size and thickness of the existing ones. Welsh or Spanish slate can be used.

As a general rule, original features should be repaired rather than replaced otherwise replacement features should be in the original style of the building. Re-use or repair elements of the old roof structure as far as is practically possible.

Consider re-opening blocked doors to enhance the historic appearance of the building.
