The sample excavation of the 'Sunken Track' at Dinefwr Park, Llandeilo

RHIF YR ADRODDIAD / REPORT NO. 2005/30
RHIF Y PROSIECT / PROJECT RECORD NO. 53654

Gwilym Hughes and Peter Crane

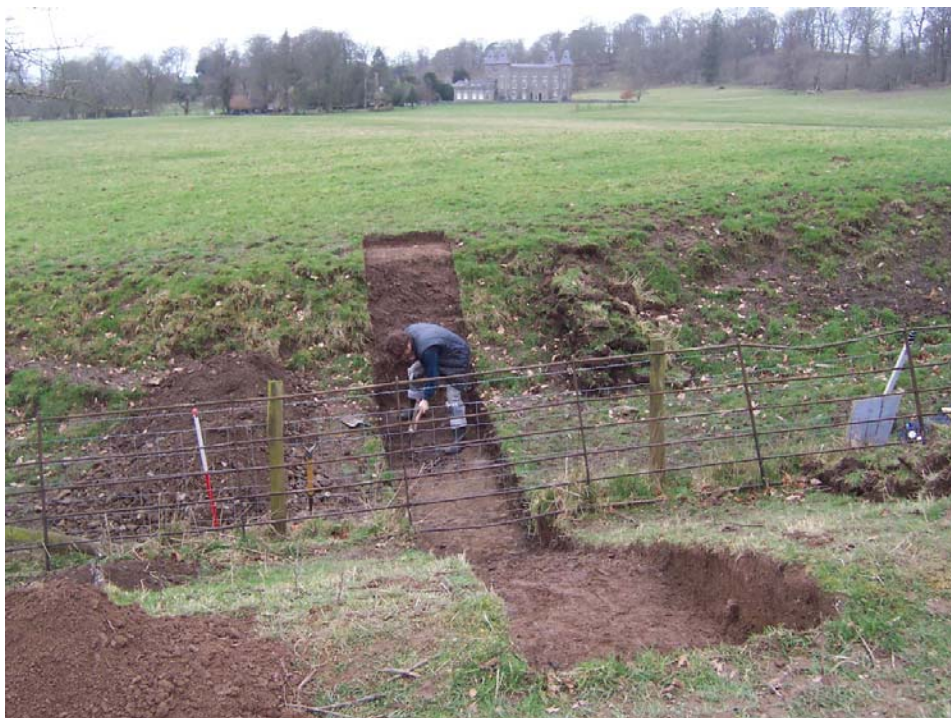
Plate 1 - View of Trench 1 looking northwest. Newton House in the background

Trench 1 (Fig. 2 and Plates 1 and 2) – The overall cut for the Sunken Track was found to be 9 wide and 1.8m deep in Trench 1. The lower part of the western side of this cut comprised a steep to vertical cut into the bedrock (106) with a gentler slope to the upper profile. The base of the cut was 3.2m wide and relatively flat although it sloped slightly from west to east. The eastern edge comprised a more regular and gradual slope. The bedrock at the base of this cut was overlain by two very compact layers of rounded gravel and pebbles set into orange brown clays (105 and 104). Each of these compact layers was up to 50mm thick. They were overlain by a layer of rounded stones, forming a compact trackway surface that included a number of larger flat stones (103). This surface extended over the eastern two thirds of the base of the cut, forming a feature 2.6m wide. Over the western third of the cut for the trackway, the bedrock was overlain by a deposit of grey brown soil that contained small mortar flecks (107). This appeared to be banked up against the steep lower western edge of the trackway.

The initial surface appears to have been replaced by a second surface comprising small flat stones with occasional larger stones (102). This extended across the whole width of the cut and overlay the mortar layer, forming a trackway surface 3.4m wide. This was in turn overlain by a mixed deposit of topsoil and turf (101) that had been heavily disturbed by livestock.

It is suggested that the initial surface, represented by the lower layer of compacted pebbles (103) and its underlying make-up deposits (105 and 104), was originally associated with a boundary wall, built up against the near vertical inner slope of the Sunken Track. This appears to have been subsequently removed leaving a deposit of soil with mortar flecks (107). The later surface, represented by the upper level of compacted pebbles (102), was built over the area formerly occupied by this wall, providing a wider trackway surface.

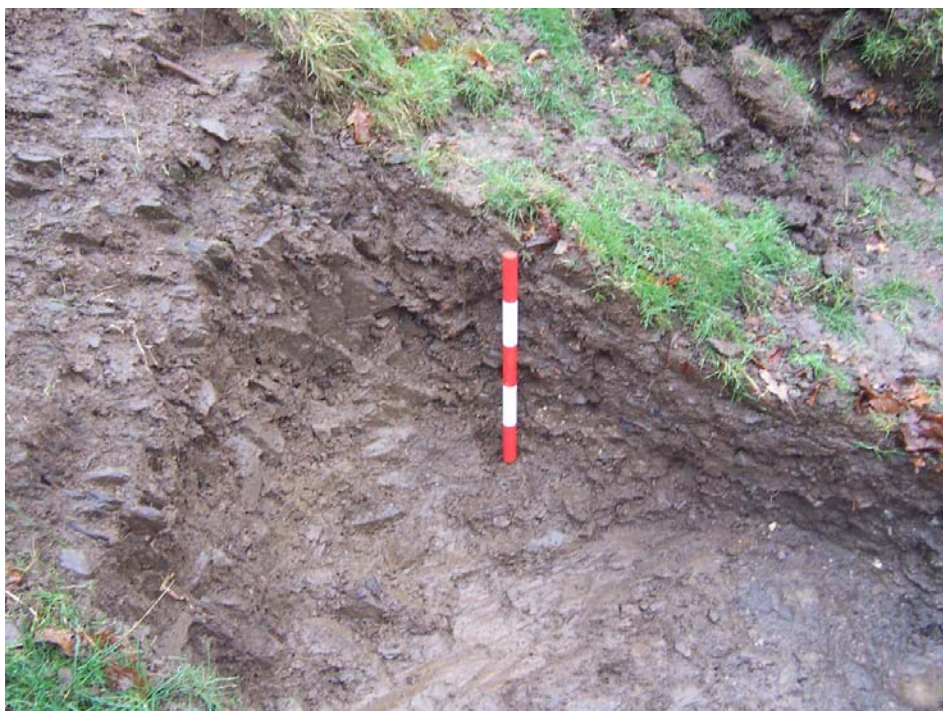
Plate 2 – Detail of western end of section in Trench 1 showing deposit with mortar flecks (107) against the near vertical cut into the bedrock

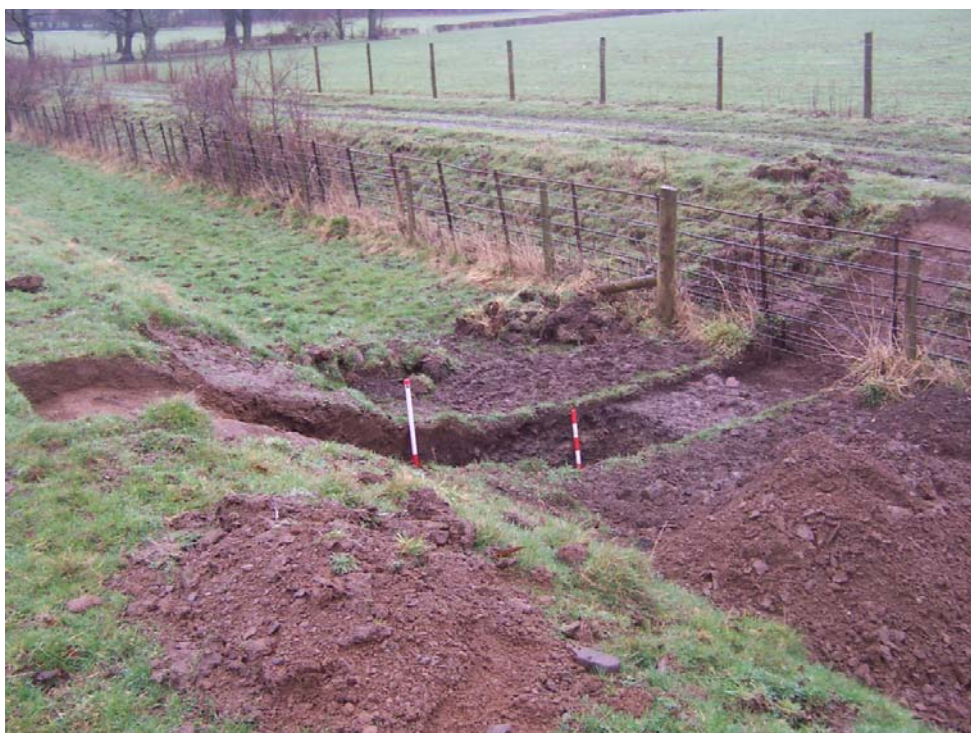
Plate 3 – View of Trench 2 looking northeast

Trench 2 (Fig. 3 and Plates 3 and 4) – The cut through the bedrock had a similar profile to that recorded in Trench 1 and was 7m wide and 1.8m deep. Again the lower part of the western side was steep to vertical with a gentler slope to the upper profile and the eastern side of the cut. The base of the cut was flat and up to 3.4m wide. The

The lowermost deposit in the central area of the trench comprised a compact surface of small pebbles set into a grey brown silty clay, c 2.2m wide (207). This appeared to abut a deposit of large angular stones (205) overlying the western side of the base of the trench. Between this stony deposit and the base of the western side of the trench was a series of silty clay deposits with mortar flecks and fragments (208, 209 and 210).

The stony deposit and pebble surface (207) was overlain by a series of compact, rubble makeup levels (206 ~~and~~, 204 ~~and~~ 203) for an upper metalled surface of small rounded pebbles (203). This was overlain by larger angular flat stones with occasional bricks (202). This upper surface was also c 2.2m wide. Both these surfaces and the mortary deposits in the western part of the trench were overlain by a series of grey brown topsoil deposits (211 and 201).

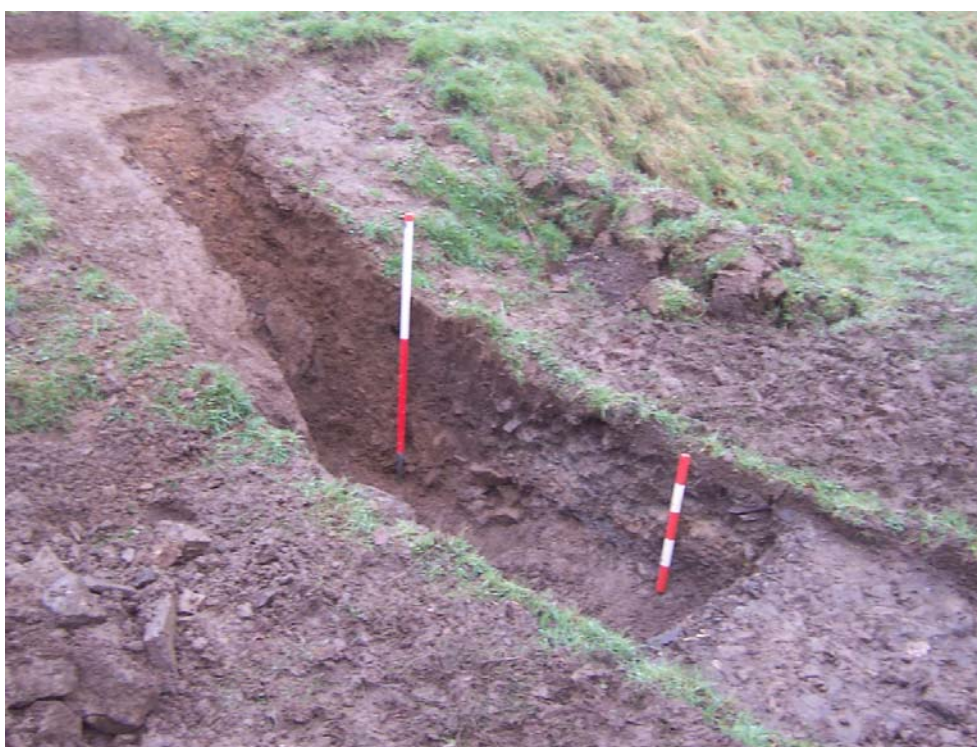
Plate 4 – Western end of section of Trench 2 showing possible cut for robbed out wall

The series of deposits suggests a similar sequence to that encountered in Trench 1 with traces of a boundary wall, represented by a series of deposits with mortar fragments, originally built against the lower, inner edge of the cut. The stony deposit (205) may also be remnants from the dismantling and removal of this wall. Unlike Trench 1, it seems that the later trackway surfaces (represented by 203 and 202) did not subsequently extend across the area formerly occupied by this wall.
