TIR GOFAL MANAGEMENT PLAN: HERITAGE MANAGEMENT INFORMATION (HE2)

Prepared for: Drim Farm

Tir Gofal Reference No W/13/5576

ACA Report No. 2005/78 Project Record No. 53660

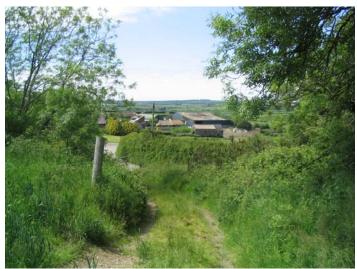
A view of Drim Farmstead from the north-east (PRN 53877).

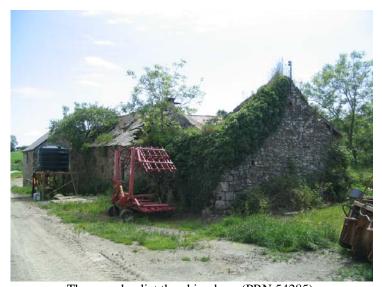
A derelict and much altered threshing barn at Drim Farm. The barn is of masonry construction under a slate roof and originally formed part of a longer range with cartshed/granary and another building now destroyed. It was probably built in the late eighteenth or nineteenth century and is recorded with a horse gin attached on the OS 1st edition map (1889).

The barn was extensively modernised in the post war years when converted to a cow shed with feed loft above. It is derelict and dangerous with the roof now semi-collapsed and walls beginning to lose stability. The interior was not seen. Climbing vegetation and some young trees are established on and around the building.

The now derelict threshing barn (PRN 54285).

The building has been outlined as a possible candidate for restoration under capital works offered within Tir Gofal. Alhough altered it is still an important element of the historic farmstead group. Its ongoing deterioration would be to the detriment of the farmstead as a whole. In addition to the Generic Management Prescriptions listed above the following is emphasised.

- Repairs should be based on an ethos of repair over replacement as far as is practicably possible in order to preserve the historic character of the building.
- Care should be taken to re-use the maximum number of old slates possible. New slates should, ideally match the type, colour, texture, size and thickness of the existing ones. New slates can be mixed with old ones across the roof or reserved for less prominent slopes.

If restoration is not undertaken the management aim should be to slow down the deterioration of the building.

• Cut back any vegetation or young trees growing on or near the walls leaving the roots *in situ*. This will prevent displacement of masonry by uprooting or collapse.
